Chebsey Conservation Area Appraisal

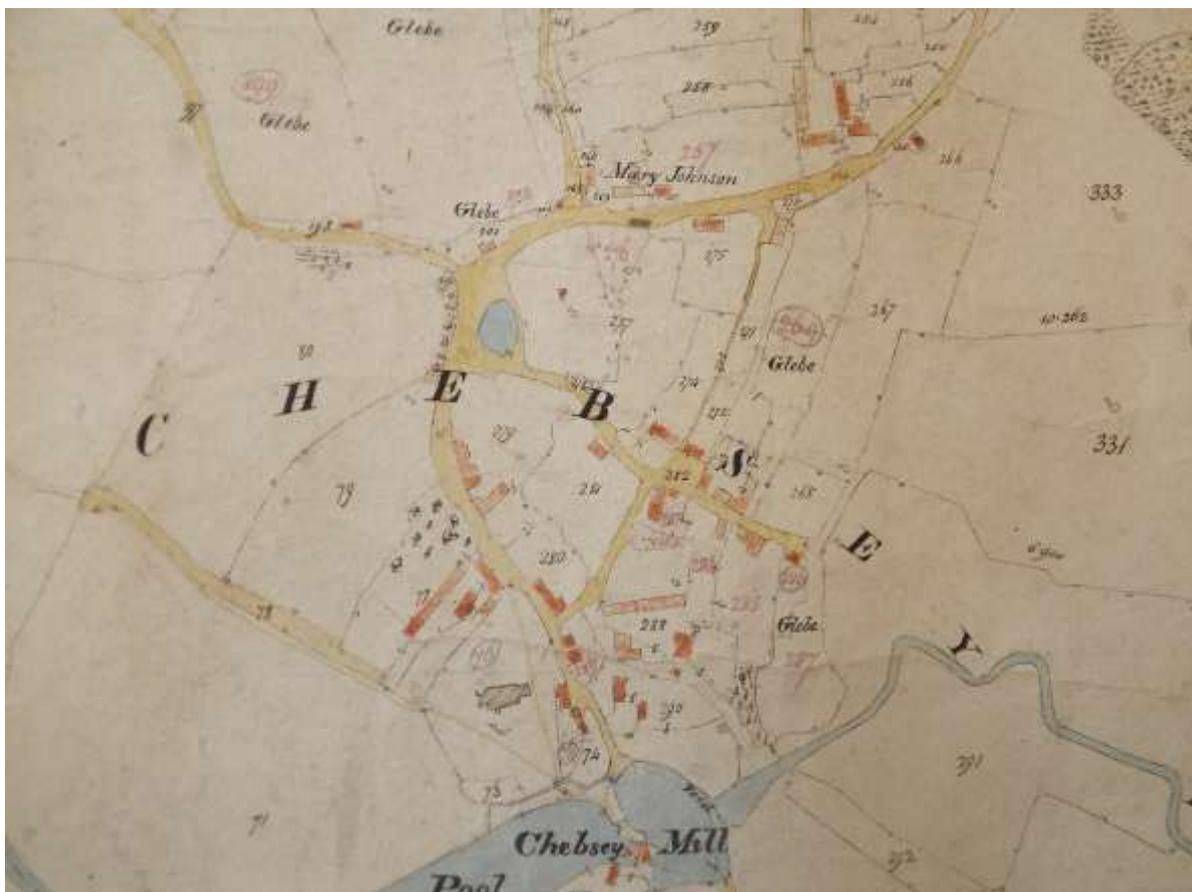
Figure 4: Map of Chebsey 1819. Reproduced with permission from Stafford Record Office

2.3.3 The 1819 map of Chebsey shows a small pond or pool located to the northwest of the core of the village. Not identified on earlier maps this could indicate an element of village planning consistent with the development of rural communities during the 19th century. Possibly created as a focal point or communal area for villagers, the pond has disappeared by the 1847 Tithe map.

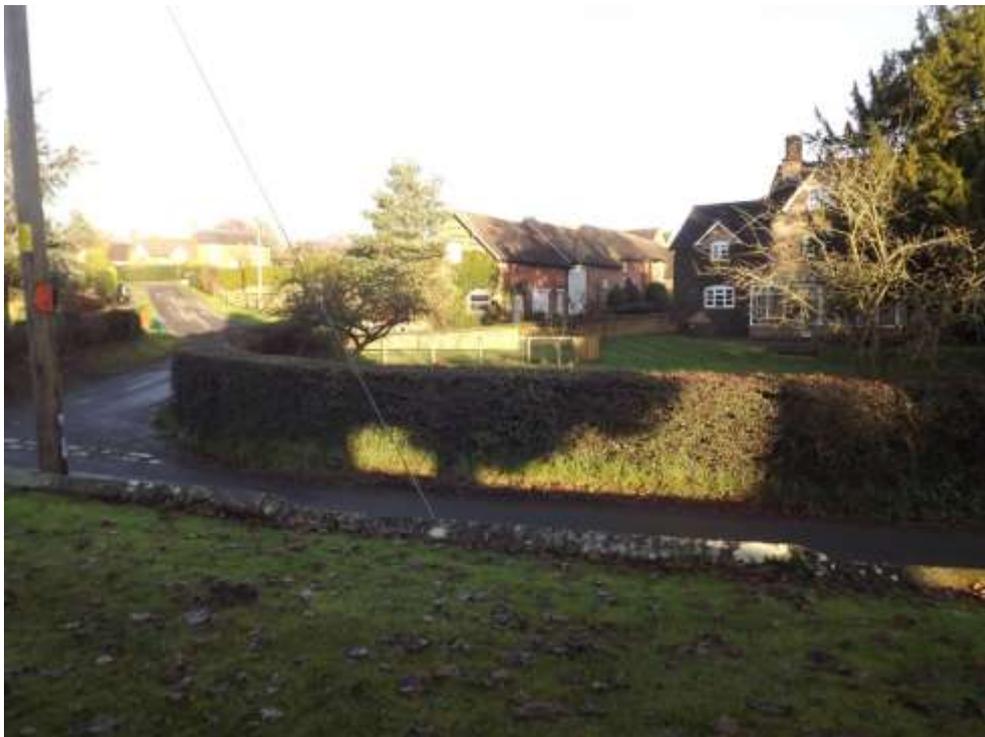
Figure 8 Riverside Farm and agricultural buildings

3.1.3 There are two historic farmsteads in Chebsey. Riverside Farm on the southwest of the Conservation Area is a grade II listed 17th century farmhouse with associated agricultural outbuildings. To the east of the village is Old Mill Farmhouse, formerly Mill Farm, an 18th century farmhouse with 18th and 19th century outbuildings.

3.2.2 Riverside Farm is positioned set back from the road facing away from the village and the church, and is much larger in form than the cottages. Two-and-a-half storeys and on a square plan the house is part of a farm complex containing several buildings arranged around a loose courtyard plan. The agricultural outbuildings are a combination of modest-scale, single-storey, rectilinear buildings with simple gabled roofs of a shallow, stepped pitch, along with other two-storey buildings which now form part of a courtyard conversion. Old Mill Farmhouse is a more modest-scale, two to two-and-a-half storey farmhouse sited next to the church with single storey agricultural buildings arranged around an evolved L-plan courtyard. All agricultural buildings at Old Mill Farmhouse have been converted to domestic use.

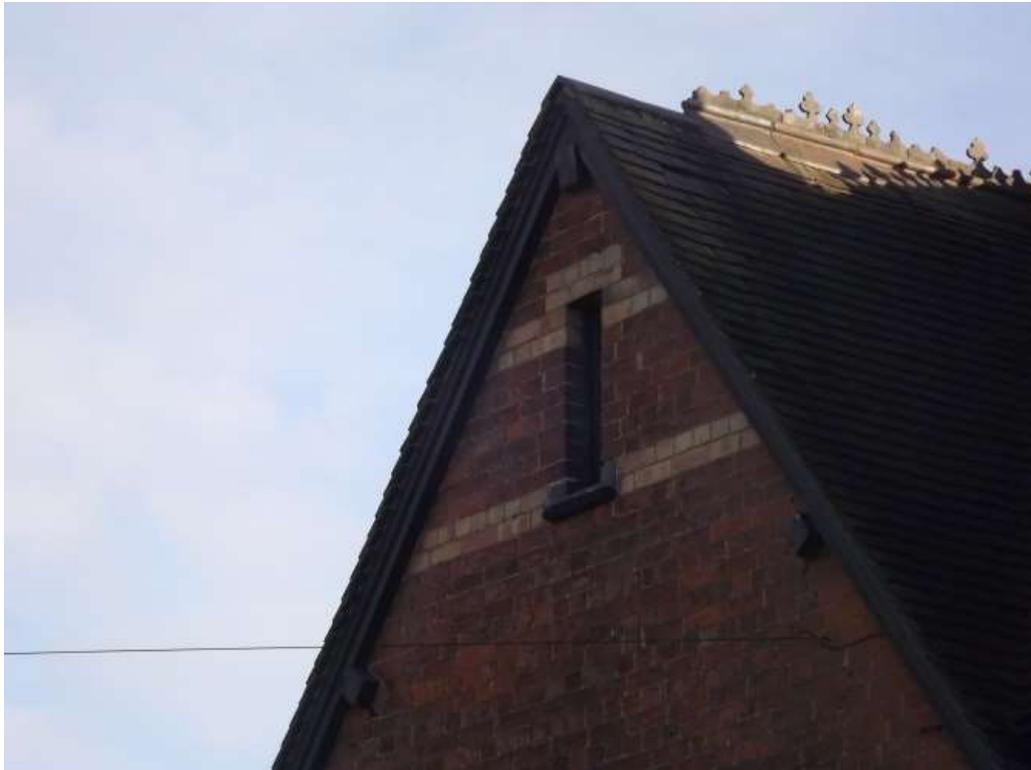
Figure 20 Decorative ridge tiles and slit vent to village hall

3.3.8 Decorative ridge tiles and slit vents are found to the roof of the Village Hall and provide an interesting contrast with the less decorative vernacular buildings elsewhere in the village.

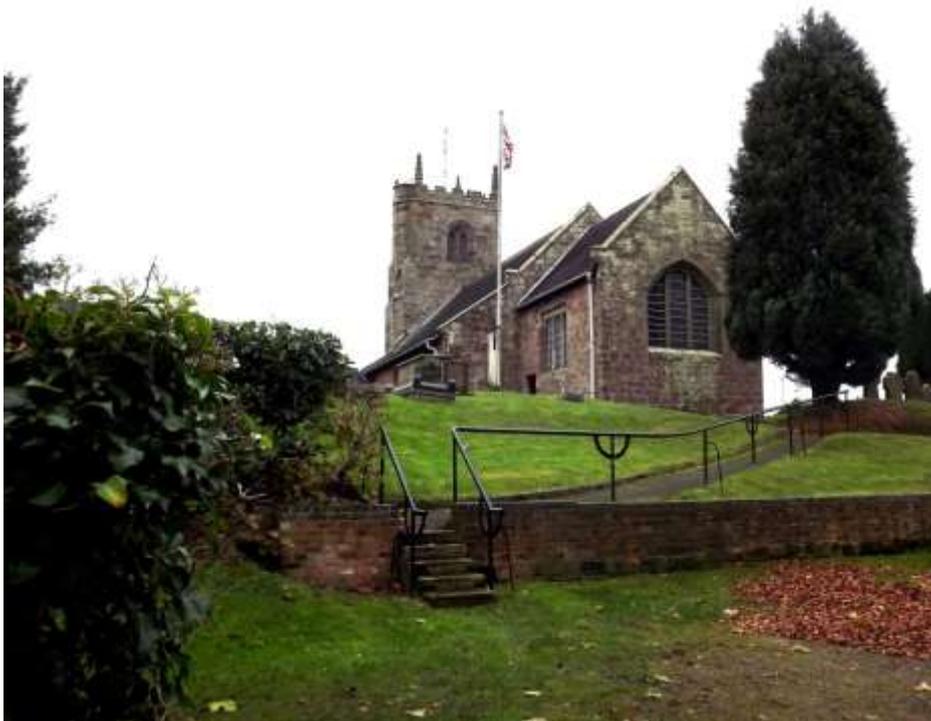
Figure 23 All Saint's Church

Of Norman origins, the Church was built in the 12th century, although is thought to have 11th century foundations. Of red sandstone with a tile roof, the Church retains original fabric in the nave and chancel, and a late Norman north doorway, but also has 13th, 15th, 17th and 19th century additions and alterations. The turret on the southeast corner of the tower houses an external staircase and there are late 19th century stained glass windows by Charles Eamer Kempe. The south wall has had large areas of recent repair and replacement red sandstone.

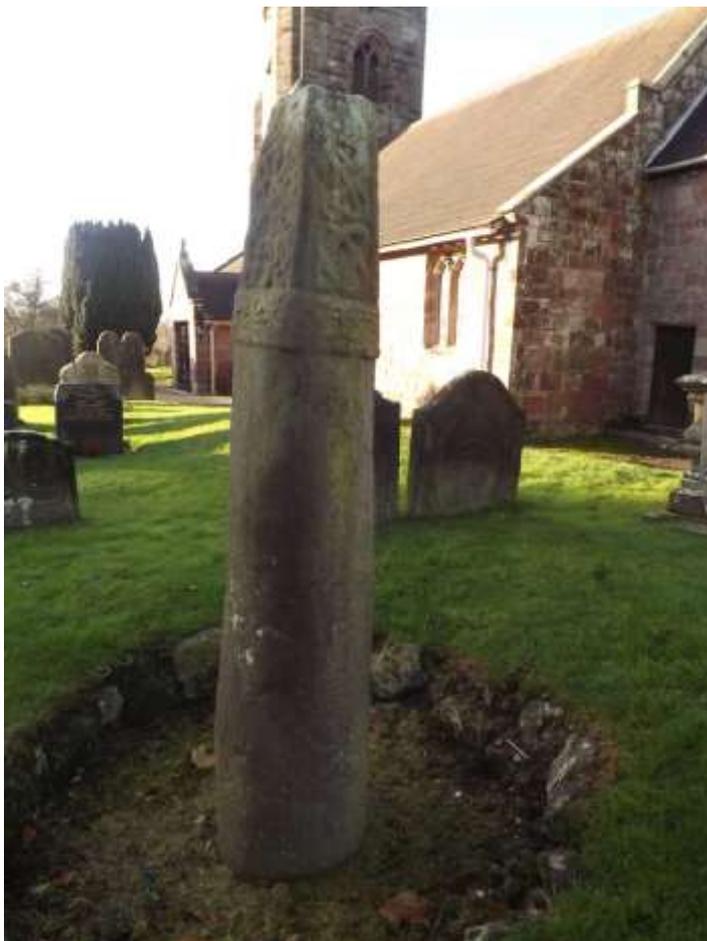
Figure 24 Anglo Saxon Cross

The Anglo-Saxon stone cross shaft lies to the south of the south east corner of All Saint's Church, and is a good example of an early medieval cross with Scandinavian-influenced ornamentation on the shaft. Built from millstone grit, the cross shaft is 2.2 metres high with a round base tapering up towards a collar above which is a rectangular stem. The cross is decorated with intertwined oval rings and vine scrolls to the north and east sides, and interlaced plaitwork to the west; the south side design is indistinguishable. Appearing on 18th century mapping as a 'pillar', the cross is believed to stand in or near its original position and retains its original fabric.

The cross at Chebsey is a good example of an early medieval cross with Scandinavian-influenced ornamentation on the shaft. Situated near the south porch of the church, it is believed to stand in or near its original position. Partial excavation of the area immediately surrounding the cross failed to locate the bottom of the shaft, indicating that archaeological deposits relating to the monument's construction and use are likely to survive intact at some depth below the present ground surface. The cross has not been restored and has continued in use as a public monument and amenity from at least the 11th century to the present day.

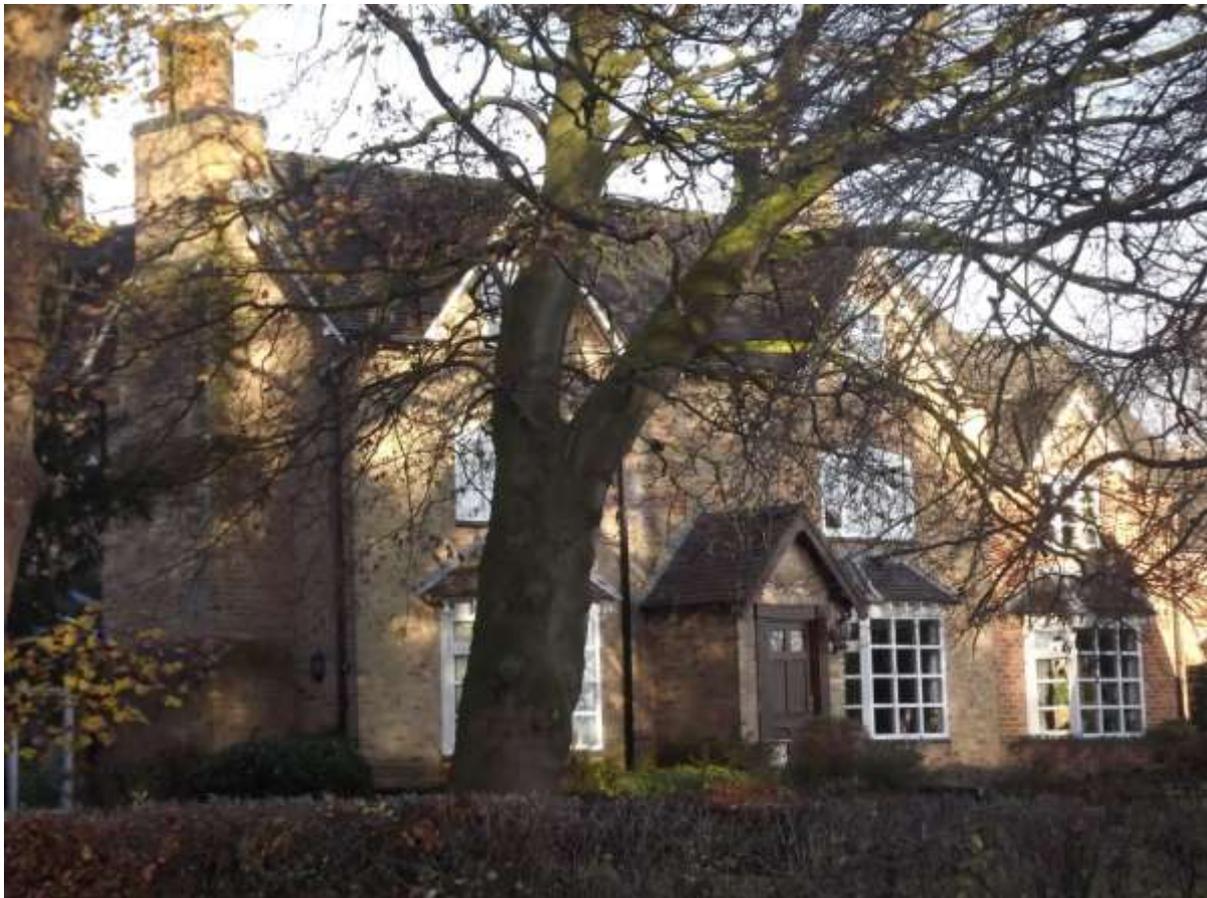
Figure 25 Riverside Farm

Located to the south of the Conservation Area, this substantial building faces out of the village overlooking the River Sow and open fields. Forming part of a 17th century hamlet farm, the farmhouse is of brick with a 17th century timber frame core.

Identified on early maps and plans, Riverside Farm is one of Chebsey's oldest surviving buildings along with the outbuildings to the rear, which are thought to be contemporary with the farmhouse. The farmstead formed part of an early cluster of buildings in this part of the village, including the corn mill, which have all since disappeared.

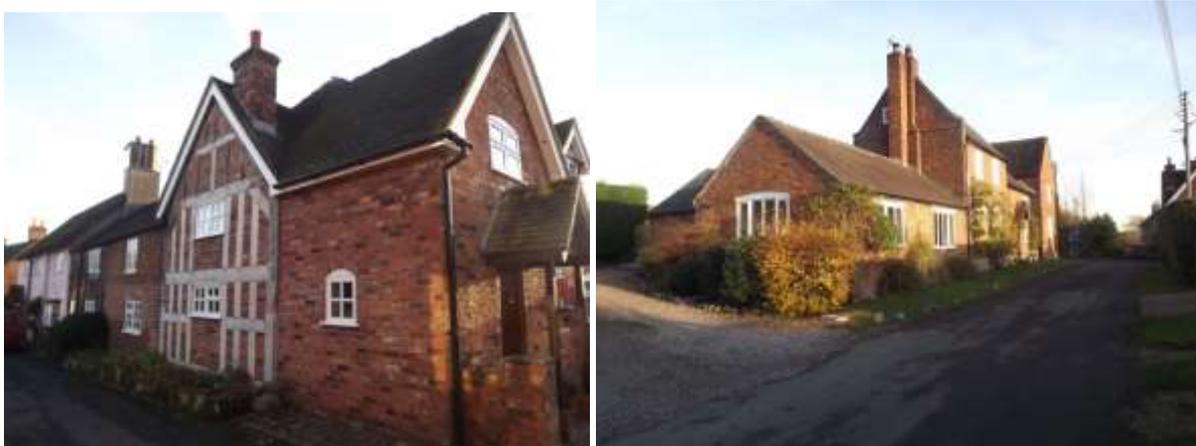
Figure 26 Park Cottages and Park Lane Cottages

Originally one dwelling, these two 17th century timber framed and red brick cottages have areas of exposed timber frame. Sharing one listing, the section to the left was originally single storey, possibly raised in the 19th century, and has some exposed timber frames. The cottage to the right has some original and some replacement timber frame exposed. There is a large side extension and modern uPVC windows have been fitted.

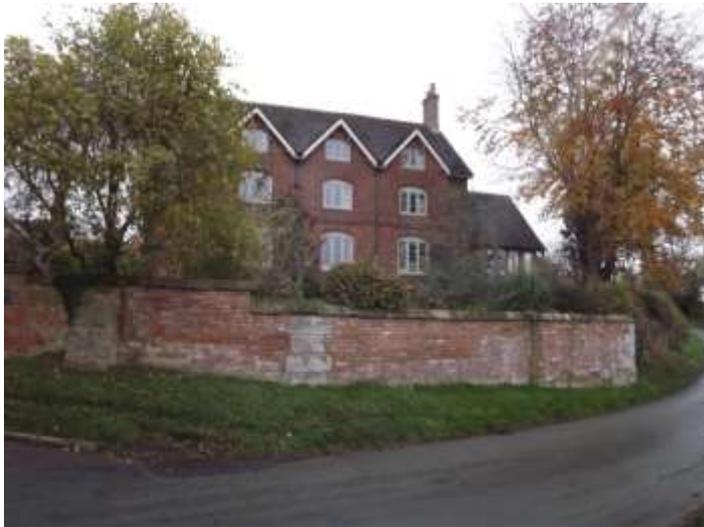
Figure 27 Chebsey House

Dating to the early 18th century, Chebsey House is of red brick with an earlier timber-framed core. A large scale building sited at the top of School Lane, it is in a raised position looking down over the village and has been significantly extended.

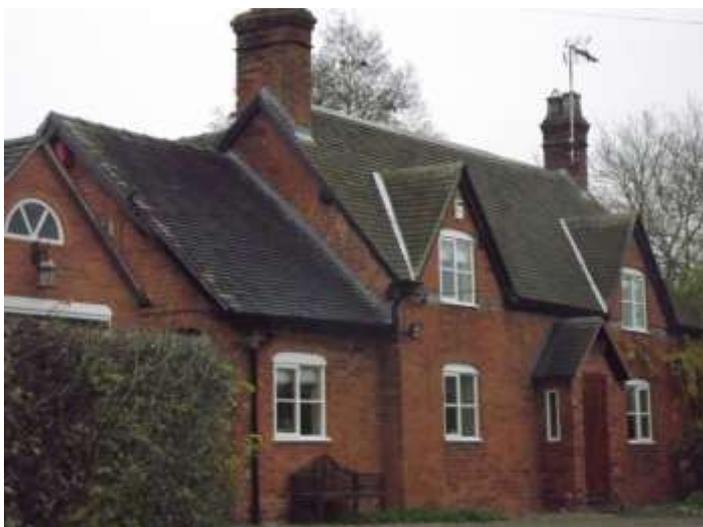
Figure 28 The Homestead

Originally known as The Green, The Homestead is a 17th century cottage of timber frame and brick with later alterations. Of two-storeys, the second storey gabled dormers pass through the eaves and the steep pitch of the roof indicates an earlier thatched roof. There is some exposed timber-framing to the east side elevation.

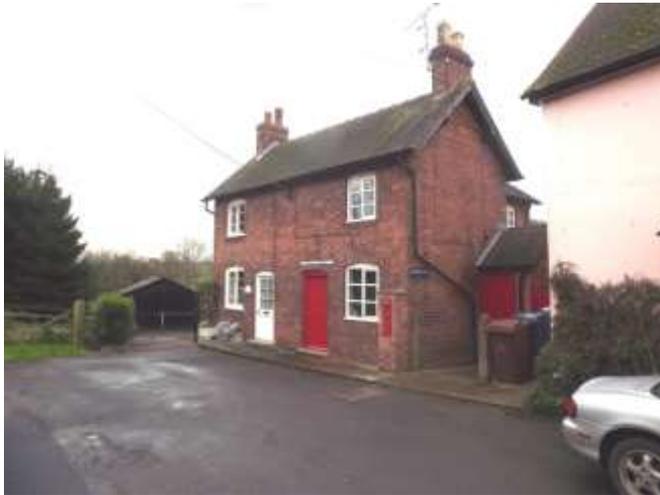
Figure 29 Old Post Office

An 18th century cottage used as a village post office in the 19th century, the building now forms part of a pair of cottages which share a listing. The building is a red brick, two-storey construction with later alterations.

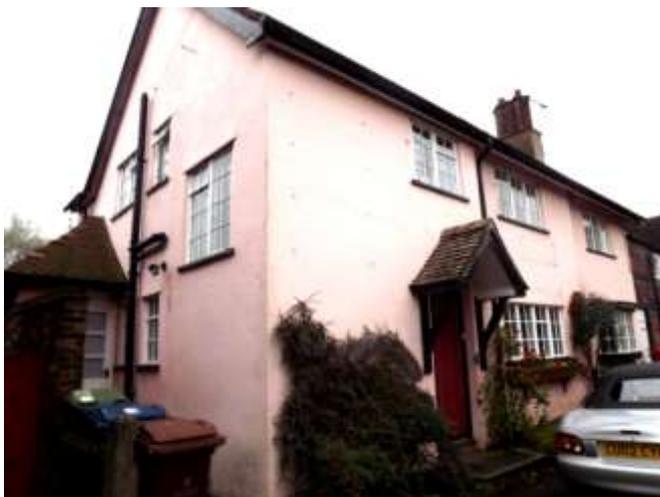
Figure 30 Park Cottage

A two-storey, brick cottage built circa 1800, with later alterations and renovations including 20th century cement render and modern metal casement windows. Forming part of the cluster of historic buildings along Park Lane, the cottage is listed for group value.

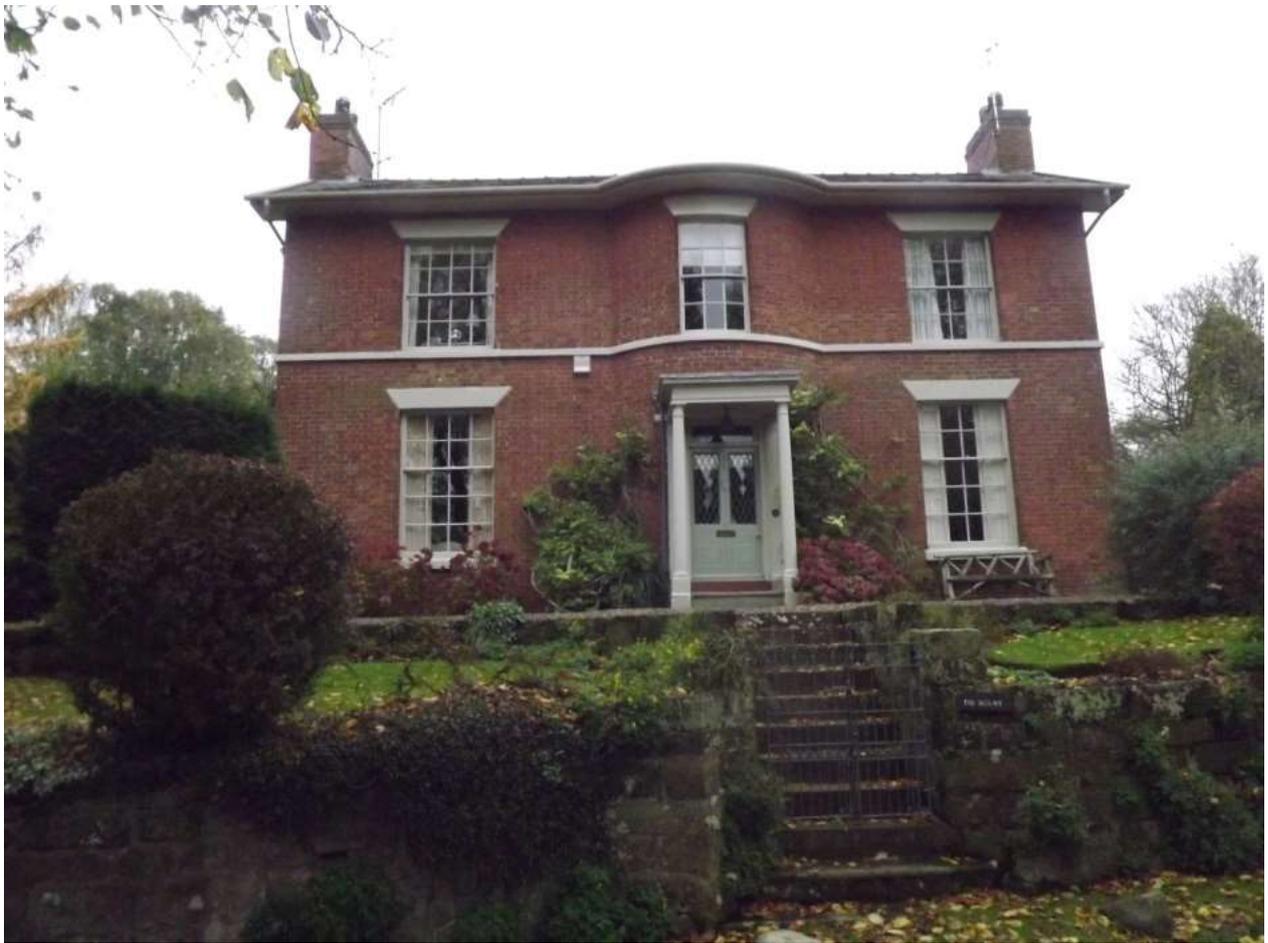
Figure 31 The Mount

An impressive late 18th century/ early 19th century red brick house of two storeys, The Mount displays Regency architecture and adds charm and interest to the village scene. Large sash windows and a double height bow dominate the front elevation, whilst the stone sill band, projecting eaves and porch with Tuscan columns add further interest. The former stables to The Mount lie to the east of the property. Now known as Soapsuds Cottage the stables have been converted into two holiday lets.

3.3.4 Surviving historic sash windows can be found on the 19th century houses along School Lane. The Mount displays original sash windows to the first floor and grand, eight over twelve sashes to the ground floor. The shallow bow window to the second storey central bay is an interesting feature, fashionable in the early part of the 19th century on a house of high status. Surviving sash windows can also be found at the Old Vicarage, and the village hall shows good examples of original Victorian school windows with some historic glass and includes a large tilt window

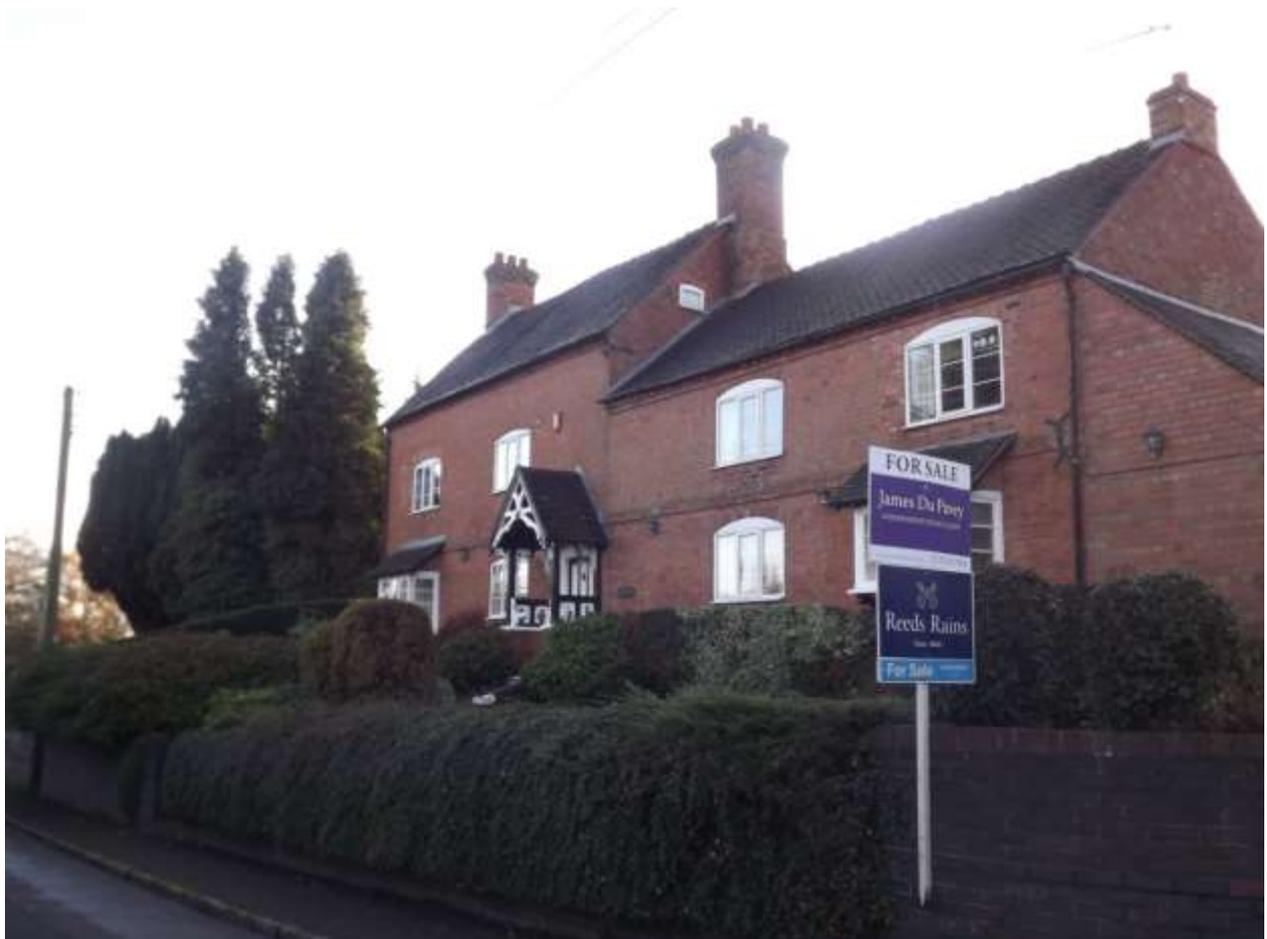
Figure 32 Old Mill Farmhouse

Old Mill Farmhouse is a significant historic farmstead forming part of the rural and agricultural development of Chebsey. Identified on early mapping, the present farmhouse appears to date to the early 18th century and outbuildings to the late 18th century, with site development continuing throughout the 18th and 19th centuries. Dentiled brick cornice to eaves, a brick string course and segmental arched windows, add interest to the building, as does the late 19th century porch.

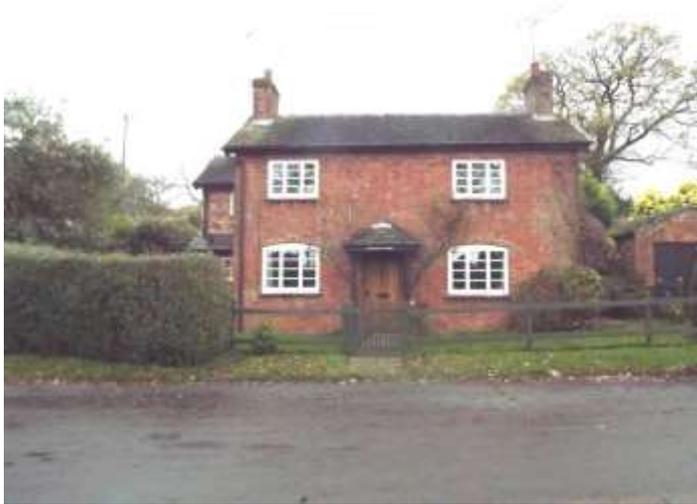
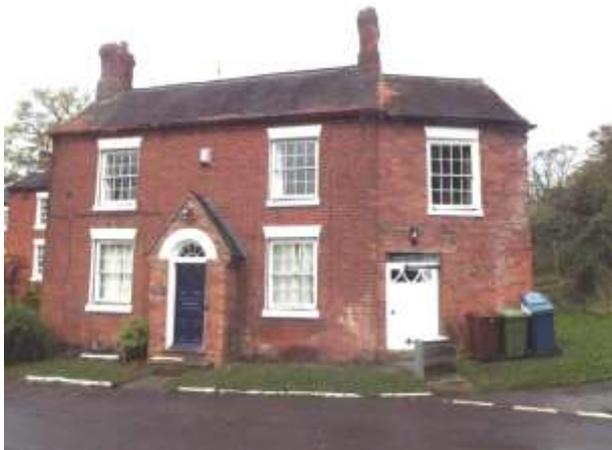
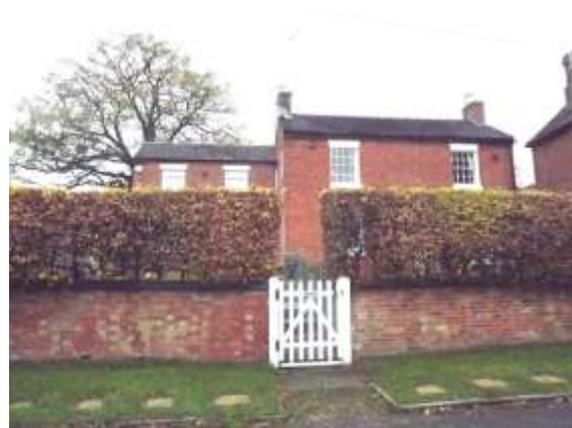
An 18th century red brick and tile cottage with later additions, this building is identified on the 1795 map and forms part of a key focal point within the Conservation Area. Sited at the junction of Parsons Bank and School Lane, Hawthorne Cottage is the first building to be seen upon entering School Lane from Church Road.

Figure 33 Hawthorne Cottage (top), The Dove (left) and Croft House (right) form a cluster of historic buildings.

Appearing on historic maps from 1880, The Dove and Croft House form part of the cluster of historic buildings identified as contributing positively to views within the Conservation Area. The buildings appear to date from the mid-late 19th century and are two-storey of red brick and with shallow pitched tile roofs, replacement sash windows, stone lintels and cills. The Dove fronts onto the road and has an unusual angled side extension which appears to be contemporary with the building. Croft House is set back from the road behind a wall and hedge boundary and has been significantly extended.

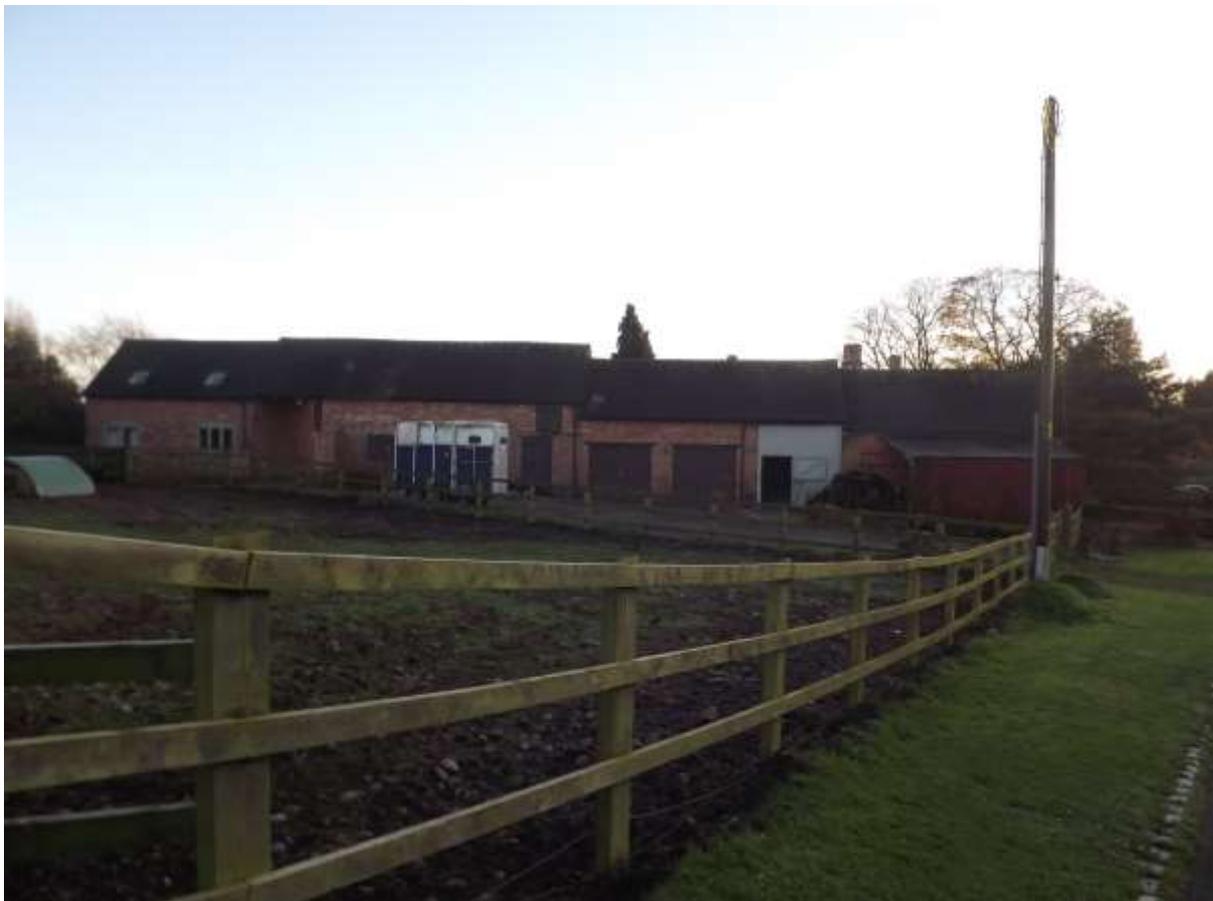
Figure 34 Agricultural buildings to Riverside Farm

The agricultural buildings at Riverside Farm retain some original fenestration that defines their original use. Identified on early 18th century mapping, these buildings are most likely contemporary with Riverside Farm. One section of the buildings has been converted to domestic use.

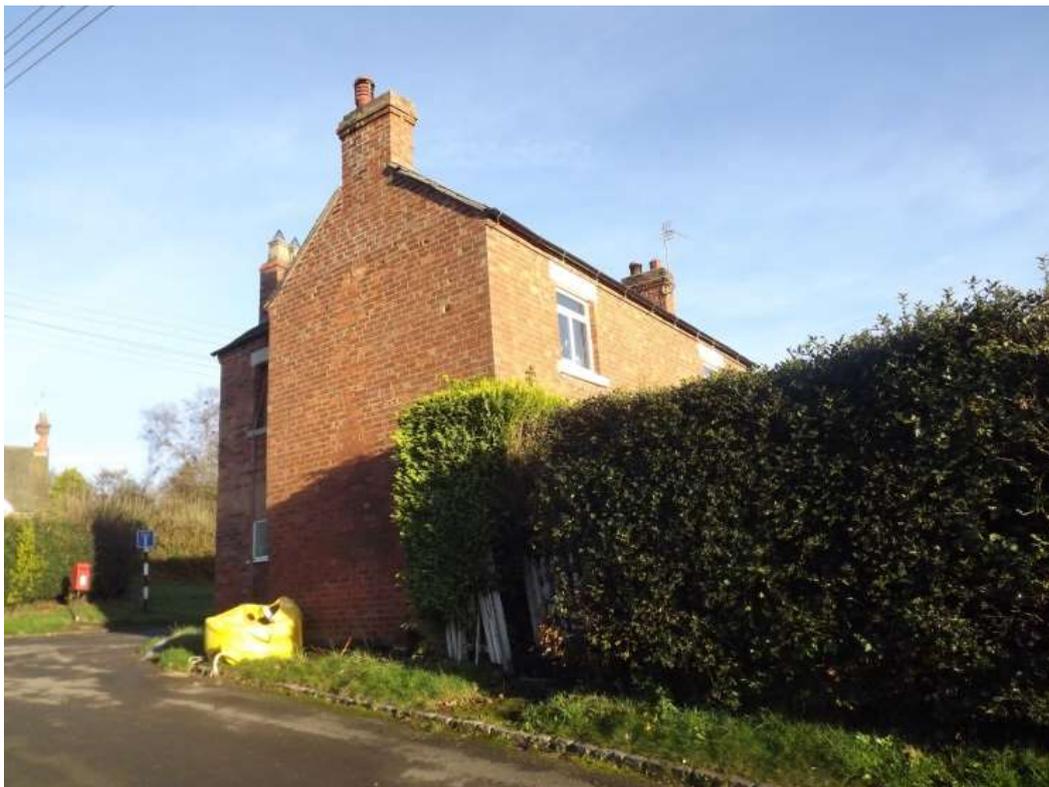
Figure 35 Dove Cottage

A building is shown on this site from 1726, however the present building dates from the very early 20th century. Situated at the corner of The Green and Park Lane, Dove Cottage is oriented with the rear elevation to Park Lane and it is thought that the extant building surrounds a much earlier structure. Of a similar style to The Dove and Croft House, the building is two-storey, of red brick and tile, and has been extended to the rear.

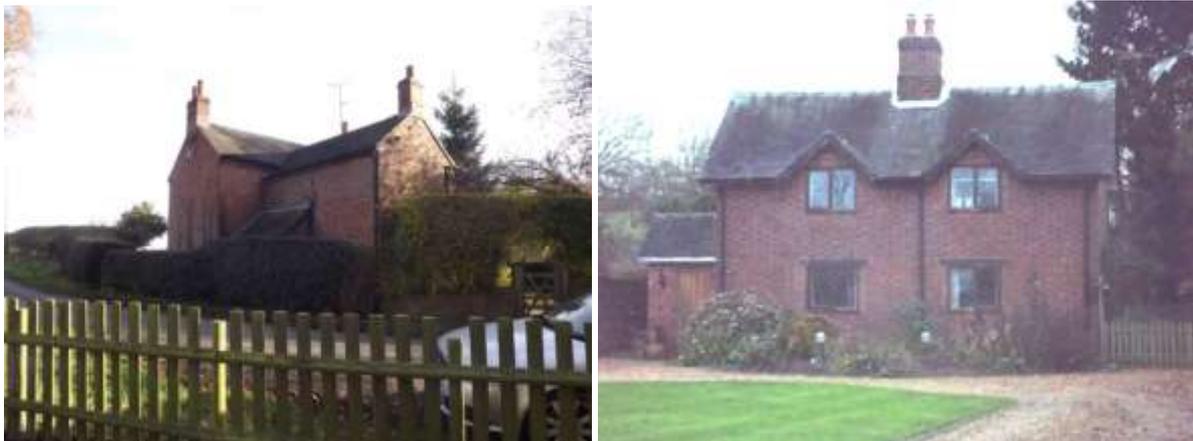
Figure 36 Drumble Cottage and The Gardens

Set back from Church Road behind tall hedgerows and within its own grounds, The Gardens is a secluded, small-scale, two-storey cottage with gabled dormers mirroring earlier styles of buildings within the village. Formerly two farm workers cottages and recorded on mapping from the 1880s, The Gardens sits on the site of earlier buildings, and appears to have occupied an isolated plot until re-development of this part of the village in the mid-late 20th century.

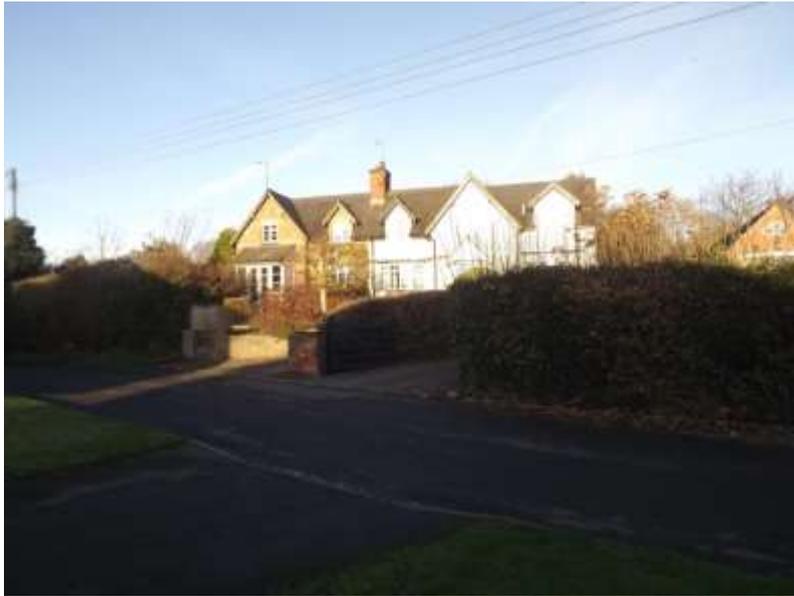
Figure 37 Victorian Cottages

Situated along The Green is a pair of semi-detached Victorian cottages of red brick and tile with forward-facing gables and dormers. Built between the 1840s and 1880s, both cottages have been altered and extended, however they retain their basic form including distinctive gables and dormers. Kenavon Cottage to the right has been rendered and painted but both are significant 19th century buildings within the village.

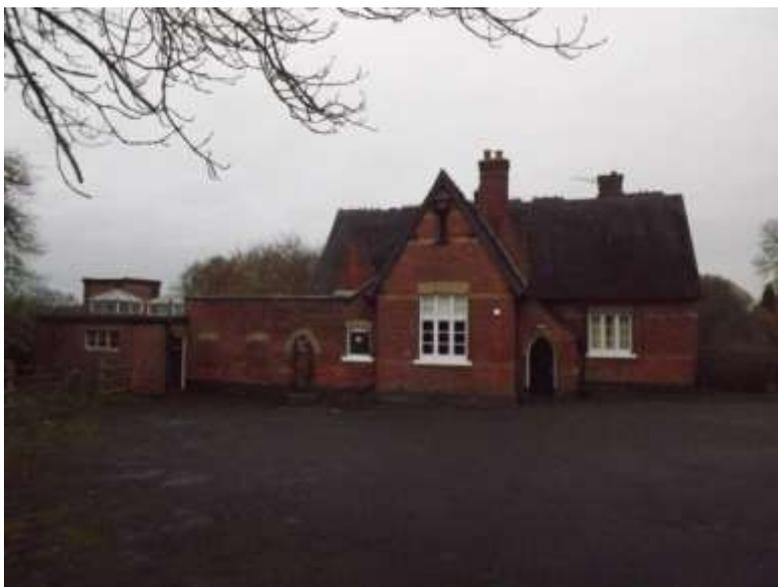
Figure 38 The Village Hall

Built in the 1860s as a school, the Village Hall is a building of note with a distinct Victorian style and many architectural features. Situated half-way along School Lane, with views down over the village, the building was identified on the 1st edition OS map of 1880 as a School (for Boys and Girls). Known as the Laurence Panting School it remained the village school until the 1980s, becoming a village hall shortly after.

3.2.3 The 19th century buildings of Chebsey tend to be located outside the main cluster or core of the village. The village hall (previously the village school) is sited along School Lane. Built to an asymmetrical plan form of double height single-storey and two-storeys with steeply pitched gabled roofs, the building is set back from the road within its own grounds, which include a large tarmac car park. The Old Vicarage is located to the far northwest corner of the Conservation Area at the end of a wooded lane. A Victorian building of modest scale, the Old Vicarage is rectangular on plan, of five bays with a projecting fourth bay and a hipped roof.

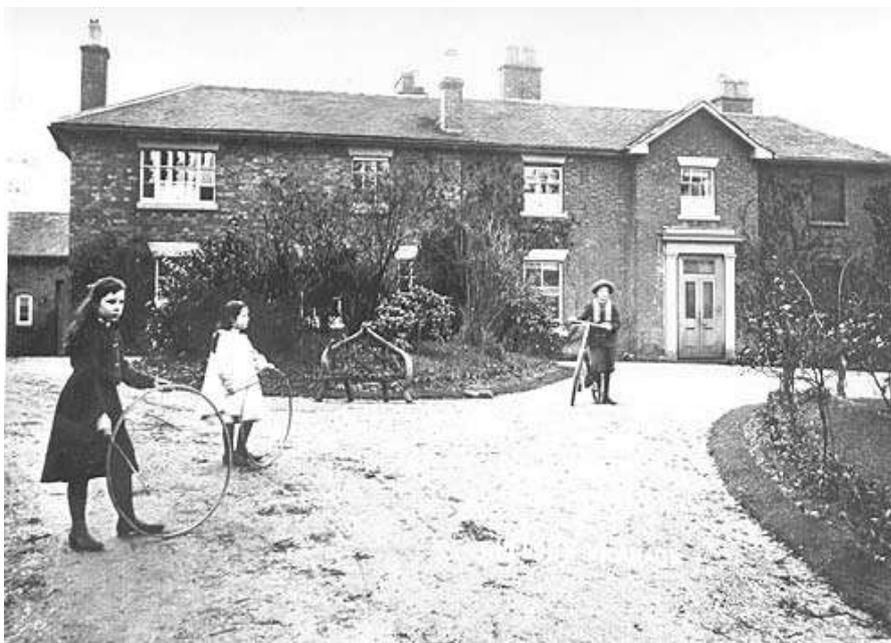
Located to the far northwest of the Conservation Area, the Old Vicarage lies in a secluded position at the end of an avenue of horse chestnut trees and is now surrounded by woodland. Physically separate from the village and the church, this mid-19th century building retains many of its historic features, including an unusual mixture of glazing to the sash windows and different coloured brickwork, suggesting that it was constructed as two separate buildings, or in two distinct phases.

Figure 39 The Old Vicarage in c.1900. Many original features have been retained including some sash windows.

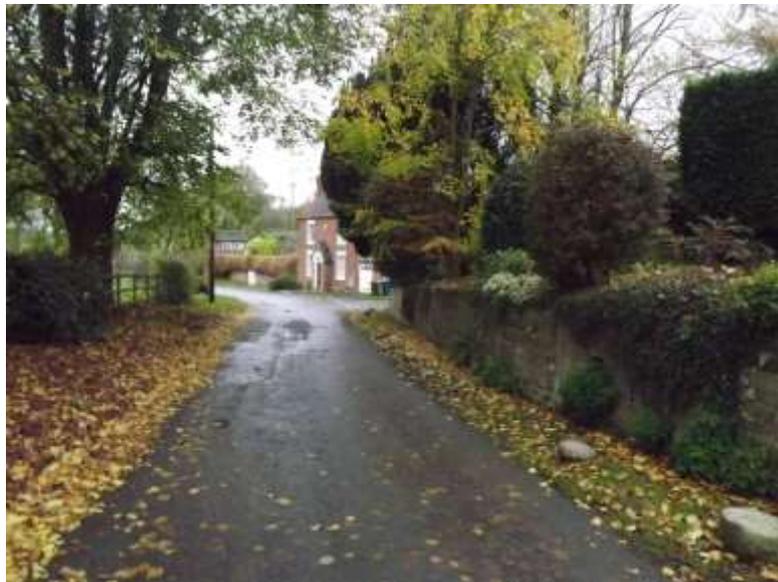
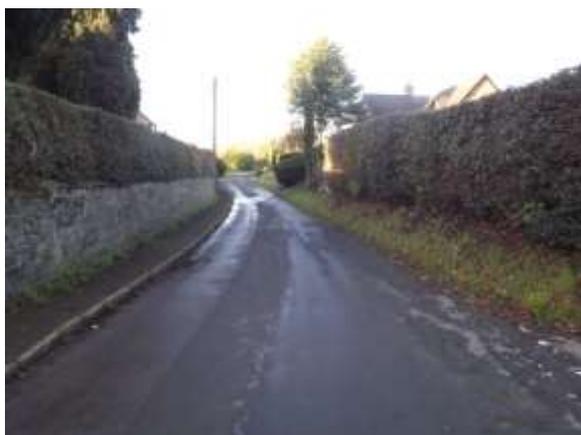
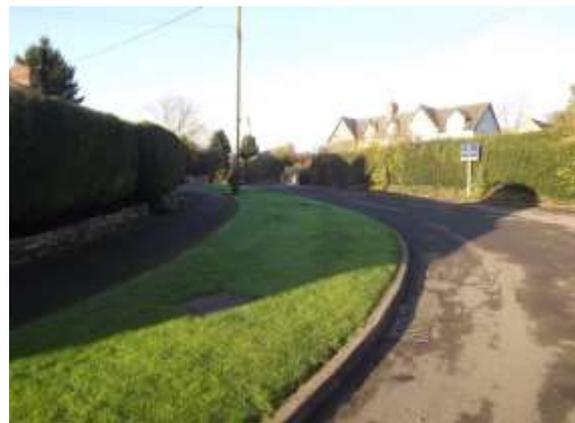
Figure 53 Roads, pavements and verges

4.3.1 All of the roads within the Conservation Area are of tarmac with some road markings, and for the most part have informal grassy verges without kerbs. Those along School Lane and Park Lane display stone bollards which contribute to the rural feel of Chebsey. There is a section of concrete paving to the front of The Old Post Office Cottages, and sections of tarmac paving with a combination of concrete and stone kerbing alternating with grass verges along Church road. There are mid-20th century deep pavements and kerbs with grass borders which give a slightly more suburban feel to the modern housing of The Green.

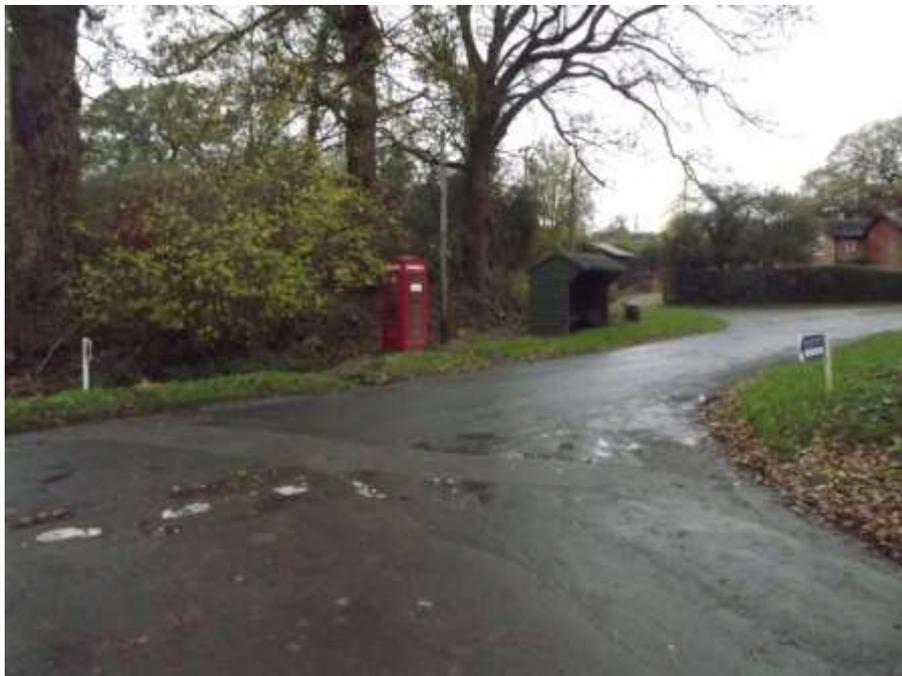
Figure 55 Traditional red telephone box and bus shelter

4.3.3 There is minimal street lighting and highway signage within the Conservation Area, and little street furniture. A traditional red K6 telephone box, a bus shelter, bench and rubbish bin are located before the junction of School Lane with Parson's Bank. There is a new cast iron traditional style fingerpost sign on School Lane and two post boxes on Park Lane, one built into a brick pillar attached to Post Office Cottage.

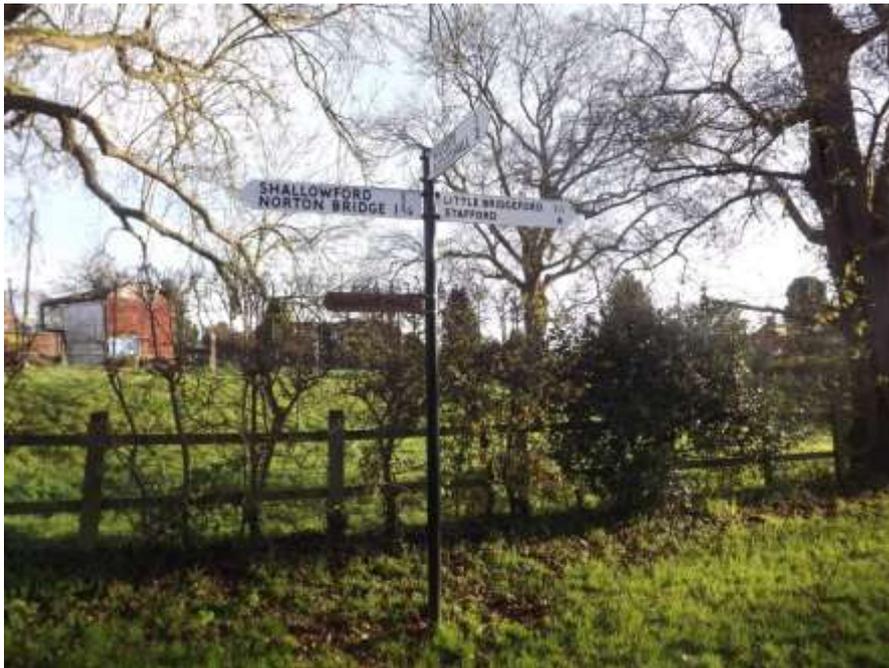
Figure 56 New cast iron traditional style fingerpost sign

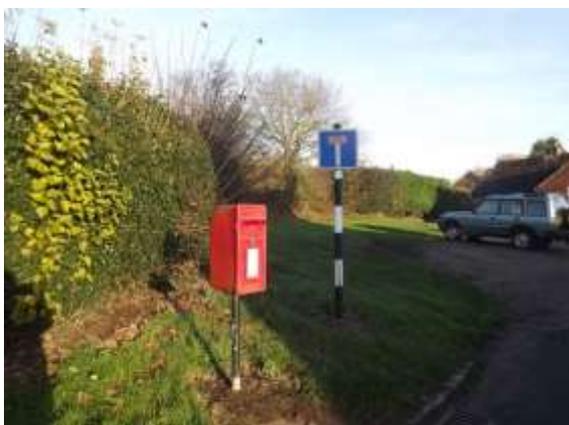
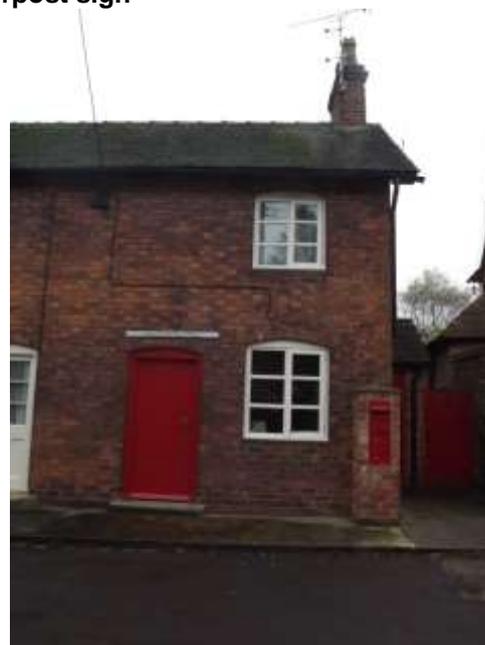
Figure 57 Post boxes along Park Lane

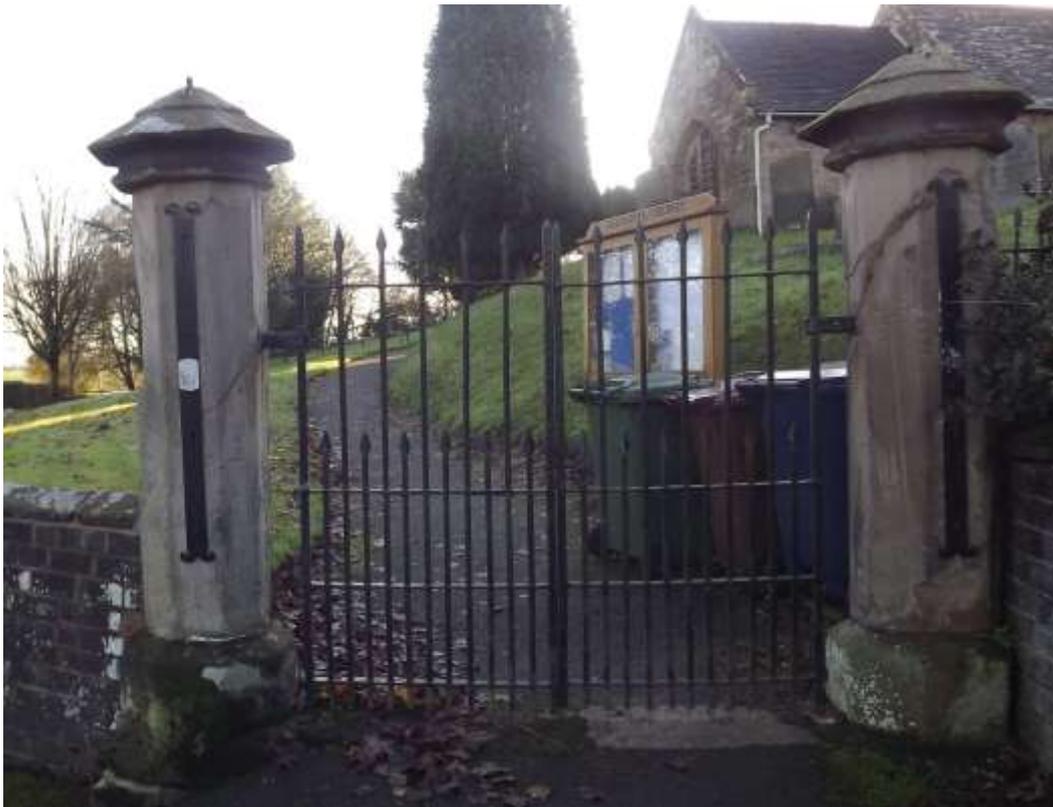
4.6.3 There is occasional timber paling or metal fencing and gates interspersed throughout the village. Wrought iron gates mark the walkway entrance to All Saint's Church and modern black metal railings follow the line of the brick boundary wall.

Figure 63 Wrought iron gates at All Saint's Church
