Chebsey Conservation Area Appraisal

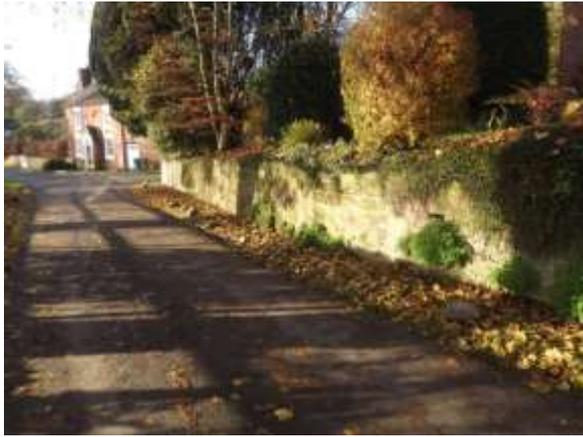
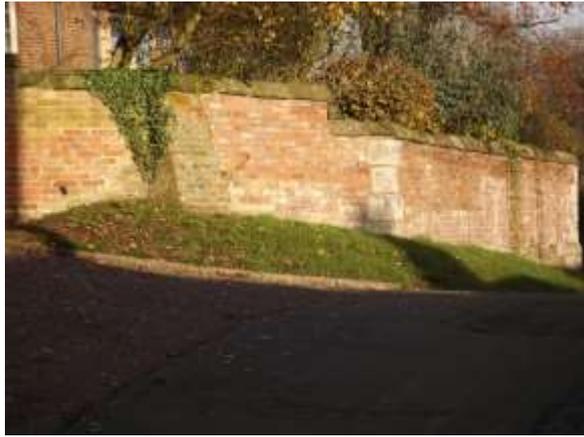
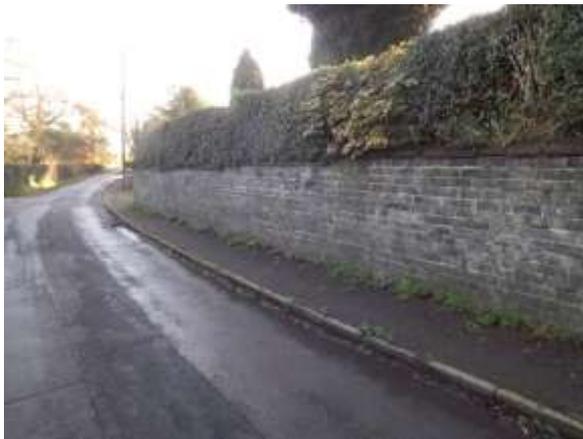
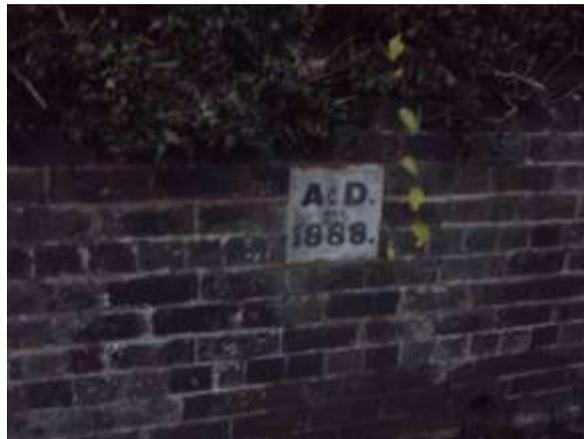
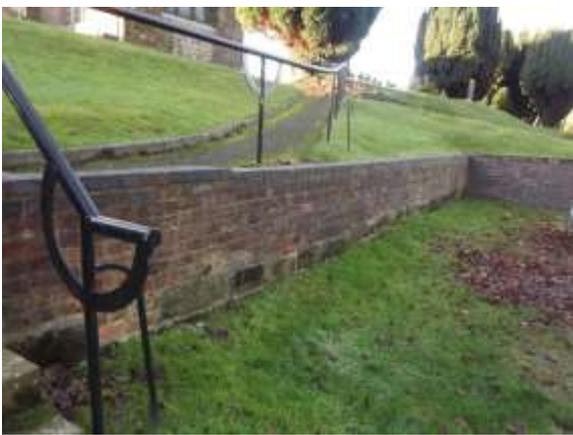
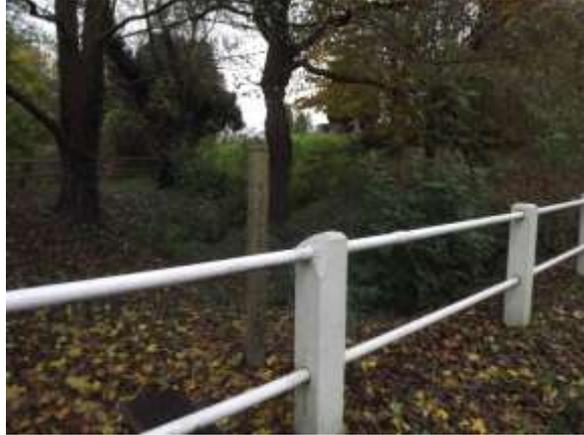
4.6.1 The typical boundary treatments within the Conservation Area are a combination of mature trees, hedgerows and red brick and/or stone boundary walls.

4.6.2 To the south of the Conservation Area along Church Road there is a contrast in boundary treatment, with predominantly blue brick walls, stone copings and moulded stone gateposts to the Church boundary. A bridge of blue brick with stone copings, bounded on either side by white, modern post and rail fencing, defines the southerly entrance to the Conservation Area.

Figure 64 a variety of boundary treatments within Chebsey Conservation Area
