Fulford Conservation Area Appraisal

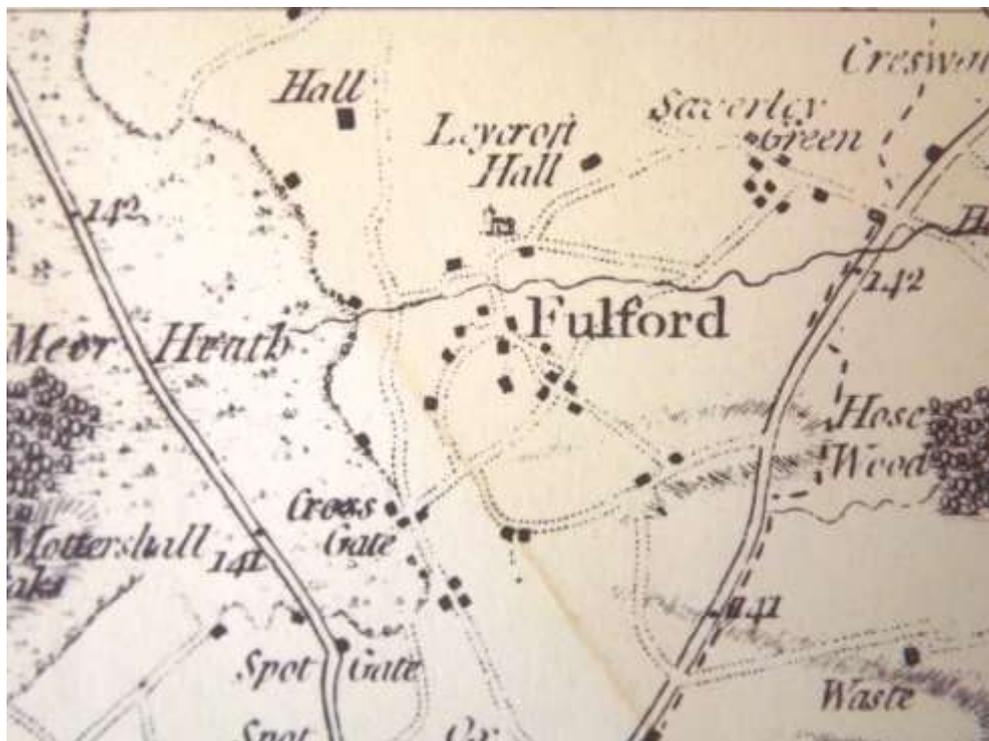
Figure 3 Yate's map of Staffordshire 1775 shows the early linear development of Fulford

2.2.4 The historic buildings of Fulford follow a general linear development pattern and cluster at road junctions to the north and south of the village, creating two satellites at each end of the connecting route. Staffordshire County Council's Historic Landscape Characterisation map shows these historic buildings as pre-1880s settlement, which suggests the road layout as it exists is historic. This is further evidenced by Yate's 1775 map of Staffordshire which depicts the linear development pattern along Town End through The Dale and up The Green.

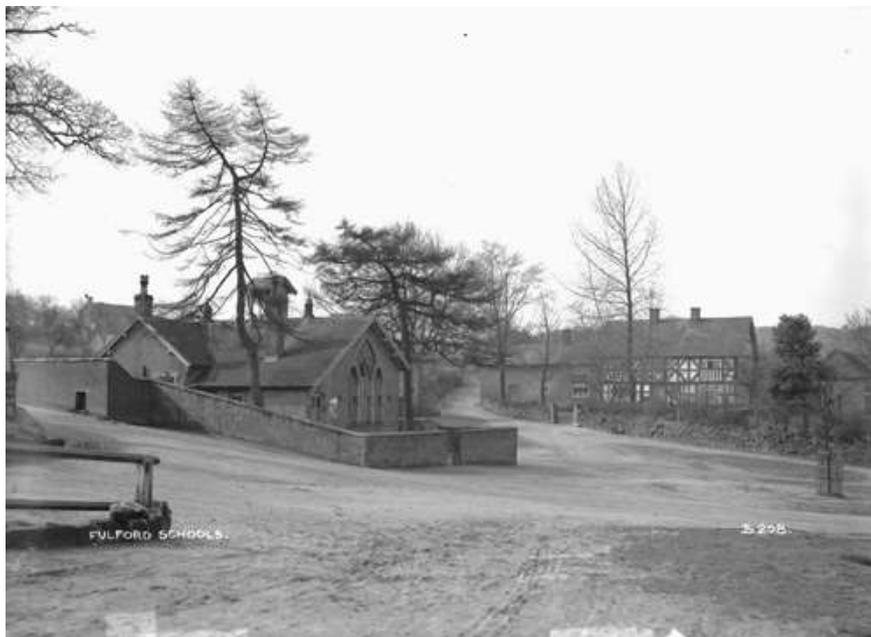
Figure 4 The National School with Olde House Farm in the background (staffspatrack)

2.2.6 Further farmsteads developed during the 17th and 18th centuries. Ivy House Farm survives from the 17th century and Fulford Hall is an 18th century manorial farm, thought to have been built on the site of the old Fulford Manor House. In 1785 the National School was built at the centre of the village on the village green; it remained a school until 1928, being eventually demolished in 1959.

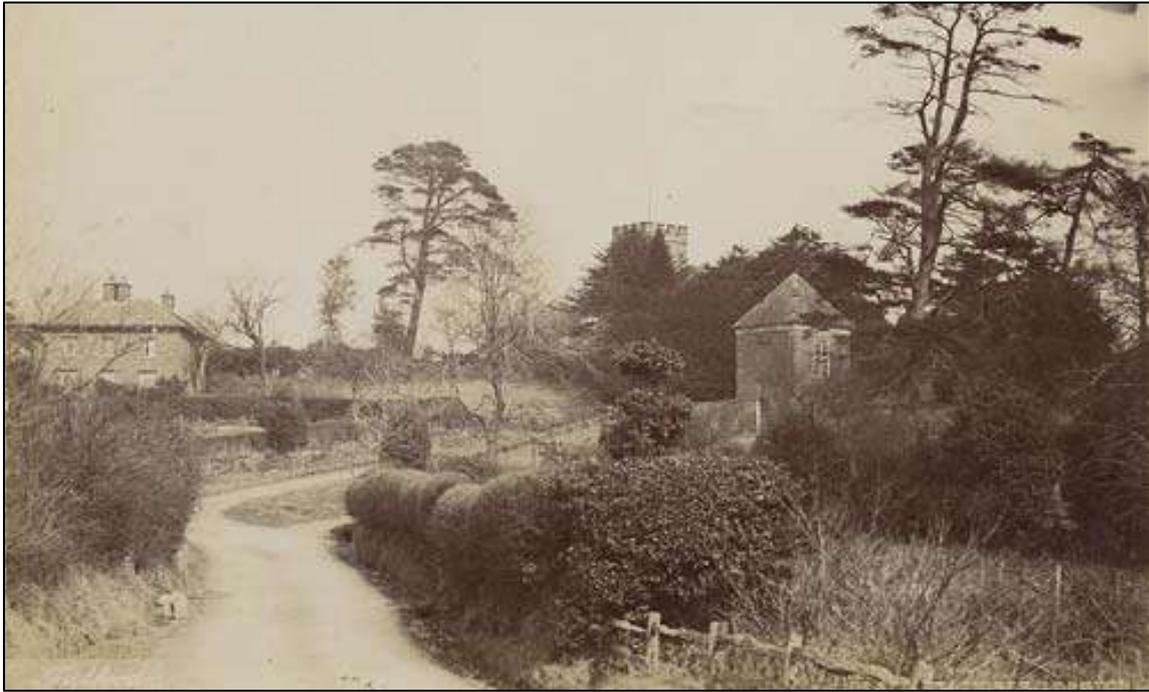
Figure 5 Fulford, 1900-1910, showing the church tower, Fulford Hall Garden house and Church Cottage. The village is remarkably unchanged in this area. Image: Bill Kirkland. Reproduced with permission Staffordshire County Museums Service, reference BK-0147.jpg 189/25625

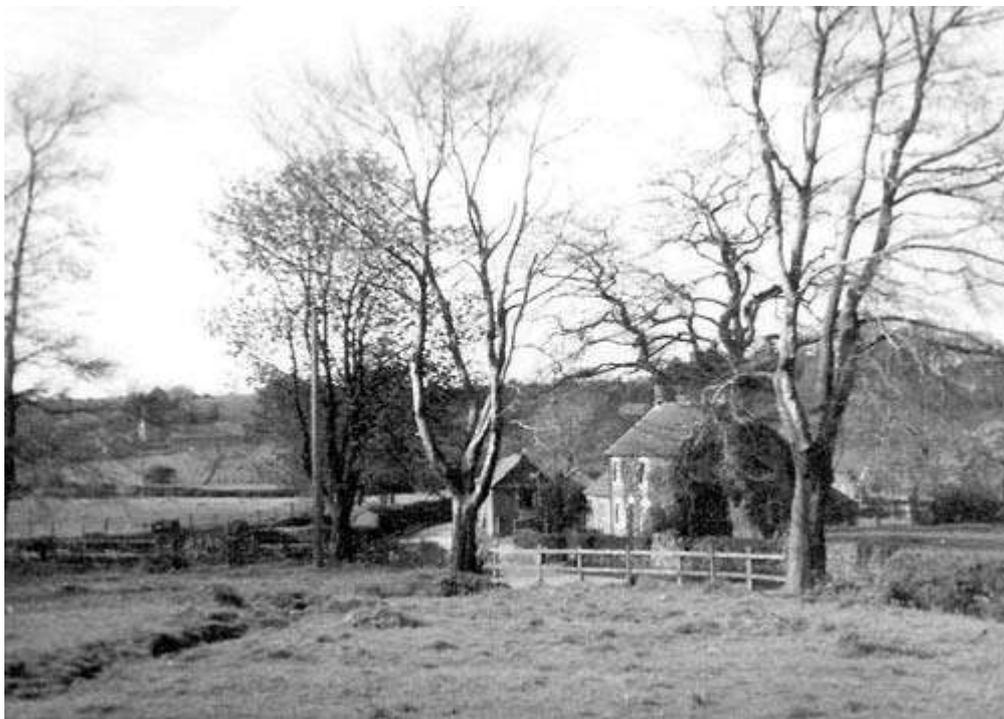
2.2.8 20th century development can be found throughout Fulford. A row of mid-20th century local authority housing is situated along The Green, and there is later 20th century development to the east and west of Ivy House Farm. Whilst this development has left The Green through the centre of the village preserved, the dense siting and cul-de-sac layout has spoilt the plan form of this clearly linear village.

Figure 6 Ivy House Farm set amongst fields which are now home to 20th century development

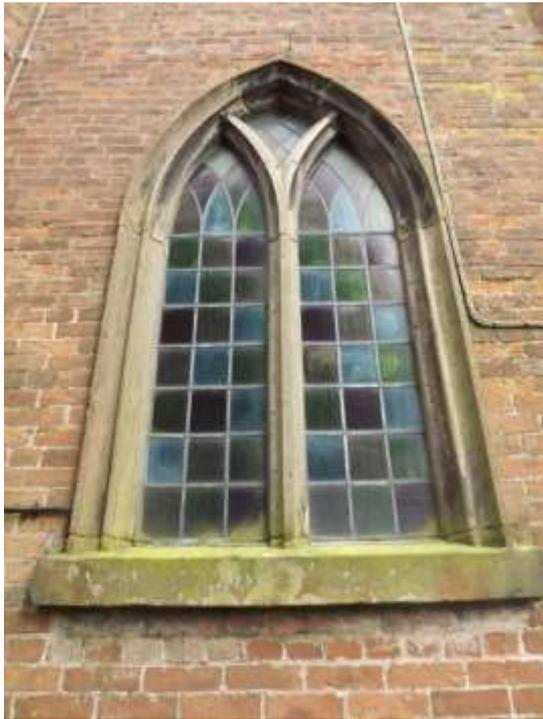
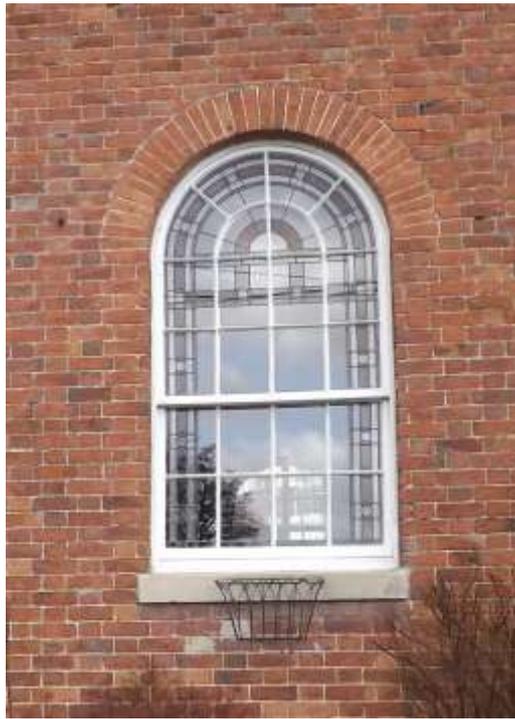
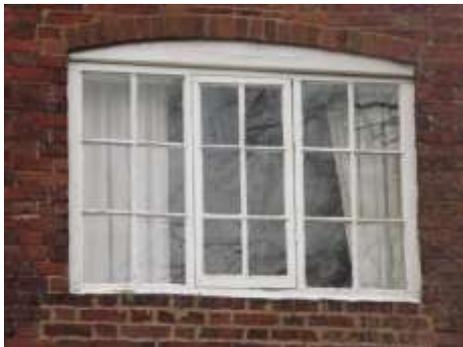
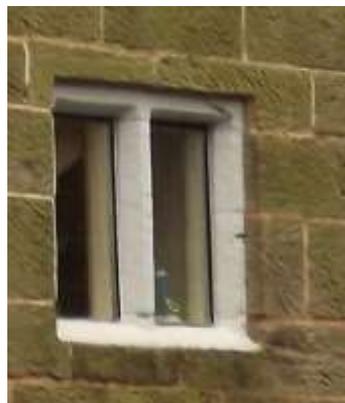
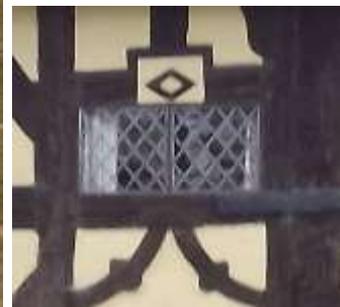
Figure 10 A variety and range of windows in Fulford

Leaded windows to St. Nicholas Church

Arched vertical sliding sash windows to former Wesleyan Chapel

Side opening timber casement windows

Stone mullion windows

Diamond-lead style glass casement windows

3.3.1 A variety of window styles within the Conservation Area highlight the periods of historical development in Fulford over the centuries. Small mullion windows and modest casements at Ivy House Farm and Rocklands sit alongside the grand ecclesiastical windows of the St. Nicholas Church and the former Wesleyan Chapel. The range of surviving window styles emphasise the difference in scale, and the eclectic mix of many of the buildings.

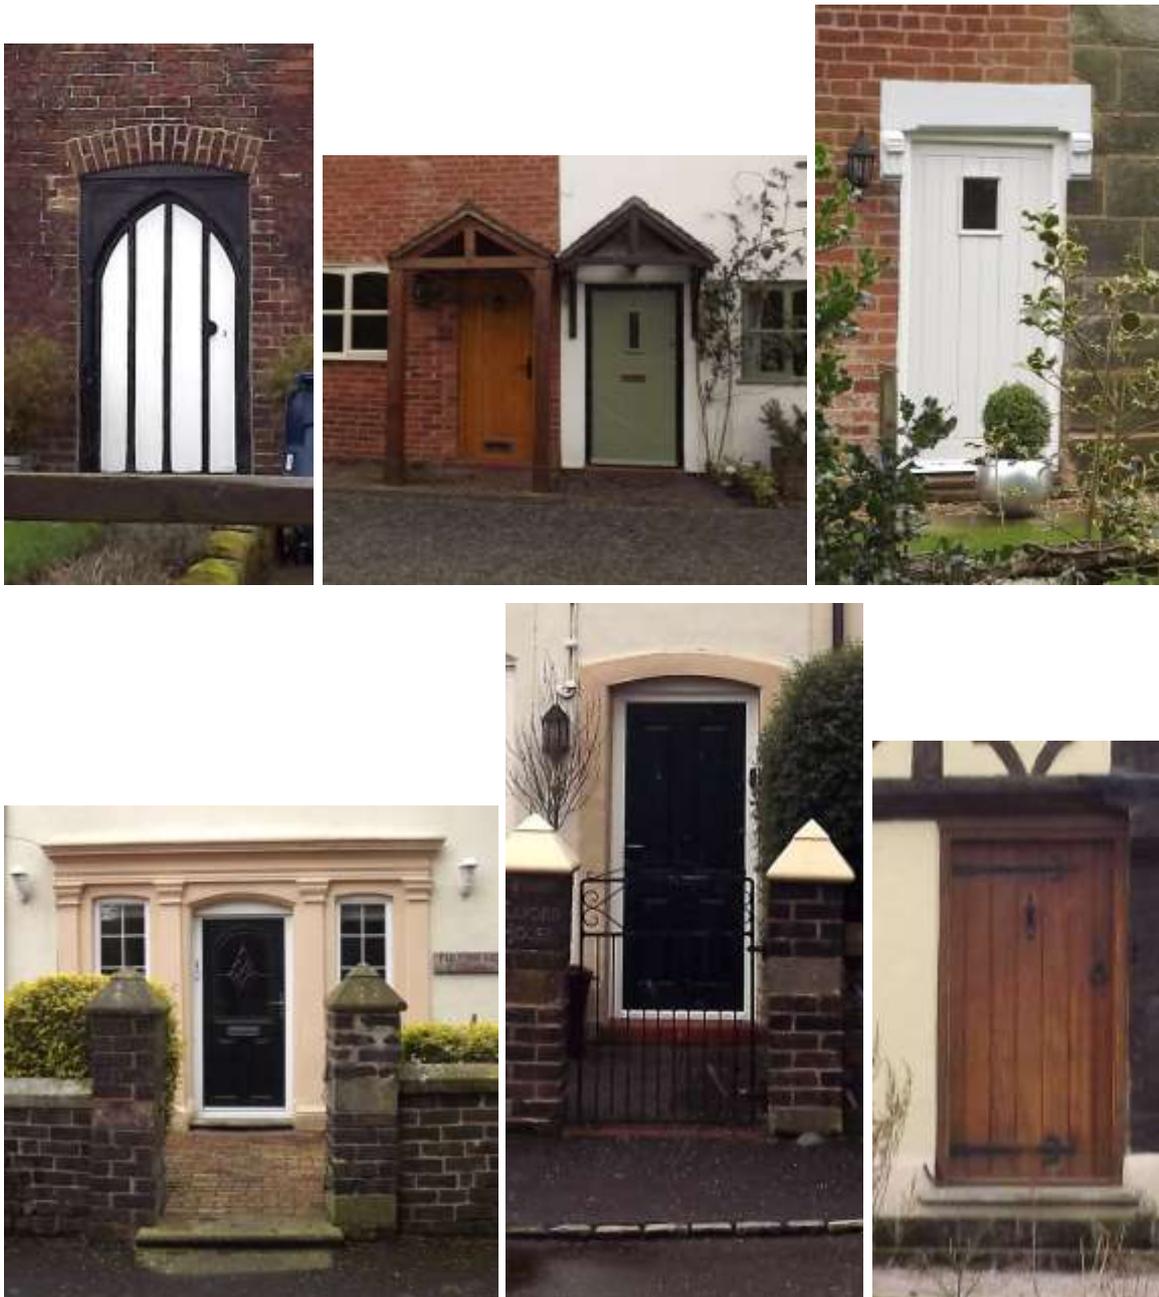
Figure 11 Doorways of the conservation area include gothic style arch and simple plank doors

3.3.2 There is an interesting array of doorways within the Conservation Area; simple timber plank doors can be found alongside more decoratively distinct doorways. The Rocklands displays an early 19th century Gothic style door with pointed arch, which creates an attractive façade, and Fulford House Farm has classical door mouldings to the door case, likely added during the 20th century.

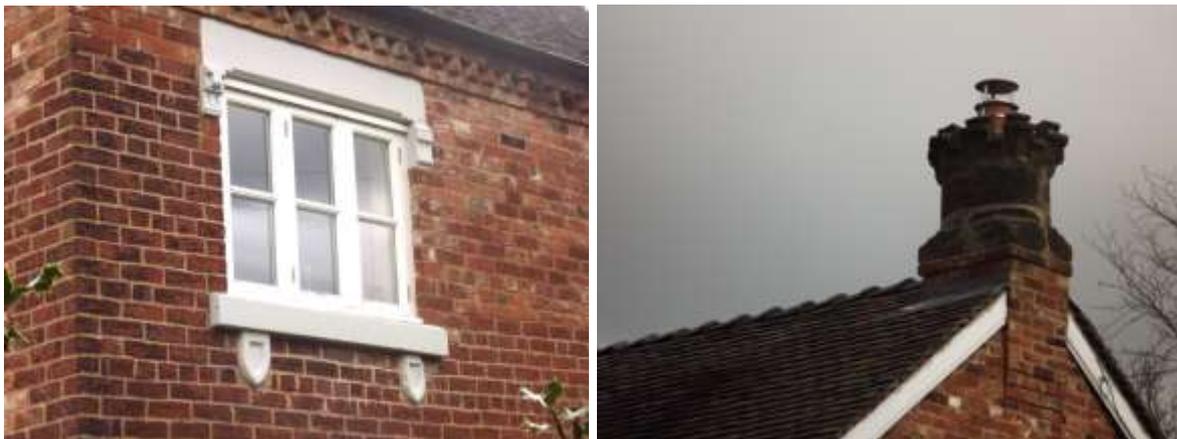
Figure 12 Cill detail and crenallated chimney stack to Ivy House Farm.

3.3.3 There are a variety of decorative and architecturally attractive features within the Fulford Conservation Area. Ivy House Farm has an unusual amount of decorative features for a modest cottage: the display of architectural detailing includes flamboyant crenallated chimney stacks, and elaborate stone lintels and cills with pendant motifs, including triglyphs and shield shapes. Fishscale-style roof tile design can be found to the School House and at Church Cottage, and the studwork and decorative panels to Olde House Farm, with its oversailing roof verges supported on elaborate projecting purlins fashioned as brackets, adds architectural interest to the historic core of the village. Fulford Hall is enlivened with stone detailing including plinth, plat band, eaves cornice and keystones, and the attached Garden House is embellished with stone quoins, plinth and eaves, surmounted with a pyramidal roof.

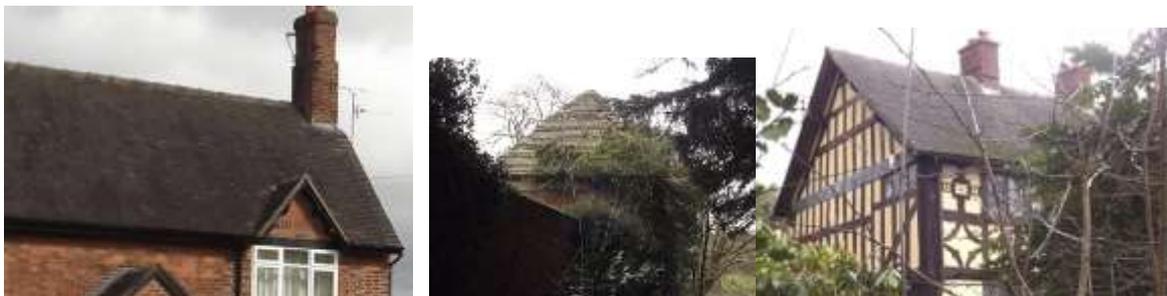
Figure 13 Fish scale design roof tiles to School House, pyramidal roof to the Garden House and decorative panels and projecting purlins to Olde House Farm

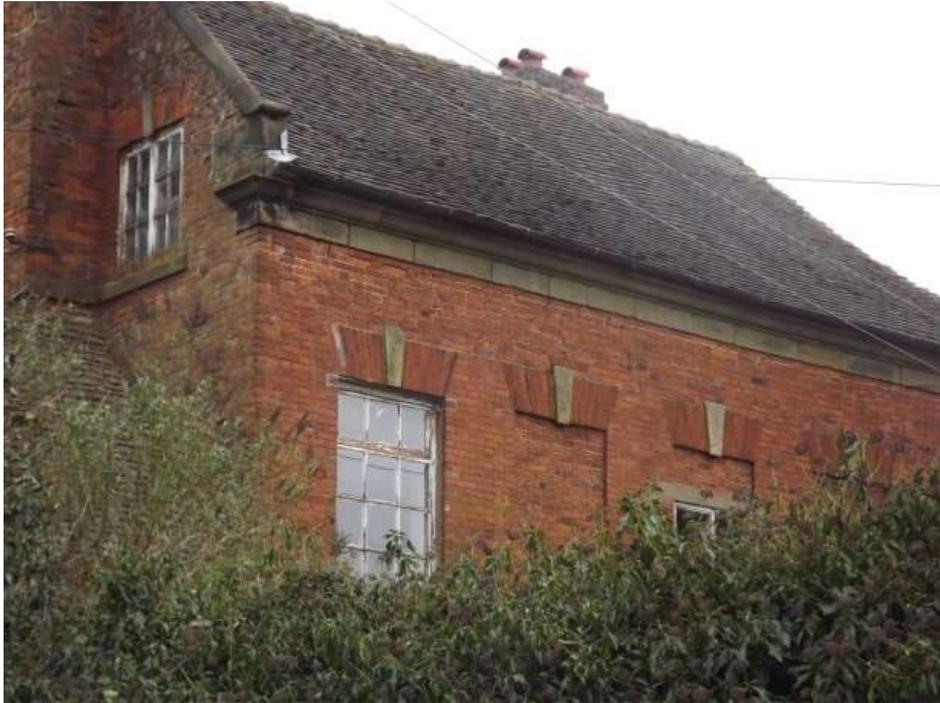
Figure 14 Stone detailing to Fulford Hall

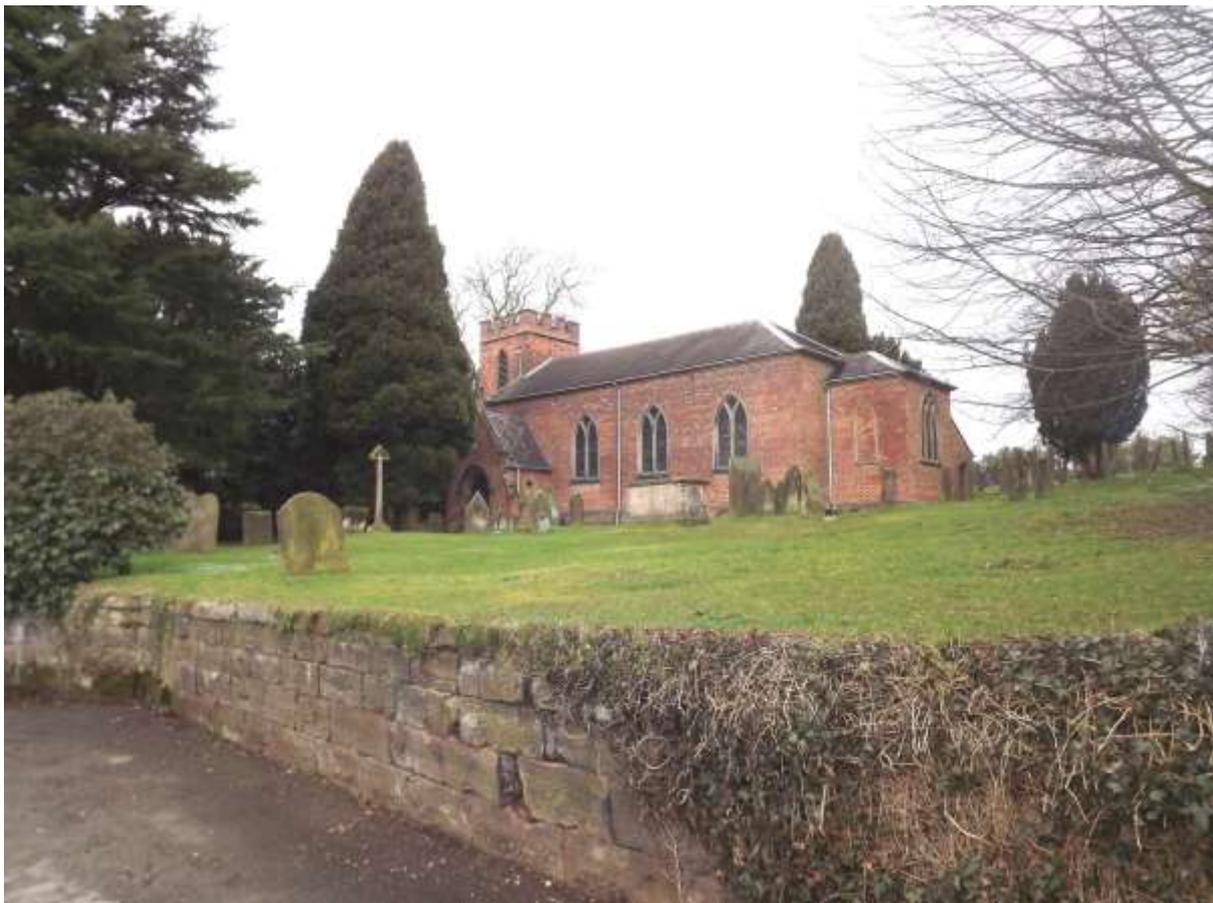
Figure 15 St. Nicholas Church

The Church of St Nicholas is set back from Church Lane, bounded by a coursed stone ashlar wall tooled in a chevron pattern. Dating to 1825, the Church was built by CH Winks and is reputedly on the site of an earlier Norman chapel. The tall evergreen Cedar and Cypress in the churchyard frame and complement this understated, charming Georgian church, which is brick-built with modest proportions and stone detailing. It possesses three pointed two-light windows in the south aisle with original stained glass.

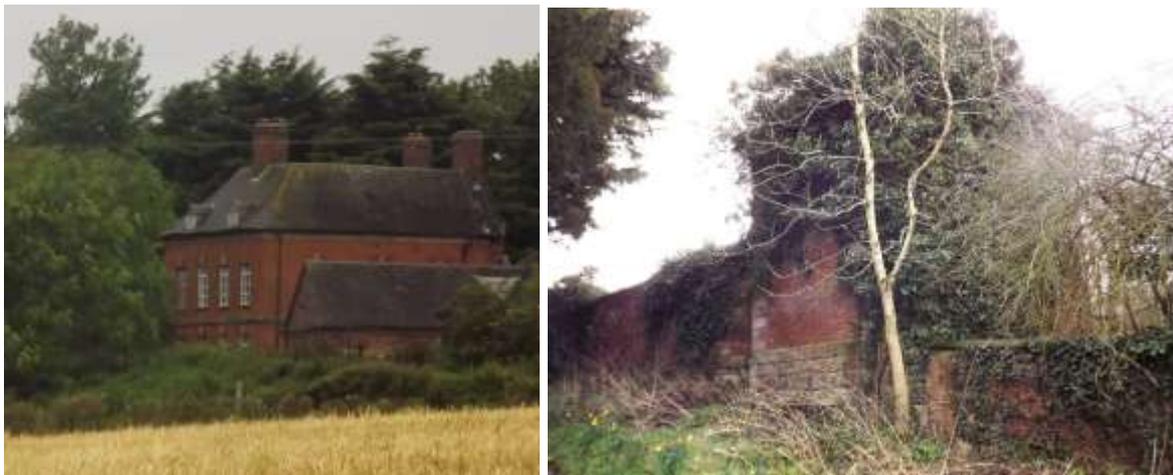
Figure 16 Fulford Hall and Garden House

Fulford Hall is a late 18th century hall with two storeys and attic. Of red brick and tile, the building is twin gabled on a square plan. The first and second floor windows are topped with a projecting keystone and framed with stone cills. The south, east and west elevations have a stone string course separating first and second floor and a substantial sandstone cornice and plinth. The gables are coped in sandstone with substantial stone kneelers and the key stones appear to have possessed fluting before erosion took place. Either side of the keystones, fine gauged flat brick arches are visible. The hall forms part of a farmstead which is a working farm to date. There are several large-scale industrial farming units to the east, remaining amongst these is a 19th century cow shed with a two-storey central gable set at right angles.

Linked to Fulford Hall by a brick wall to the west, is a red brick garden house with a pyramidal tile roof, stone quoins, stone footings and eaves. Grade II listed in its own right, the 18th century Garden House abuts the brick wall to the north, is square on plan, and emphasises the sense of enclosure created in this northerly section of the Conservation Area.

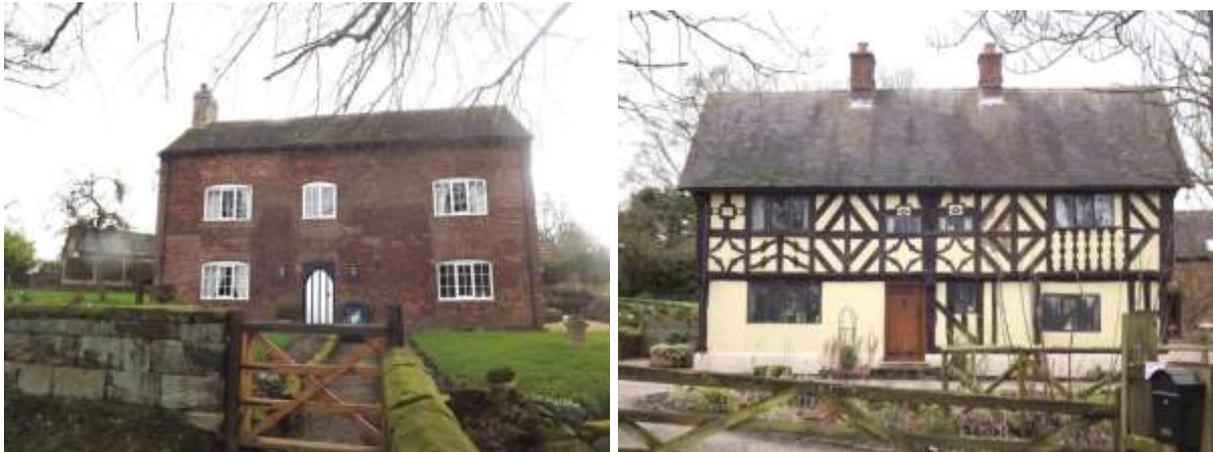
Figure 17 Rocklands and Olde House Farm

Formerly Fulford Farm, Rocklands is an 18th century, two storey farmhouse of brown-red brick and tile over three bays. Displaying casement windows and a Gothic style door, Rocklands is L-shaped on plan and framed by the sandstone outcrop along Townend.

Olde House Farm is the oldest surviving building in Fulford. Recorded in 1627 as belonging to the Bagnall family, it is thought to date from c.1580. Rectilinear on plan, the timber-framed farmhouse is of two storeys with a jettied upper floor on all four sides; a construction method for a house thought to be unique in Staffordshire (Staffordshire HER). Tile replaces a former thatched roof and the elaborate design to the front elevation indicates a display of wealth. During the 18th century the building became a farmhouse, and a stone extension was added during the 19th century. Surrounding the farm, but now demolished, would have been a loose courtyard of farm buildings (Staffordshire HER). The building remained a farmhouse until the 1960s and is now a residential dwelling.

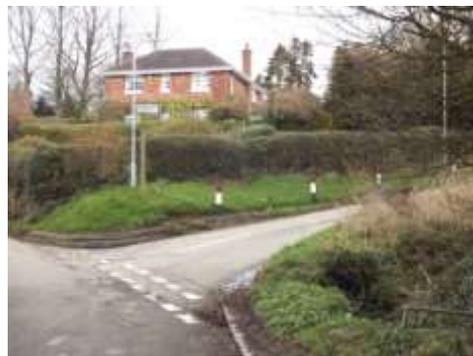
Church cottage

Church Cottage to the north is a 19th century cottage of two storeys and three bays. It is of red brick in Flemish bond with replacement casement windows and a hipped roof covered in fish scale Staffordshire blue roof tiles.

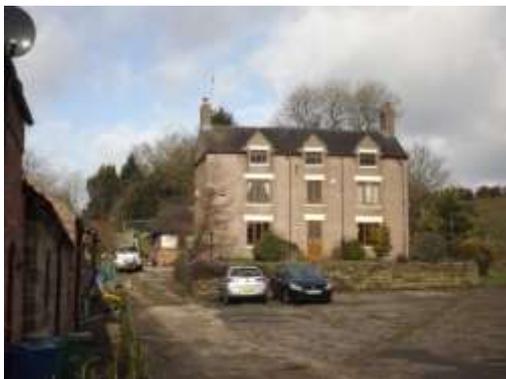
Fulford Manor Farm is a 19th century farmhouse and farm complex with rectilinear brick gabled barns arranged in a courtyard. Of two storeys with attic, and three regularly spaced gabled dormers at eaves level, the roof is gabled and covered in Staffordshire blue clay roof tiles with chimneys at each gable end. The condition of the setting, including the uneven and patch-repaired paving surfaces in the courtyard and modern cement-based pebbledash, mar the character of this building at present. The western barns are set at right angles to the road leading to the Manor, the barn to the south abuts the road and creates an enclosed feel to the group.

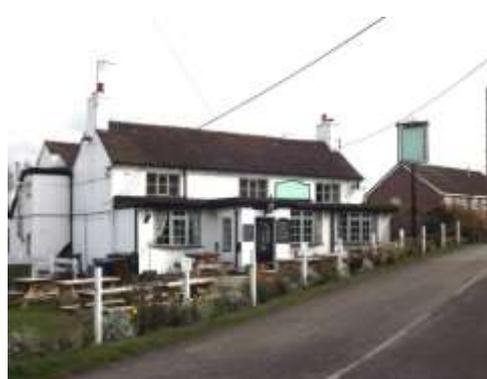
The Shoulder of Mutton is an early 19th century Inn, possibly built on the site of an existing inn as the cellars are cut from sandstone. Of two storeys, gabled and double-pile with an M-shaped roof, timber windows to the first floor replace outward opening casements and dentilation is observed at the eaves. An extension to the frontage has spoilt the symmetry of the Inn, but it remains a focal building at The Dale. The pub car park is a large negative gap site however, which detracts from the historic and generally well-preserved character of the conservation area.

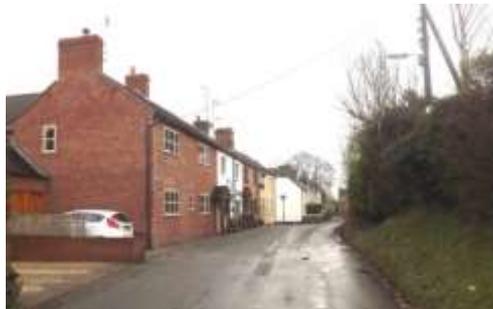
- Clusters of historic buildings set close to the edge of the road, form groups of positive buildings. A row of four modest, 19th century terrace cottages, known as Post Office Terrace, forms a linear group of historic buildings at Townend. The Post Office and general store was formerly located at cottage no.4, and a blacksmiths was sited at the end of the terrace. Beyond is the long, low range of the former Fulford House Farm. Now two dwellings, Fulford House and Fulford House Farm, the building has been altered with 20th century front-facing gables and has lost its casement windows and barge boarding. Despite this, the building continues the linear layout adding a horizontal emphasis to the southerly end of the Conservation Area.

Figure 19 Row of Post Office Terrace and Fulford House Cottages on Townend

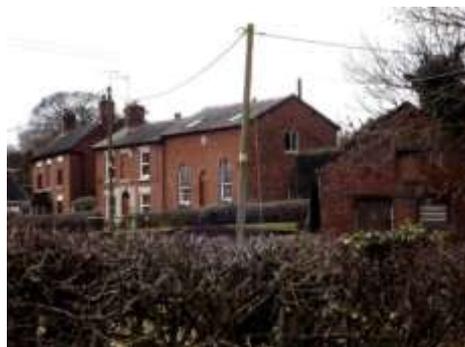
- The former Wesleyan chapel, Vicarage Farm and The Beeches create an historic cluster of 19th century buildings along with Rose Cottage which borders the field to the south along Baulk Lane. The Wesleyan Chapel is now converted to residential use but the chapel appearance has been retained through retention of the two arched headed windows either side of the central door. It is brick and gabled and covered in Staffordshire blue clay roof tiles. A plaque above the door reads *Zion Chapel*.

Figure 20 19th century cottages and former Wesleyan chapel

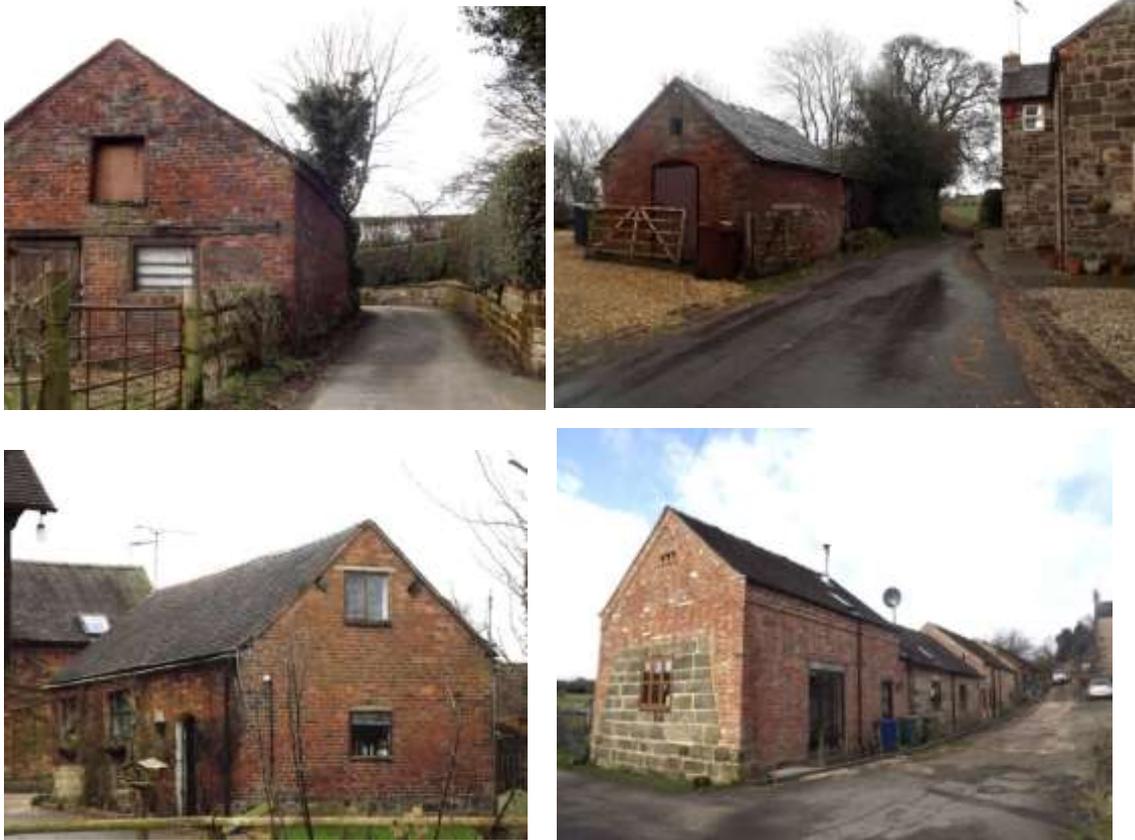
Survival of a range of agricultural buildings throughout the conservation area emphasises rural and agricultural character. The one to one-and-a-half storey, pitched roof outbuildings form a harmonious group which reflect former agricultural use and the development of Fulford as a farming settlement. Some outbuildings retain original fenestration whilst some have recently been converted to dwellings.

Figure 21 A range of farm outbuildings survive throughout the conservation area reflecting historical agricultural development of Fulford

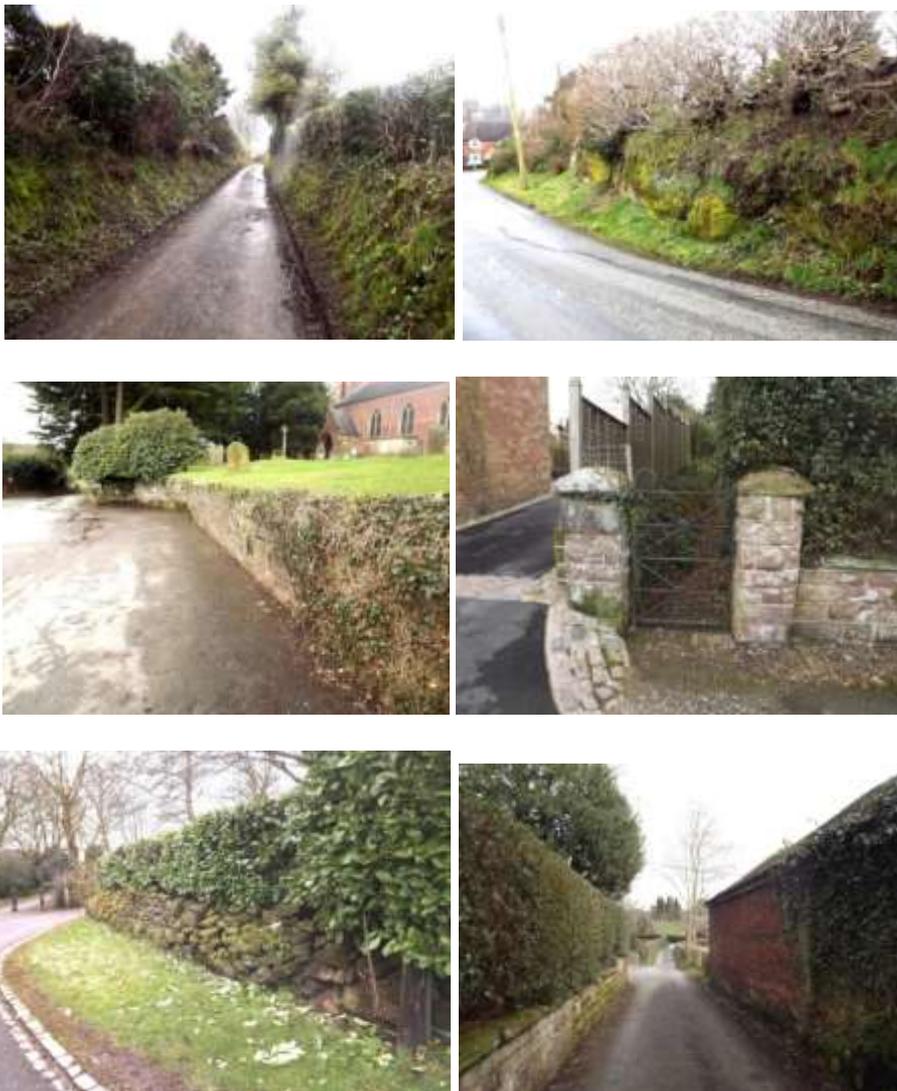
There are no pavements along the main thoroughfare lanes of the conservation area. Simple grass verges lined with brick kerbing combine with mature hedgerows and coursed and rubble stone boundary walls. Coursed stone walls and carved stone gate posts are found at St. Nicholas Church, creating a contrast with the brick wall opposite which runs to the west of Fulford Hall. Stone gate posts combine with simple wooden or metal gates, and at Townend a pleasant blend is created between the sandstone outcrop and adjacent stone property boundary walls. The tall native hawthorn and holly hedgerows that line Baulk Lane create a sense of enclosure and emphasise the narrow winding nature of the greenway, contrasting with the deep grass verges found along The Green.

Figure 27 Boundary treatments in the conservation area

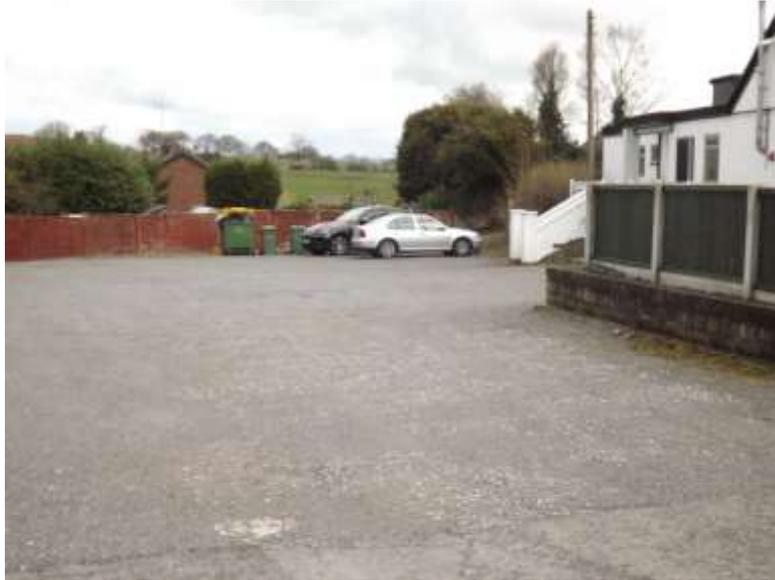
- Modern concrete steps, railings and signage, and a large expanse of tarmac car park at the Shoulder of Mutton, detract from the historic character of the area.
- Open space at the village green appears cluttered due to excessive signage.

Figure 37 The large tarmac car park at the Shoulder of Mutton

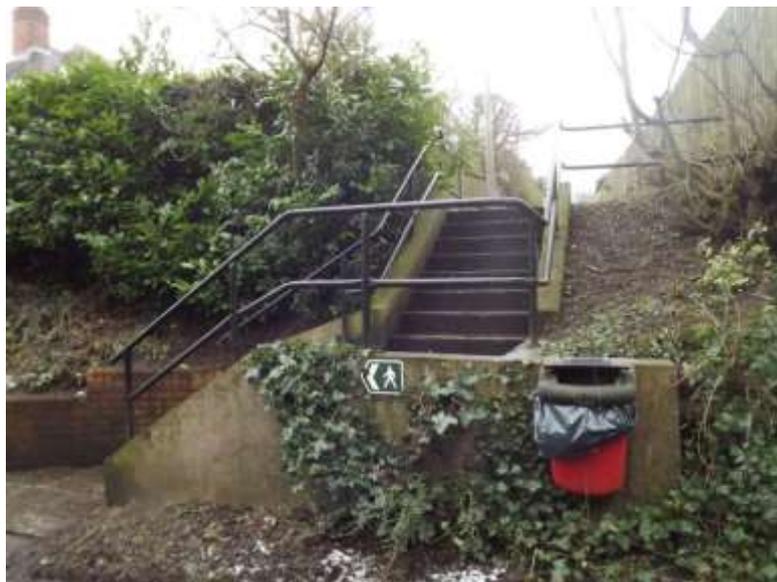
Figure 38 Concrete walls and steps, modern railings and signs detract from the character of the conservation area

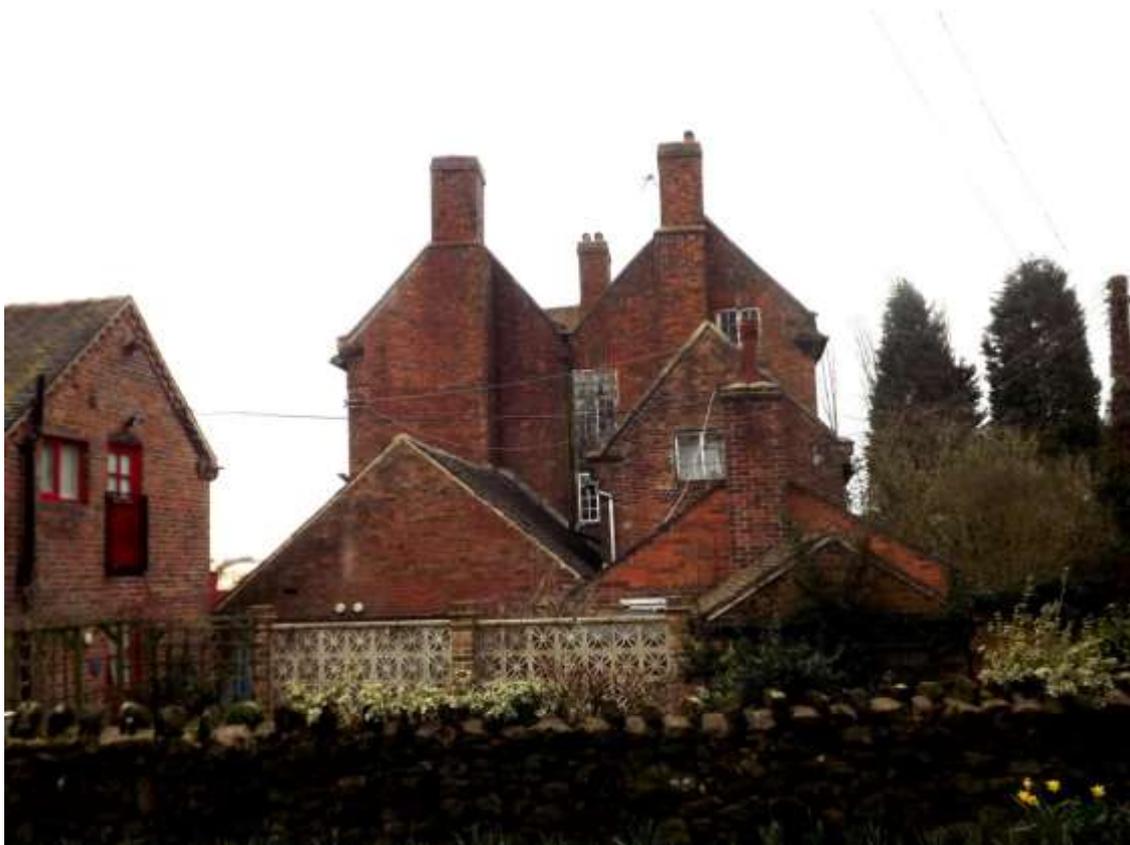
- The grade II listed Fulford Hall is currently in a poor state of repair and work is required to the brick and stone detailing to halt further decay. Window joinery also appears damaged and a two-storey Georgian multi-paned stair window is in need of repair.

Figure 39 Parts of Fulford Hall have suffered from lack of maintenance and repair
