Ingestre Conservation Area Appraisal

**Tixall with Ingestre Parish Council
Stafford Borough Council**

March 2015

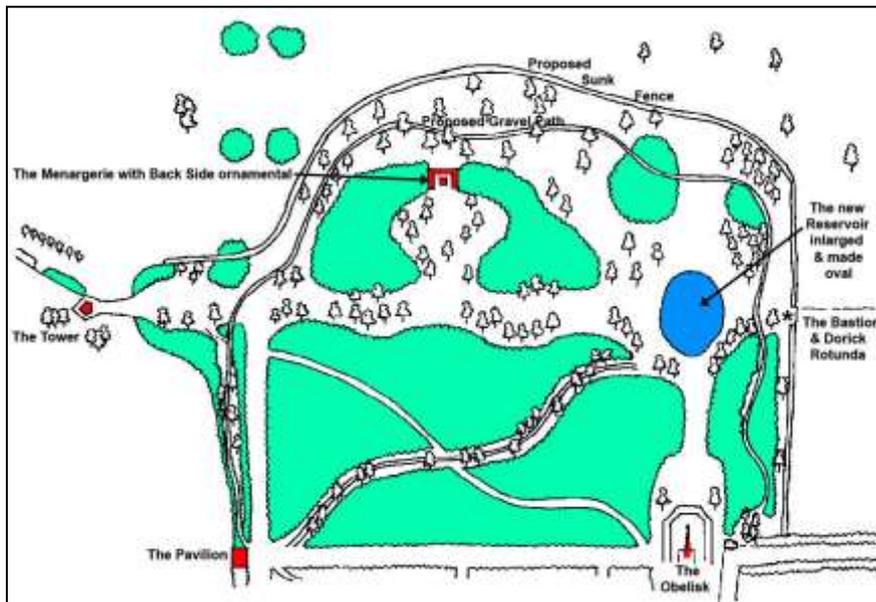
Figure 7: Sketch copy of Capability Brown's 1786 Map of Ingestre

- 5.3 The landscaped area to the north of the house is still bounded by a brick haha, as shown in a map by Capability Brown⁴ in 1786 as a sunk fence. Only the Grade II Listed Pavilion remains in situ from the buildings shown in this plan. The Doric Rotunda was moved to Tixall when the estate was broken up in the 1960s.

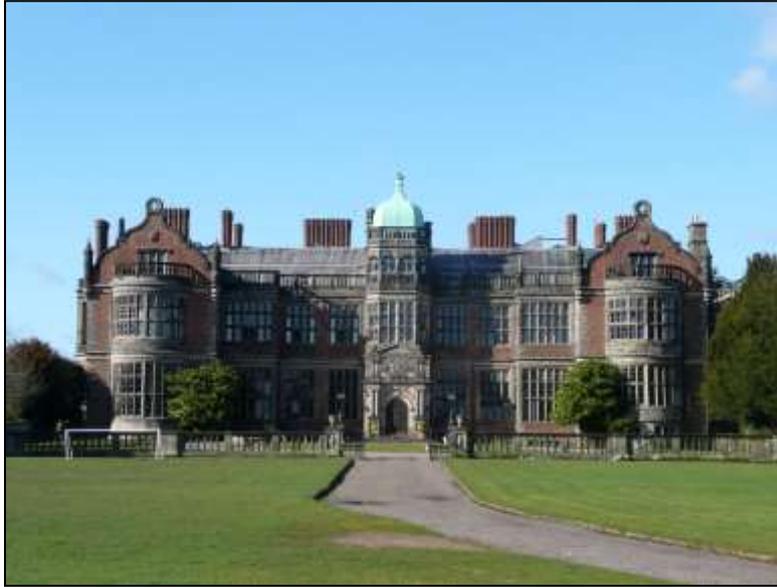
Figure12:Ingestre Hall south front

- 6.10 The south front of the Hall was originally built in 1638, restored in 1688 probably by Nicholas Hawksmoor, altered by Nash 1808-1810, and then rebuilt after a fire in 1882 by John Birch largely to the same plan.
- 6.11 The house is of brick with sandstone dressings. The windows have several stone mullions and transoms. The wide angle bays project and have a big bow of ten lights and a broad shaped gable. There is also a middle projection, and this has a doorway with coupled Roman Doric columns, a round arch, and a heavy attic with short pilasters. Above is a canted bay with 2-2-4-2-2 lights. The cupola terminating the projection is a reconstruction by Birch after Nash had altered it drastically. The contrast between the over-adorned portal and the plain grid of the rest is impressive.

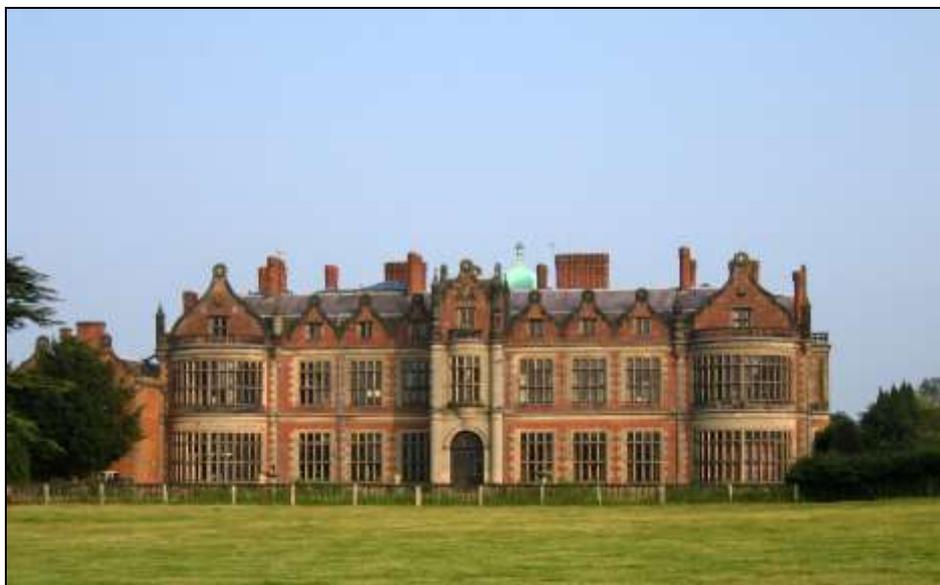
Figure 13: North side of Ingestre Hall

6.12 The north side is by Nash, replacing a classical design. The Wren office worked out a design late in the C17 with a giant portico of six attached columns and apparently sash windows.*⁸ Nash's facade is flatter than the Jacobean south front but also has the bows and the porch bay. There are more shaped gables here, and the porch bay has curious rounded angle shafts. The west front is also by Nash.

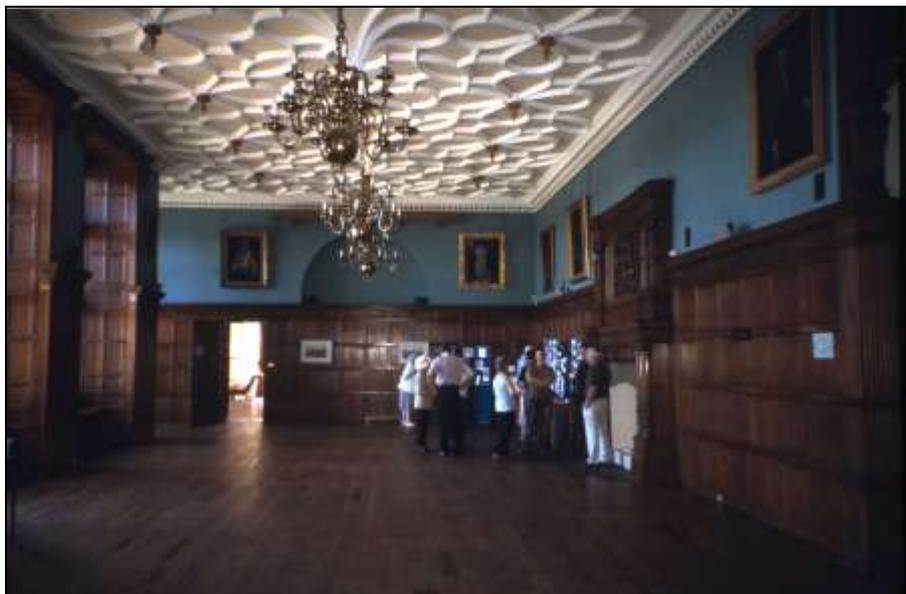
Figure 14: Ingestre Entrance Hall showing panelling and plastered ceiling

6.13 Inside the Hall, the feeling of grandeur is continued by the ample proportions of the rooms, the liberal use of panelling and plastered ceilings, and by the grand staircase.

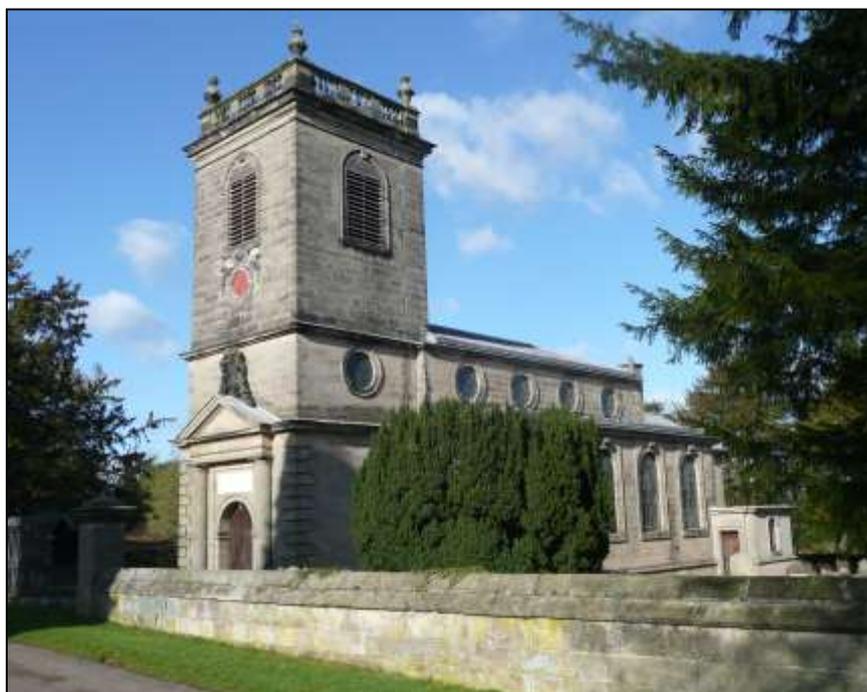
Figure 15: Ingestre Church showing tower and entrance

- 6.14 St. Mary's Church is said to be the only Wren Church outside London. It was built in 1676 of Hollington Stone. The tower has three stages. The lowest has rusticated corners and a low plinth with Tuscan columns framing the west door which has a triangular pediment framed by garlands in the middle section of the tower. The top section has a single handed clock also framed by garlands, and belfry windows, finally topped with an open balustrade decorated with stone urns at each corner.

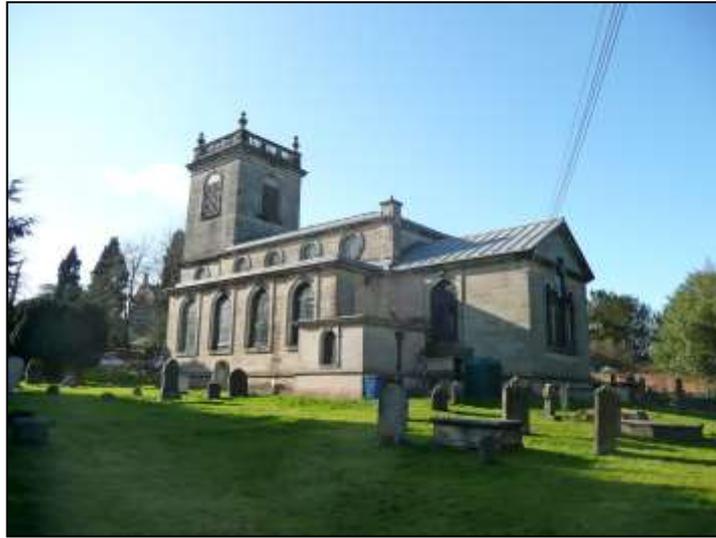
16. Ingestre Church showing windows including circular clerestory windows in nave

- 6.15 There are four windows on each side of the aisles and one on each side of the chancel beyond. All have semi-circular heads rising to foliar volutes which support the cornice. There are four circular windows to the clerestory on each side.⁹

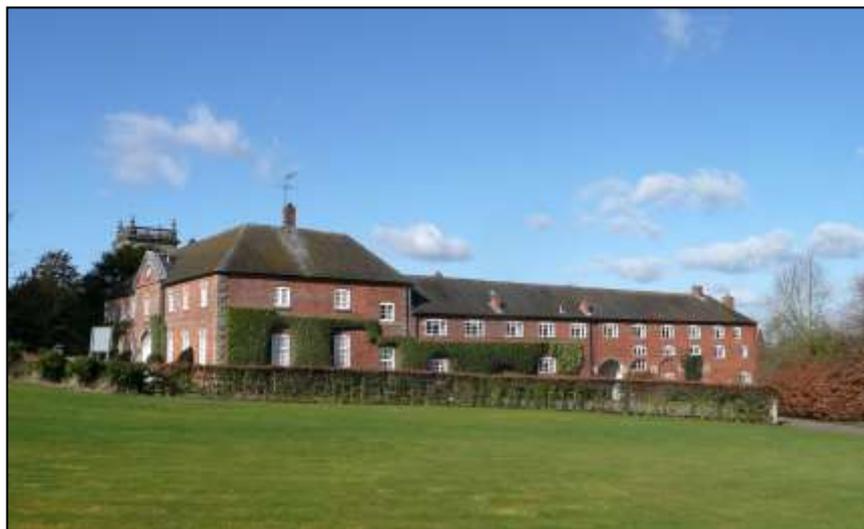
17. Ingestre Old Stables

- 6.17 These buildings are described as late 17th century or 18th century and are built of brick with rusticated stone quoins. They were converted to residential use in the 1970s, although the inner buildings had previously been used as dwellings. The arched opening on the west front has been closed over, but that on the south front is still used as the entrance to the courtyard.

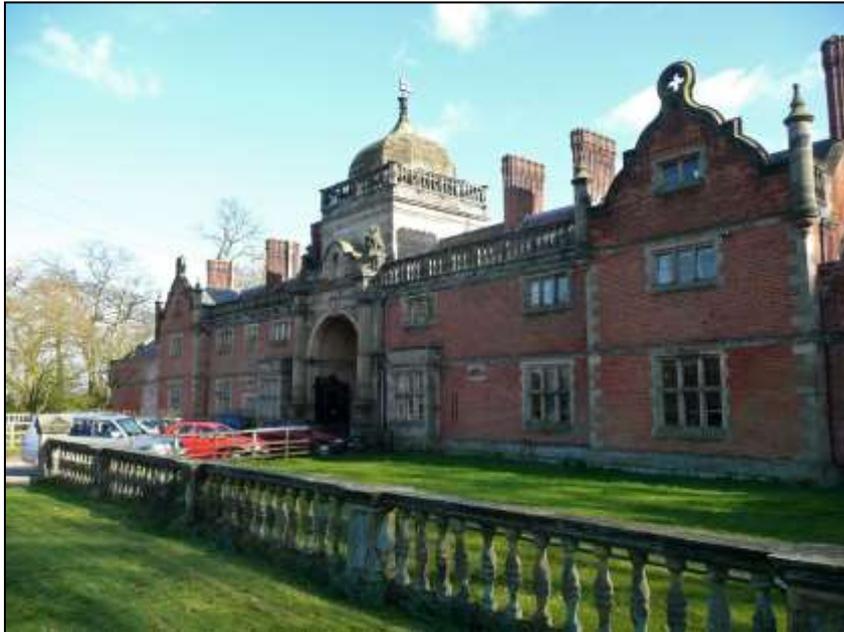
Figure 18. Ingestre New Stables showing central entrance tower

- 6.19 It was built by Birch in 1884 of brick with stone quoins and a central stone entrance under a tower to the courtyard, with old coach houses facing.

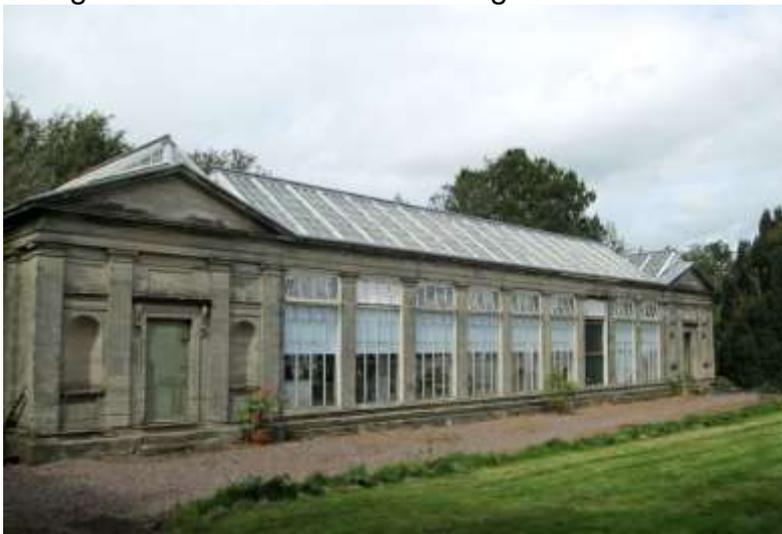
Figure 20: Ingestre Orangery

- 6.21 Probably c1770 by Samuel & Joseph Wyatt, adapting a design of James Stuart. The Orangery lies behind the walled garden and north east of Ingestre Hall. It is built of brick with limestone ashlar cladding on the front façade which has two pedimented end pavilions with Doric pilasters, either side of the central section with nine glass bays and more Doric pilasters. The doors at each end have moulded doorframes with console brackets rising from acanthus leaves and supporting a flat hood. Either side of the doors are round-headed niches. Above the doors and niches are plain friezes with rectangular panels above. A narrow dentillated eaves cornice runs along the front elevation continuing round the sides.

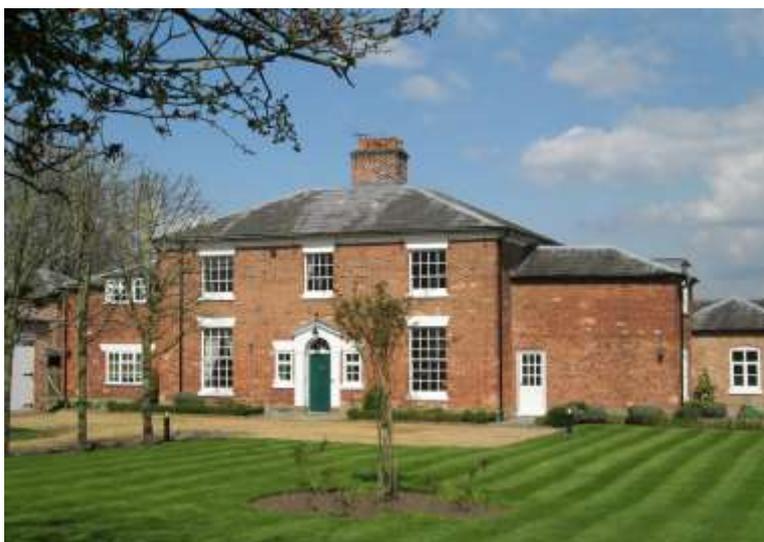
Figure 21: Ingestre Home Farmhouse

- 6.22 Nearby is the Grade II Listed Ingestre Home Farmhouse and Farm buildings. The farmhouse c1820 is built of Flemish bond red brick, with a slate hipped roof with lead roll hips and ridge and overhanging eaves with a shallow stucco frieze.

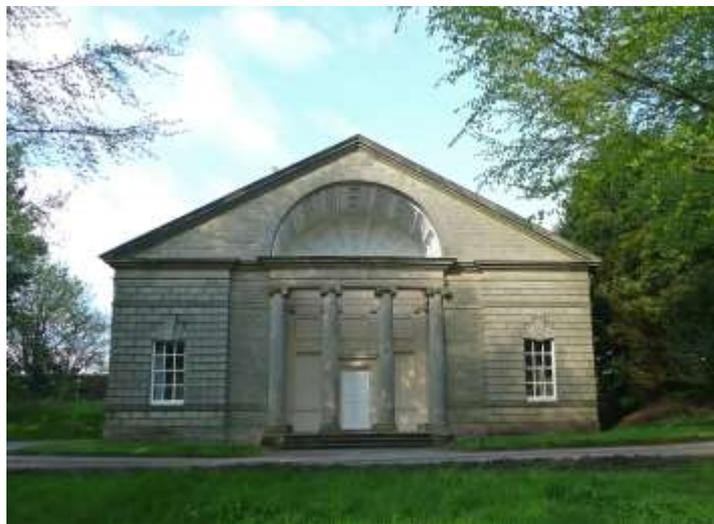
Figure 22. Ingestre Pavilion showing the portico

- 6.25 Although there is now no public access to Ingestre Pavilion, which is run as holiday self catering accommodation by the Landmark Trust, it is an important component of the Capability Brown landscape and is situated in Ingestre Wood. The mid 18th century Pavilion is Listed Grade II and has a stone façade with a broad pediment and rusticated masonry. The central portion has Ionic columns and fine plasterwork on the arched ceiling. At the back is a 1992 brick extension.

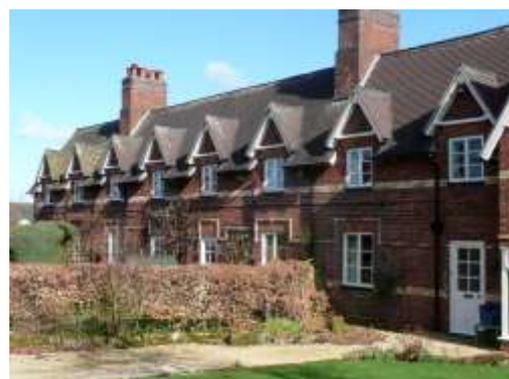
Figure 23. Terrace of 4 cottages in
Ingestre Village with Meadow
Cottage nearest

- 6.27 There are estate cottages in Ingestre Village, with decorative brickwork, attractive dormer gables, and Staffordshire blue tiled roofs. These are not listed but contribute to the special historic character of the area.

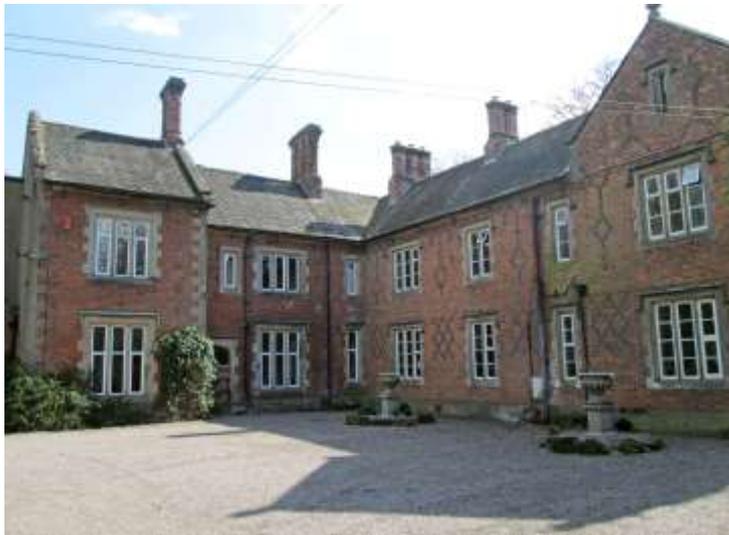
Figure 25 The Old Rectory showing truncated wing

- 6.29 The Old Rectory is not listed, and lies set back from Ingestre Road between the Village and the New Stables, backed by a belt of trees. The present building dates from the mid 19th century and was partly truncated and rebuilt following an accident with a training aircraft from Hixon in WWII. It is now divided into three dwellings. No.1 The Old Rectory is shown below. Stone quoins, copings stones and label-moulded mullioned windows reference the Jacobean Hall, as do decorative chimney stacks.

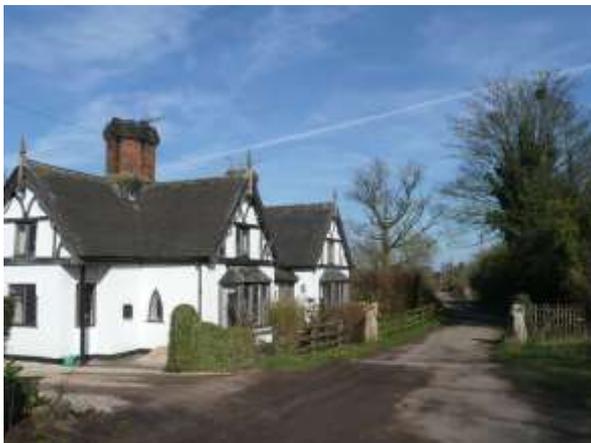
Figure 27: Trent Lodge looking towards the bridge over the River Trent.

- 6.31 Trent Lodge guarded the eastern approach to Ingestre from Hixon over the River Trent, but is not shown on the early maps. It displays typical themes of prominent gables and chimney stacks, barge-boarding and faux timber-framing.

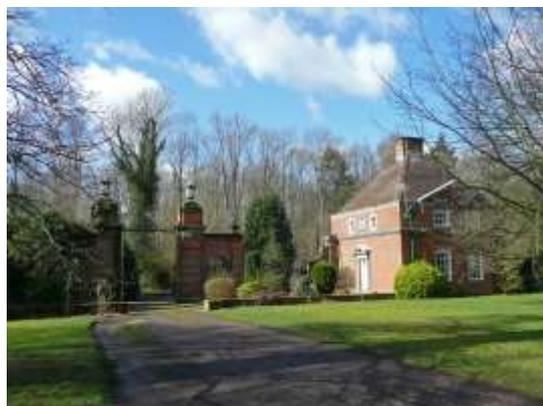
Figure 28: Lion Lodges and the earlier main entrance to Ingestre Hall

- 6.32 The other entrance to Ingestre is guarded by the pair of Lion Lodges, built in the 1930s in front of the site of earlier lodges, at the entrance to the main drive to Ingestre Hall. Here the pediment theme and hipped roofs of earlier buildings are reproduced.

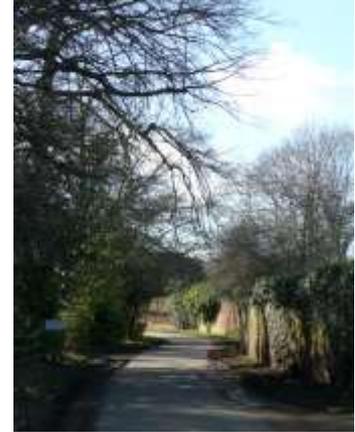
Figure 42. Brick wall boundaries of Home Farm and the walled gardens on the approach to New Stables and beyond

- 6.44 The tall brick wall boundaries of Home Farm and the walled garden are an important part of the historic character of the approach to Ingestre Hall and Church, creating a brief sense of enclosure before views of the Hall and its landscaped setting open up.

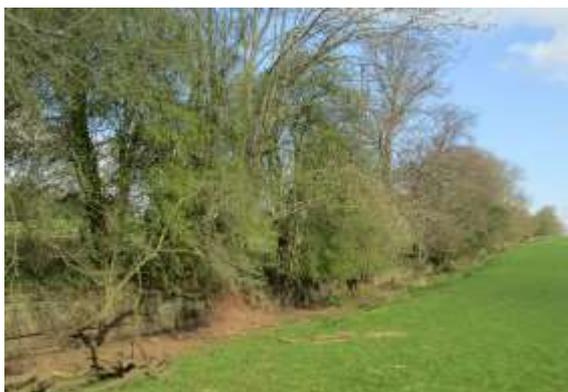
Figure 44. Line of Haha from near Ingestre Hall

- 6.46 Capability Brown's sunken fence or Haha remains in situ around the Wood Field to the north of Ingestre Hall. The section of the Haha nearest the Hall is built of stone, while that at the end of the Black Drive from the Pavilion is of brick with a stone coping. The Haha continues across the view in front of Ingestre Pavilion.

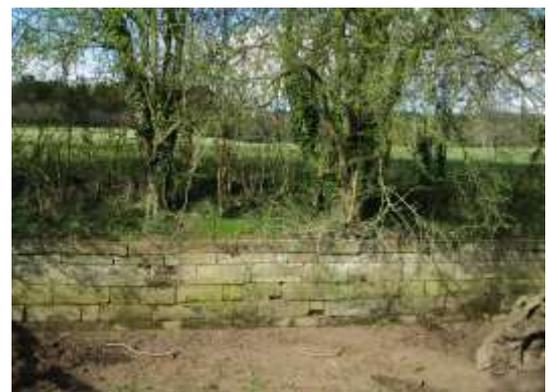
Figure 45 Stonework detail

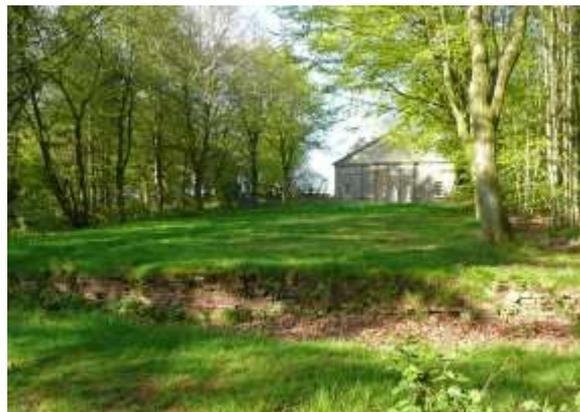
Figure 47: Brick Haha across the view in front of Ingestre Pavilion

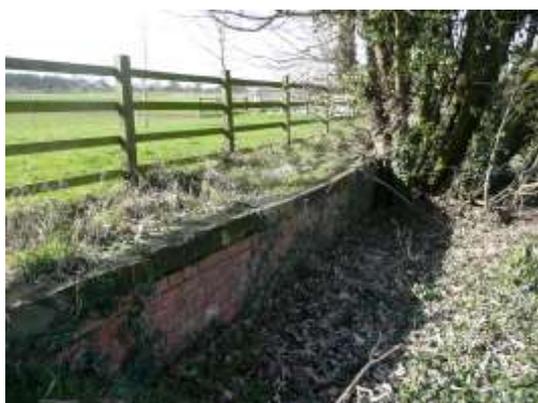
Figure 48. Stone topped wall along track leading from Home Farm to Trent Drive

6.47 There is another interesting boundary along the track leading to the top of Trent Drive, again brick with a stone coping.

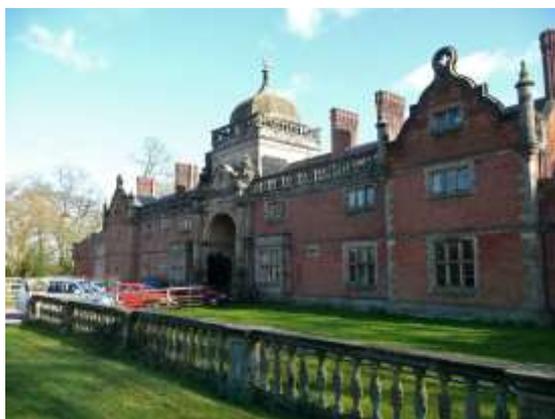
Figure 49. Stone balustrade in front of the New Stables

6.48 Finally there are the stone balustrades forming the roadside boundary of Ingestre New Stables and the northern garden boundary at the back of Ingestre Hall.

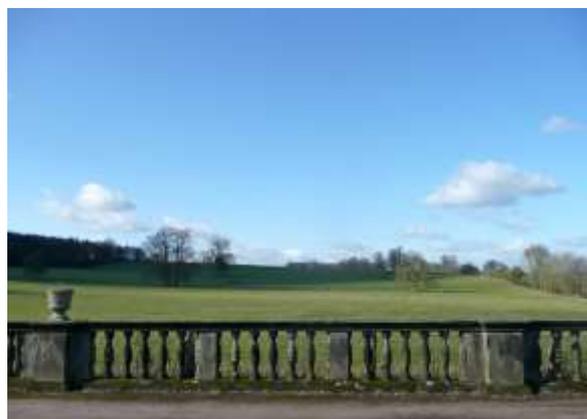
Figure 50. Stone balustrade at the back of Ingestre Hall looking towards the Wood Field

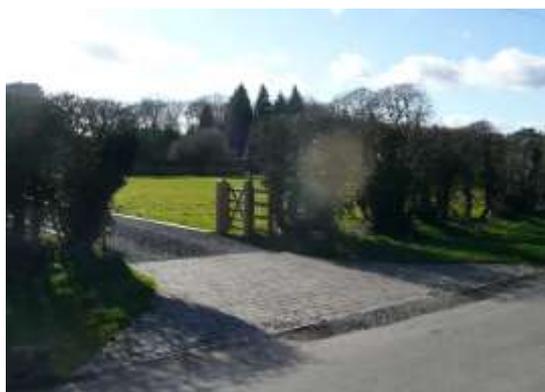
58. Rectory Cottage entrance

6.55 Some recent developments have introduced cobbled paving at their entrances, e.g. at Rectory Cottage and Home Farm Court, although there is no historic basis for this and it suggests an urban environment.

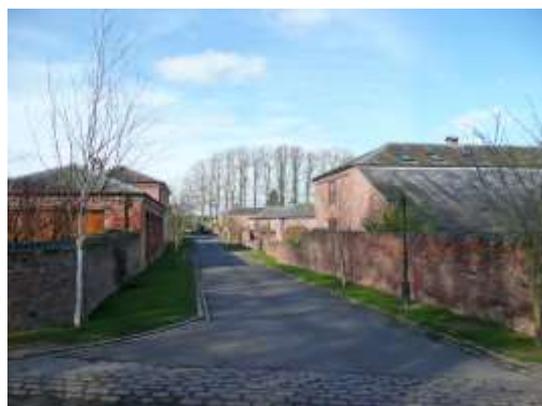
59. Entrance to Home Farm Court development showing street light on right

6.56 Home Farm Court also has some relatively inconspicuous street lights within the development.

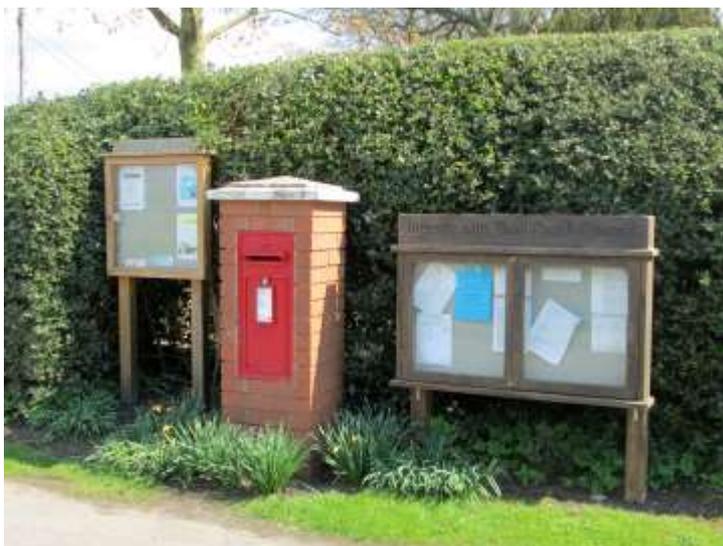
Figure 60. Ingestre Post Box

6.57 The Post Box was moved from the wall of the Post Office when this was closed some years ago, and re-sited in a specially built brick pier.

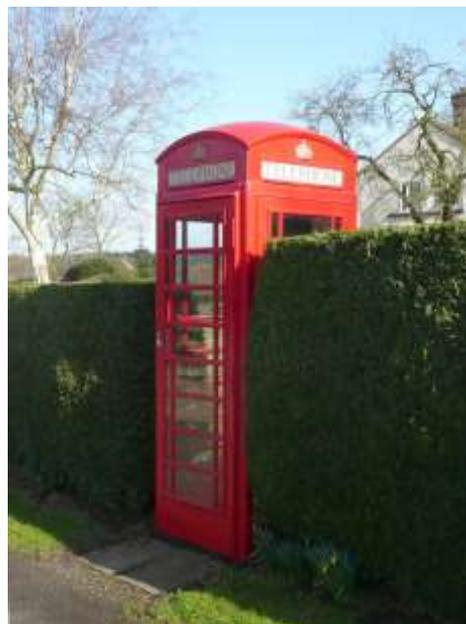
Figure 61. Ingestre K6 Telephone Box

6.58 The Grade II Listed K6 Telephone Box is also located in the Village. Designed by Sir Giles Gilbert Scott in 1935, and made of cast iron with a domed roof, unperforated crowns to the top panels and margin glazing to the windows and door.
