Walk Mill Conservation Area Appraisal

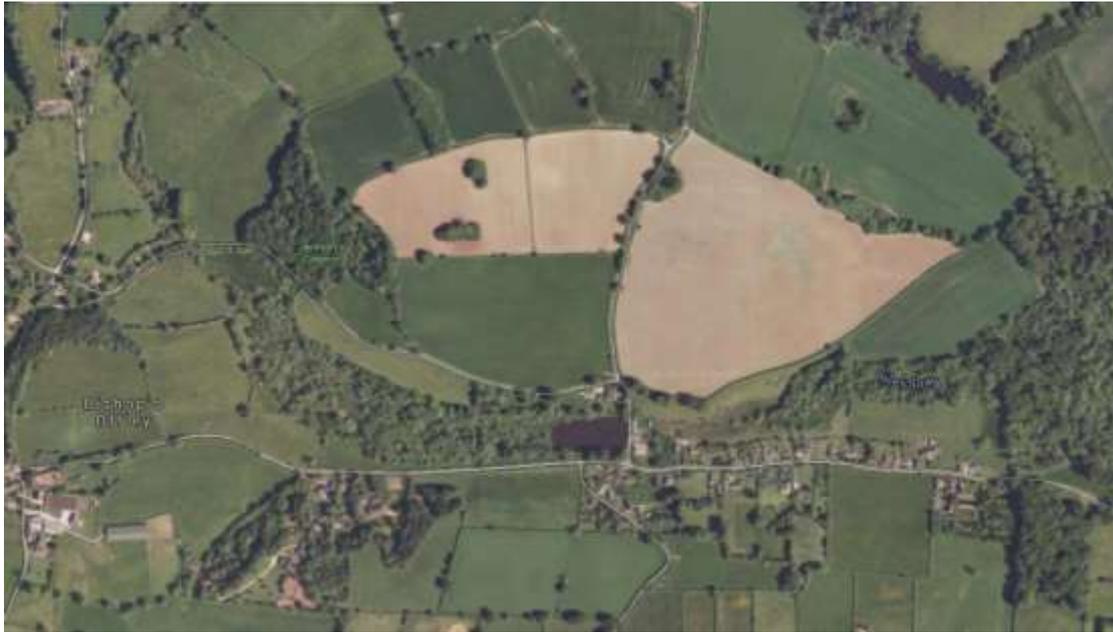
Figure 3 Aerial view of Walk Mill and surrounding countryside

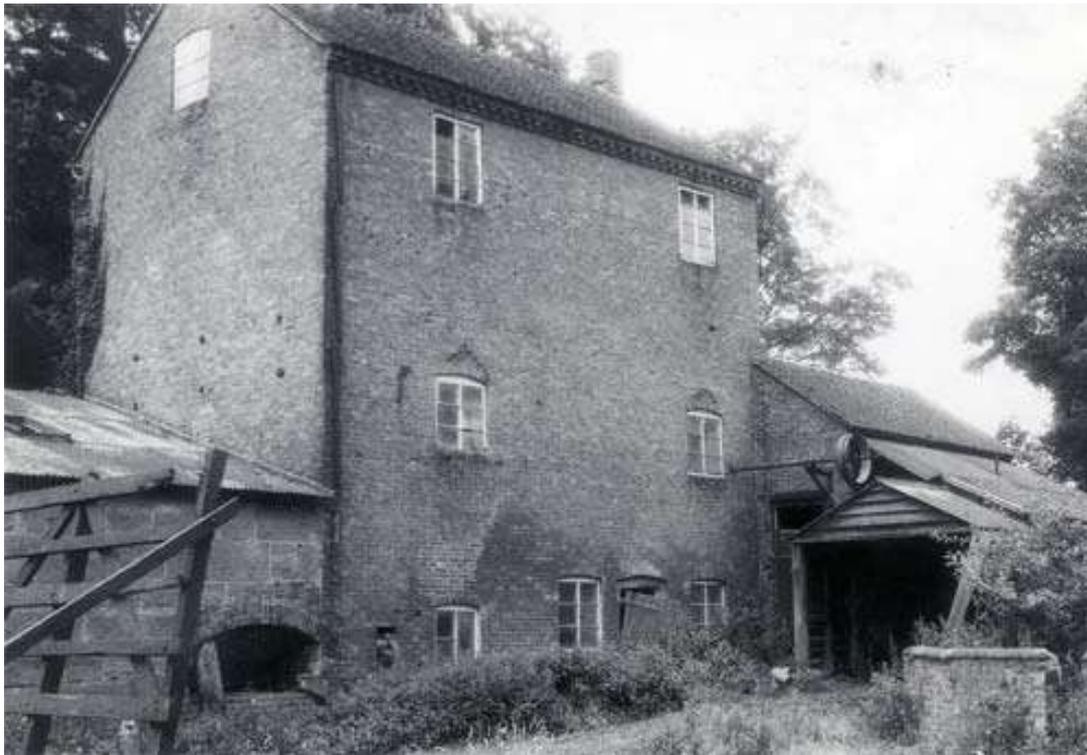
Figure 4 The main mill building and wheelhouse c.1930-1950 (Staffspasttrack)

2.2.5 The present mill building was used to grind corn and produce malt and is thought to have replaced the original fulling mill in the late 18th century. By this time Walk Mill had given its name to the settlement that had built up around it (staffordshirepasttrack.org).

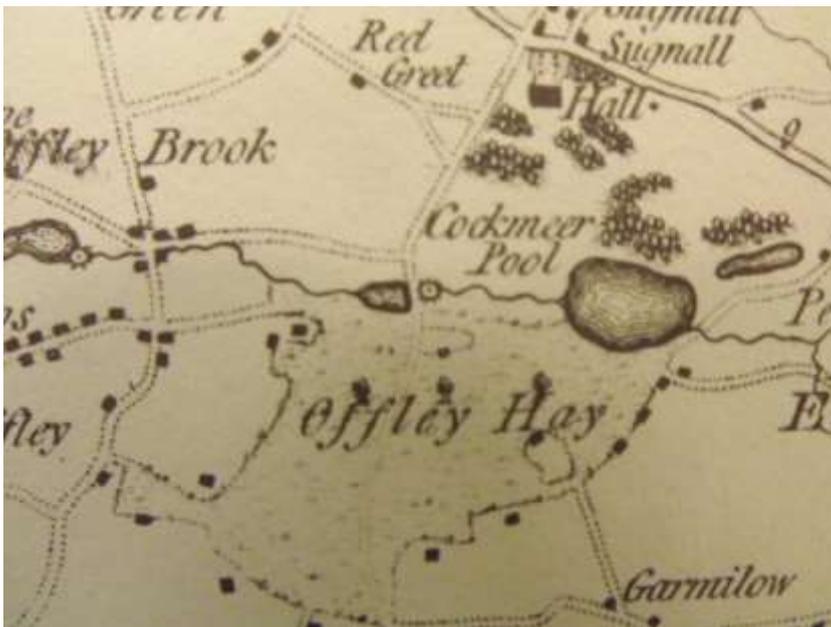
Figure 5 Yates's Map of Staffordshire 1775 showing mill and mill pond

2.3.5 Map regression shows how the hamlet of Walk Mill developed around the mill. A mill and mill pond is recorded on Yates's map of Staffordshire from 1775 (figure 5) and is the first visual record of the site. The local fulling trade had declined during the 18th century and there was an increase in the corn trade. In 1795, Walk Mill was auctioned for sale by its occupant at the time, John Jones. The sale particulars for the building mention the corn mill as 'lofty and newly erected', and it is thought that this is the extant building on the site today. The mill was purchased by a Robert Deakin and was to remain in the Deakin family throughout the 19th century.

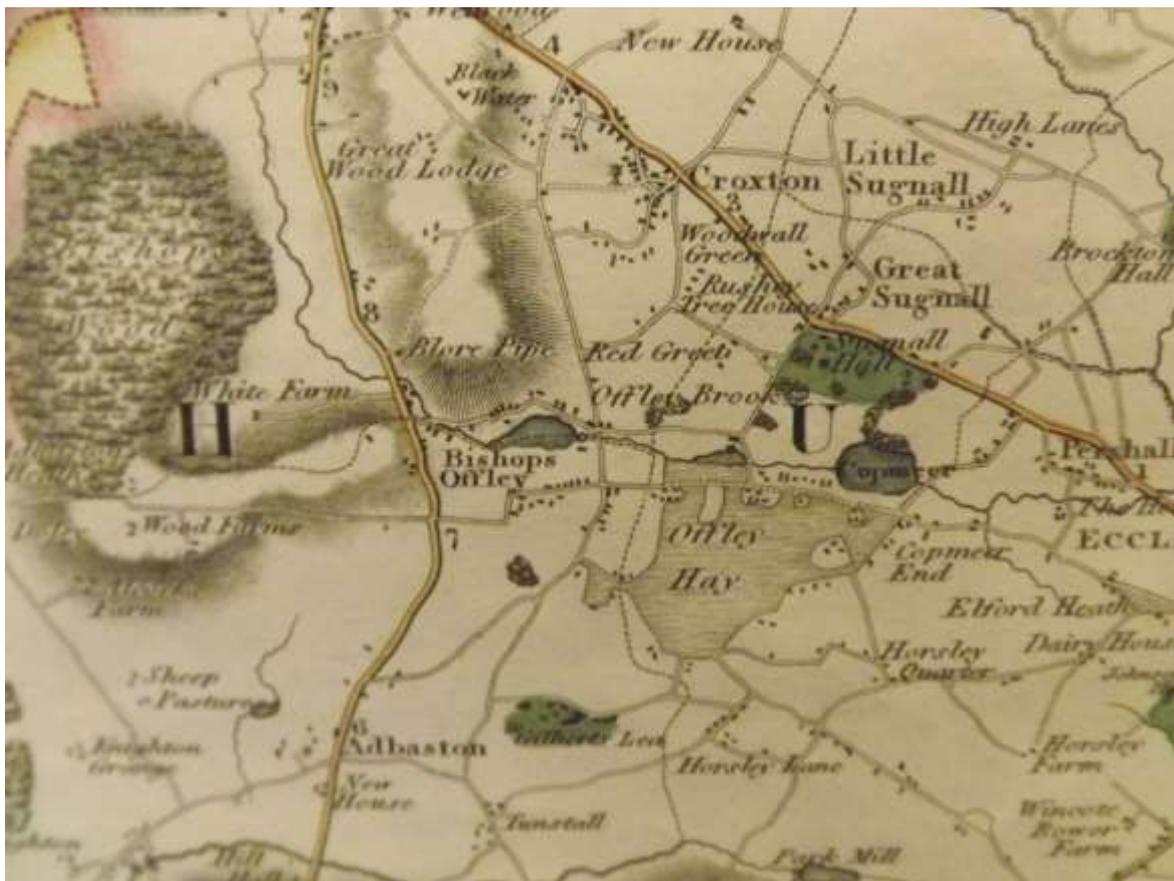
Figure 7 Greenwood's map 1820 shows the road between Eccleshall and Bishops Offley.

2.3.6 Walk Mill retains its historic road layout and the character of the surrounding landscape remains relatively similar to that of the 18th century. The road which runs between Eccleshall and Bishops Offley appears on mapping from the early part of the 19th century; no such road can be identified on Yates's Maps of 1775 and 1798, but is clearly recorded on Greenwood's map from 1820. Cutting through, what is thought to be a large area of common at Offley Hay, the road was most likely built to meet the demands of local trade and agricultural practices

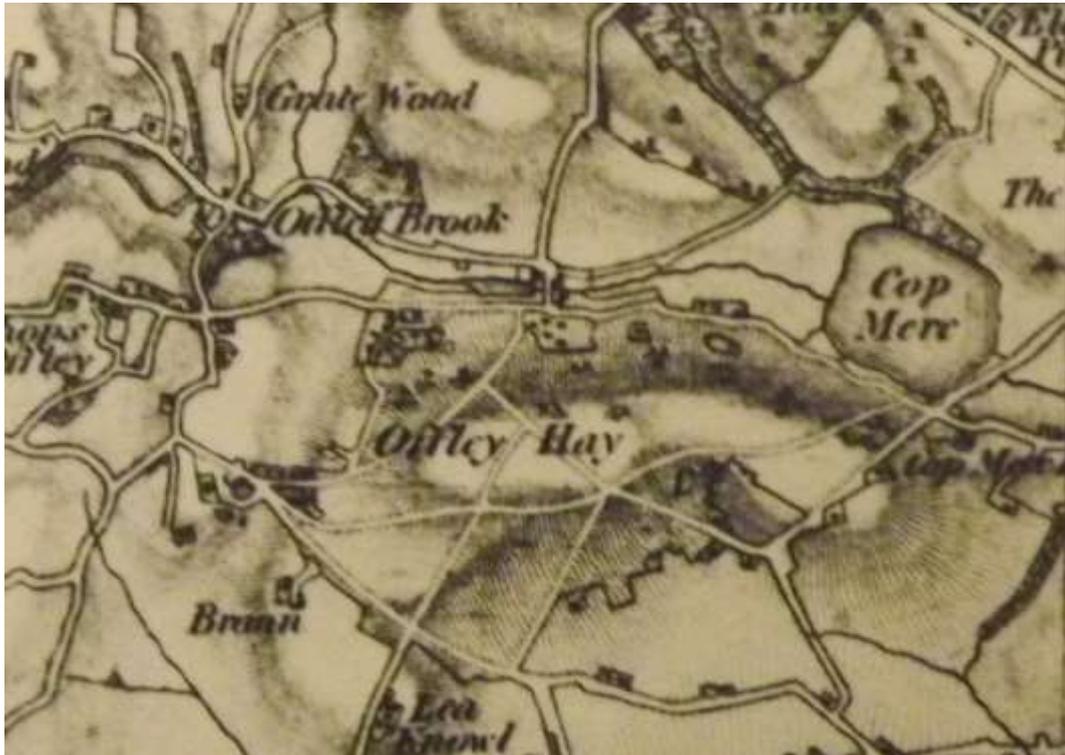
Figure 8 OS 1837 showing mill and mill pond and Walk Mill house

2.3.7 The mill, mill pond and Walk Mill House can be identified on the OS in 1837, along with a building thought to be the existing former barn. A building on the site of Walk Mill Farmhouse appears for the first time on the 1839 tithe map of Horsley. The tithe map also records the mill and the barn and shows the linear development of buildings within the hamlet.

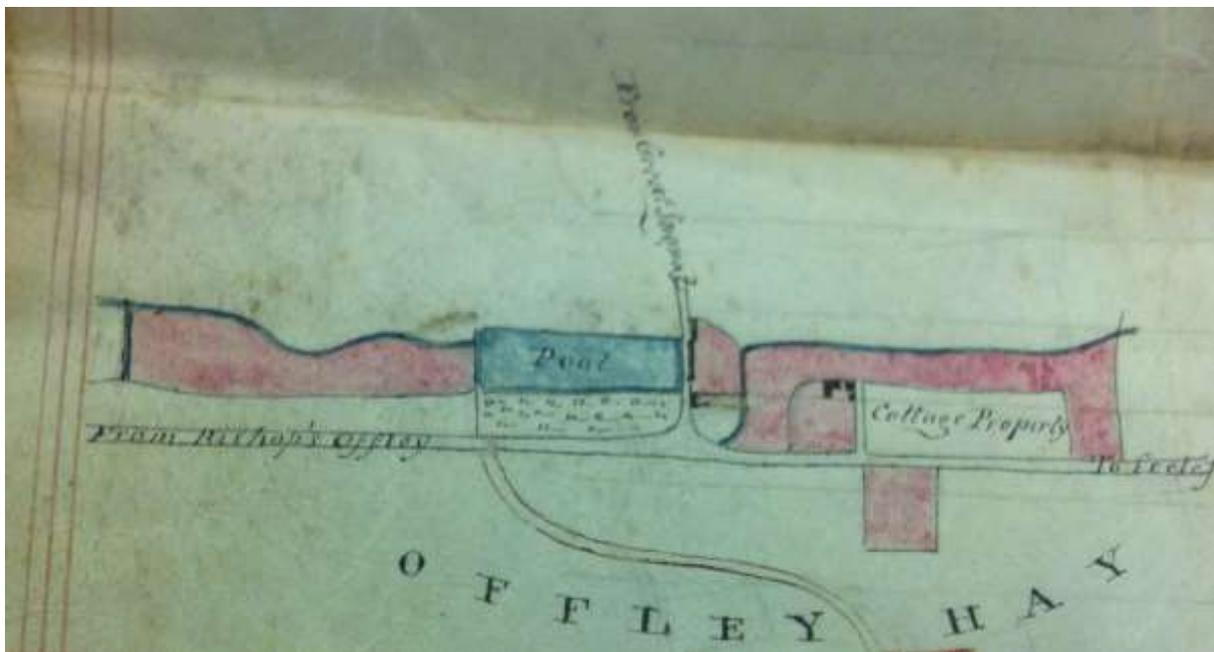
Figure 10 Map of lease from 1851 showing newly constructed Walk Mill Farmhouse

2.3.8 Further development of the mill site occurred during the 19th century, in line with changes in farming practice. Suggestion is that the former fulling mill was rebuilt as a maltings by Isaiah Deakin, who was recorded as the landowner of the mill site and surrounding land in 1841; a date stone above the door of the malthouse has the inscription, 'ID 1830', possibly referring to Isaiah Deakin and dating the maltings to this period. The site developed into a farmstead from the mid-late 19th century, most likely as a result of the newly constructed Walk Mill Farmhouse around the 1850s; this building is the existing Walk Mill Farm. By the 1st edition OS map of Walk Mill, surveyed in 1879, a small cluster of mill and farm buildings are clearly recorded. It is likely that these are the extant buildings within the Conservation Area.

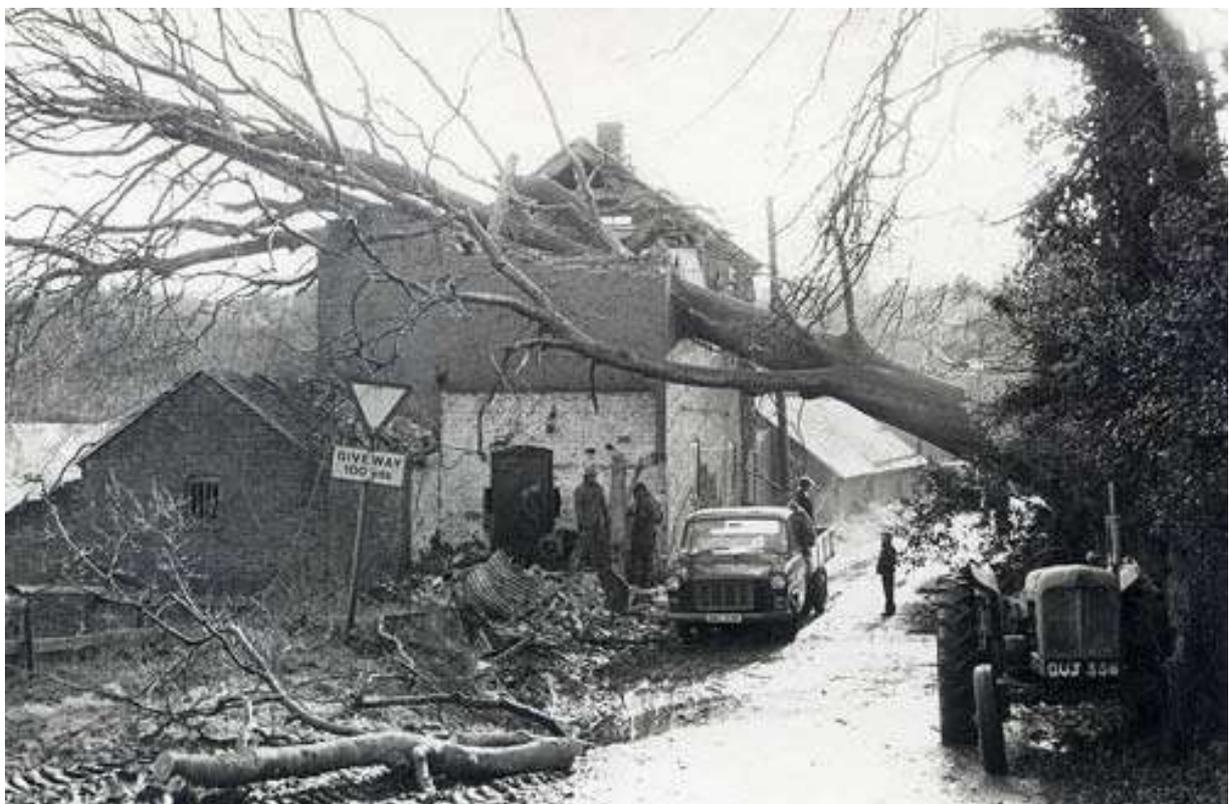
Figure 14 Storm damage to the mill in the 1970s

2.3.11 Milling continued at Walk Mill well into the 20th century. In 1975 the mill building was severely damaged by a tree which fell during a storm and milling operations ceased. As the buildings were not insured, restoration proved too costly and they remained unrepaired. English Heritage listed the building grade II in 1980, as an example of a 'former mill and grain store'. In 1988, the Trustees of the Sugnall Estate conveyed the mill to the Staffordshire Historic Buildings Trust who had plans to restore the building. When restoration proved too costly, the Trustees of the Sugnall Estate re-acquired the building. No restoration has been carried out to the buildings to date and all buildings have suffered from a significant amount of decay and deterioration. The top two floors of the mill building were lost in 2012 and the site is currently in an extremely poor state of repair and significantly overgrown.

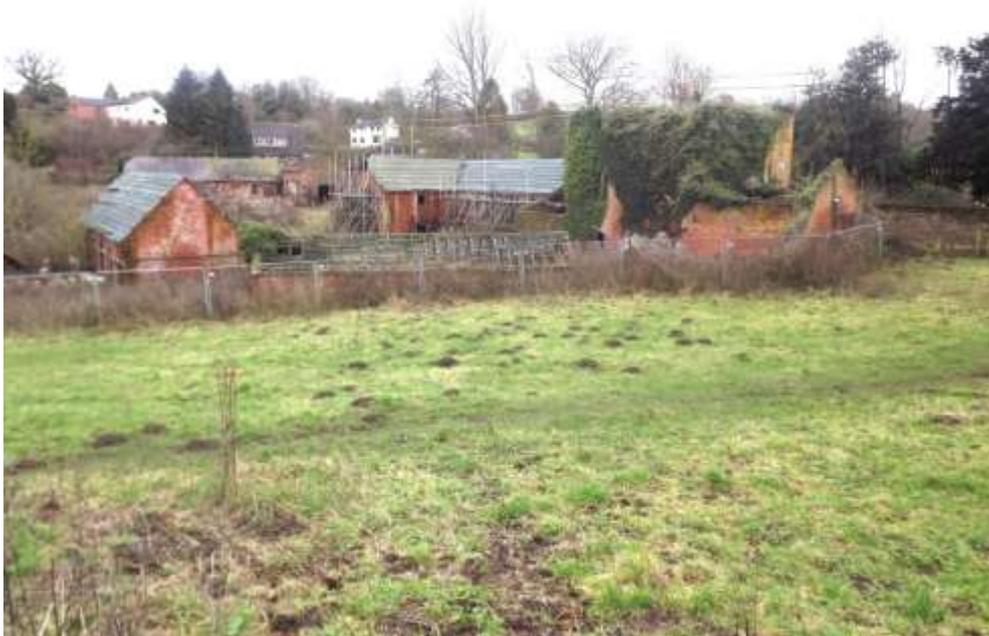
Figure 15 Mill and farm buildings on the Walk Mill site

3.1.2 The Walk Mill site consists of the mill building and attached maltings/grain store. Both buildings are in a dilapidated state and unoccupied. Other buildings on the mill site are former agricultural buildings including a cart shed, piggery and barn. These buildings are also in a poor state of repair and are uninhabited.

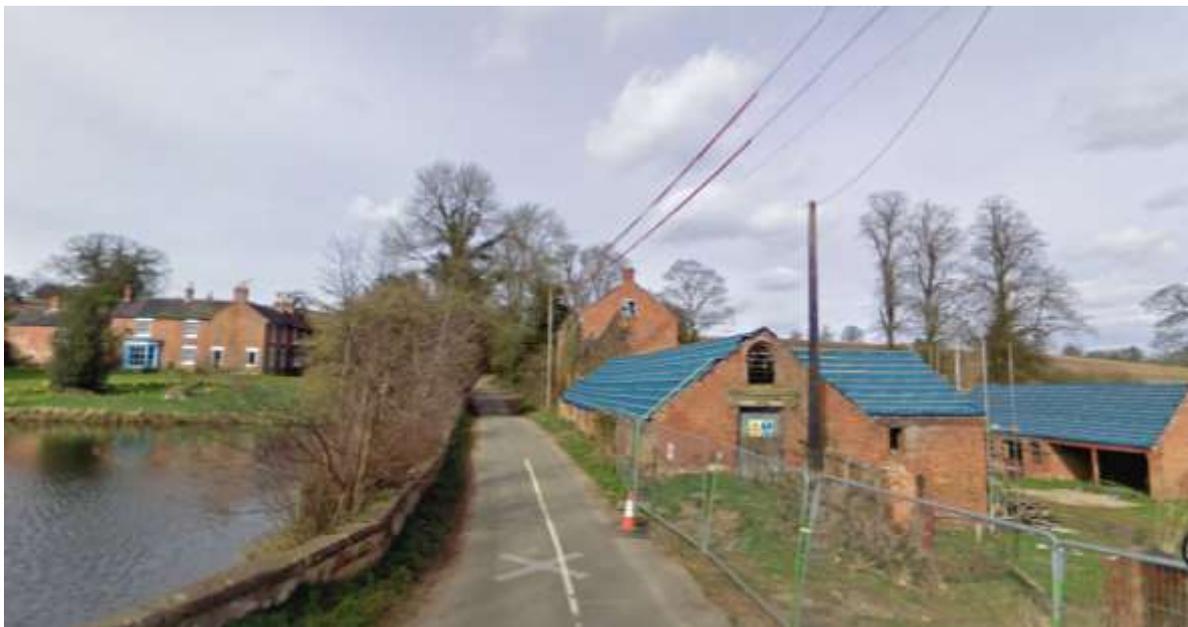
Figure 16 The three and a half storey mill building with top floors still intact shows the difference in scale and contrast to the lower storeyed maltings and agricultural buildings.

3.2.2 Storm damage to the mill in the 1970s has left the building somewhat reduced in scale. Prior to this, Walk Mill was a three and a half storey mill building, rectilinear in plan form with an attached two-storey grain store and maltings on a t-shaped plan. The buildings appear two-storey and single-storey respectively from the front elevation, with the lower storeys built below the road level to the rear. Linked via a single-storey stone wheelhouse, which houses the waterwheel and mechanisms, the mill and maltings are sited close to the roadside and form part of the original 18th century mill complex. Other buildings within the complex are former agricultural buildings of a modest-scale, single-storey rectilinear or L-shaped on plan, with simple gabled roofs of a shallow pitch. The mill and farm buildings amalgamated into one farmyard site during the 19th century.

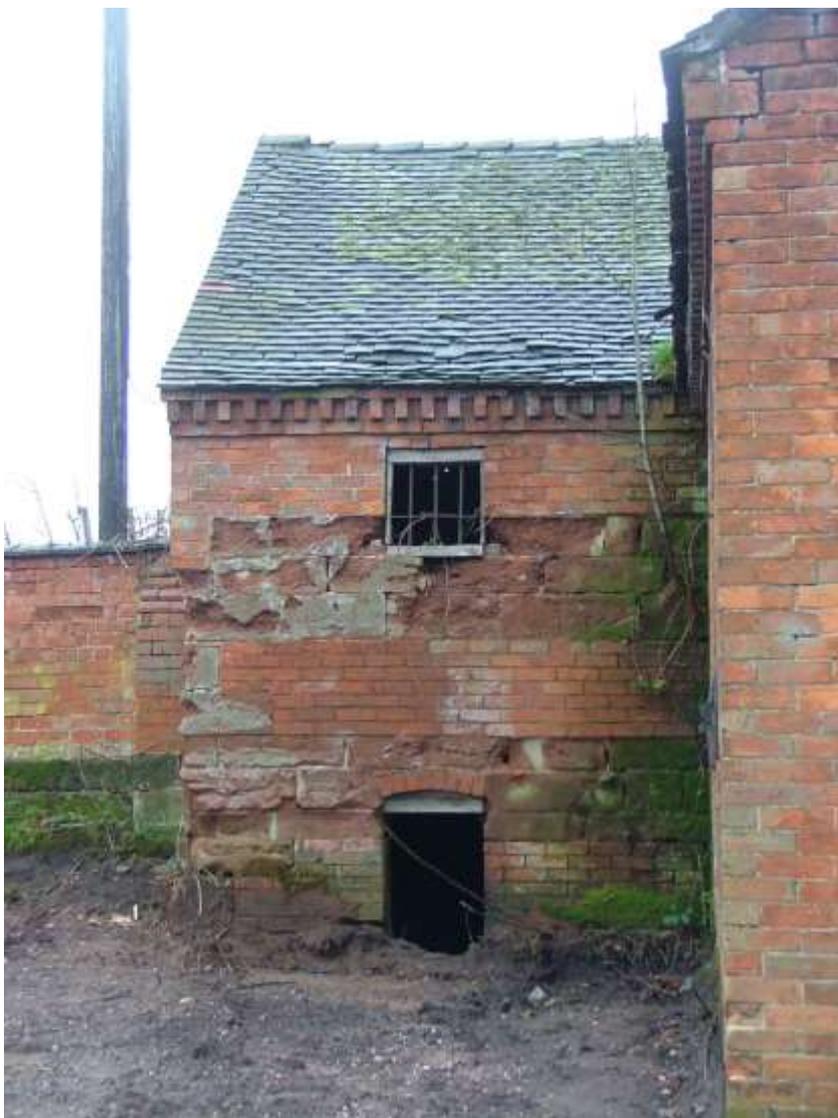
Figure 17 Courses of sandstone and brick to the maltings

3.3.1 Courses of sandstone and brick have been used on the mill, agricultural and domestic buildings. Used in a variety of ways, and for a variety of features, this gives a unity and a vernacular quality to the buildings within the Conservation Area.

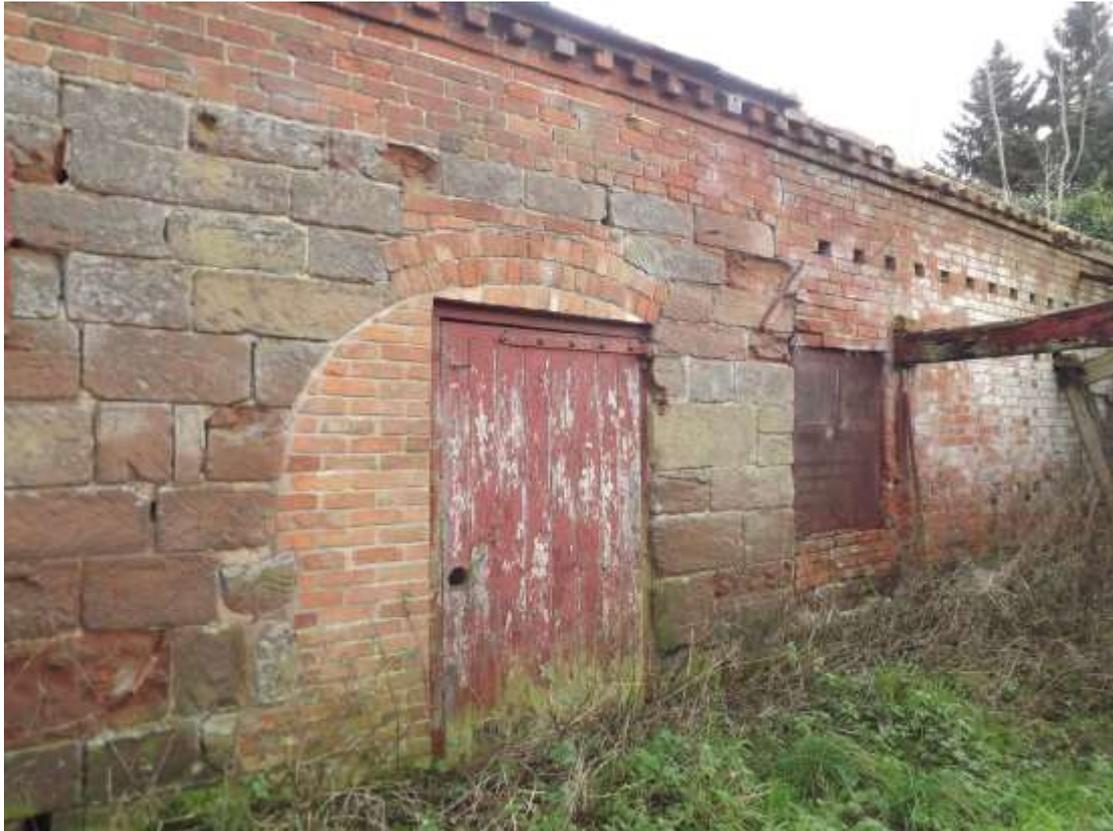
Figure 18 Combinations of sandstone and brick to front elevation of barn

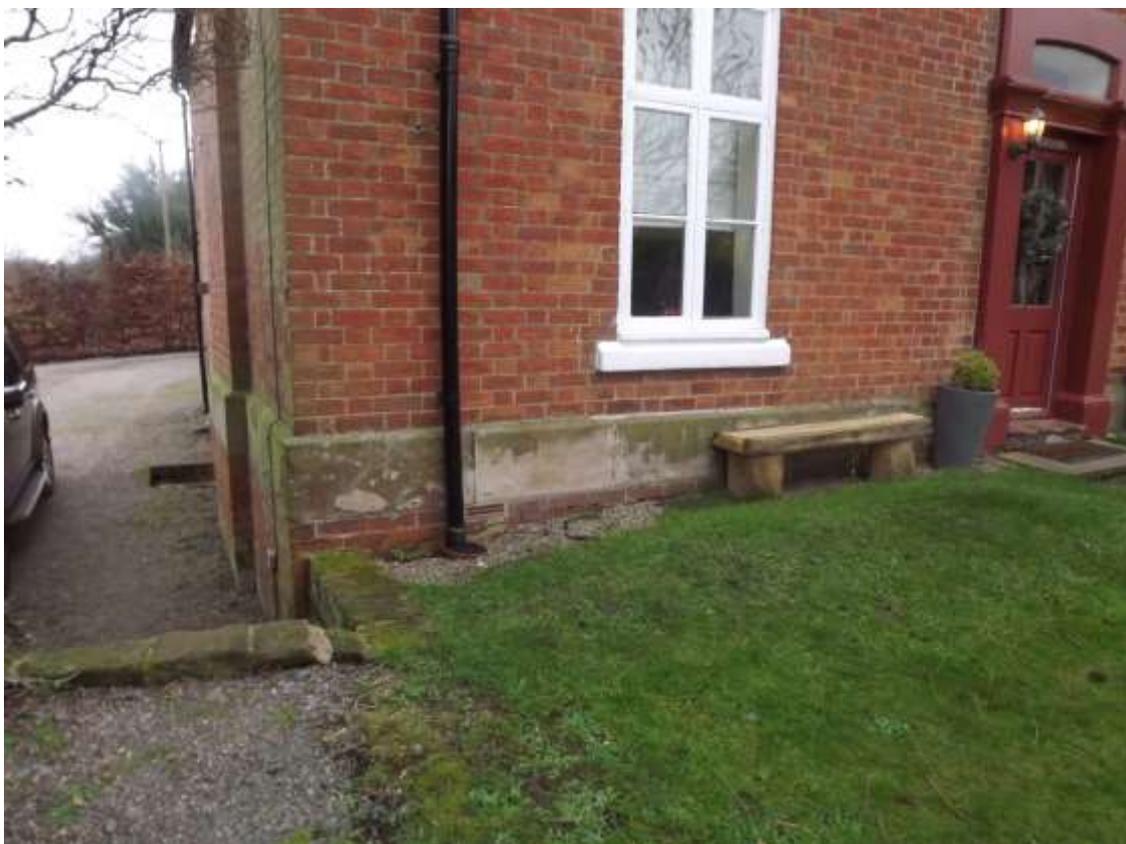
Figure 19 The use of brick and stone to Walk Mill Farmhouse

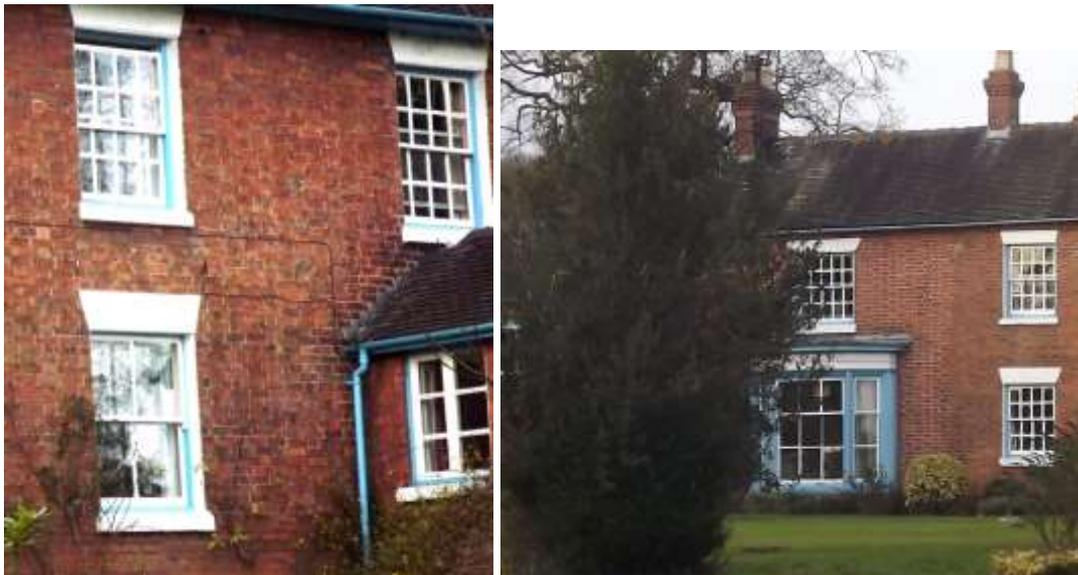
Figure 20 Sash windows to Walk Mill House

3.3.2 There are a variety of window styles within the Conservation Area, from polite, domestic sashes and casements, to more basic openings in the mill and farm buildings. Walk Mill House displays an interesting selection of surviving sash windows and historic glass; eight over eight sash windows dominate on the first floor front elevation, with two over two to the ground floor. There is a multi-light bay window to the side elevation with a ten over ten sash above. Painted stone lintels and cills reflect those at Walk Mill Farm; historically these would have been unpainted. Walk Mill Farmhouse displays an historic metal cellar window.

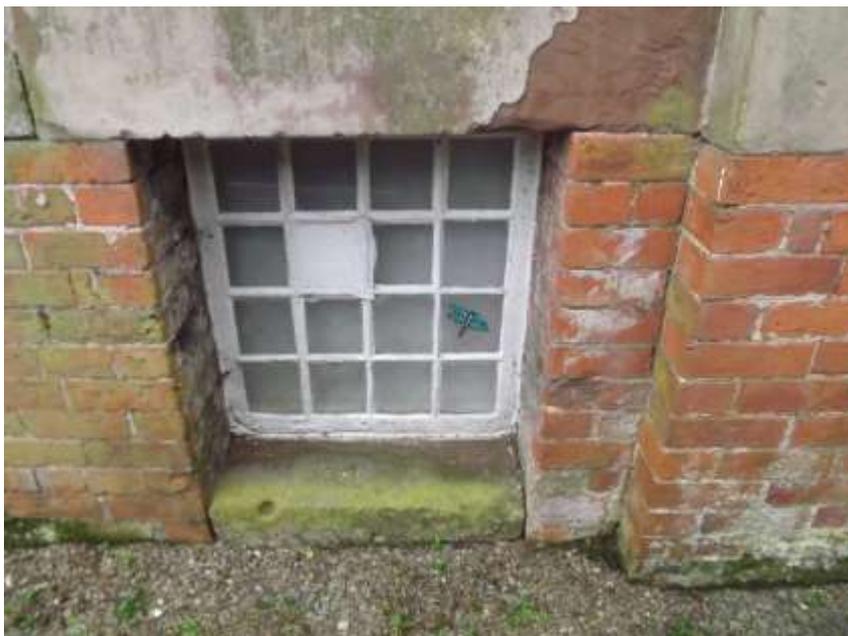
Figure 21 Cellar window to Walk Mill Farm

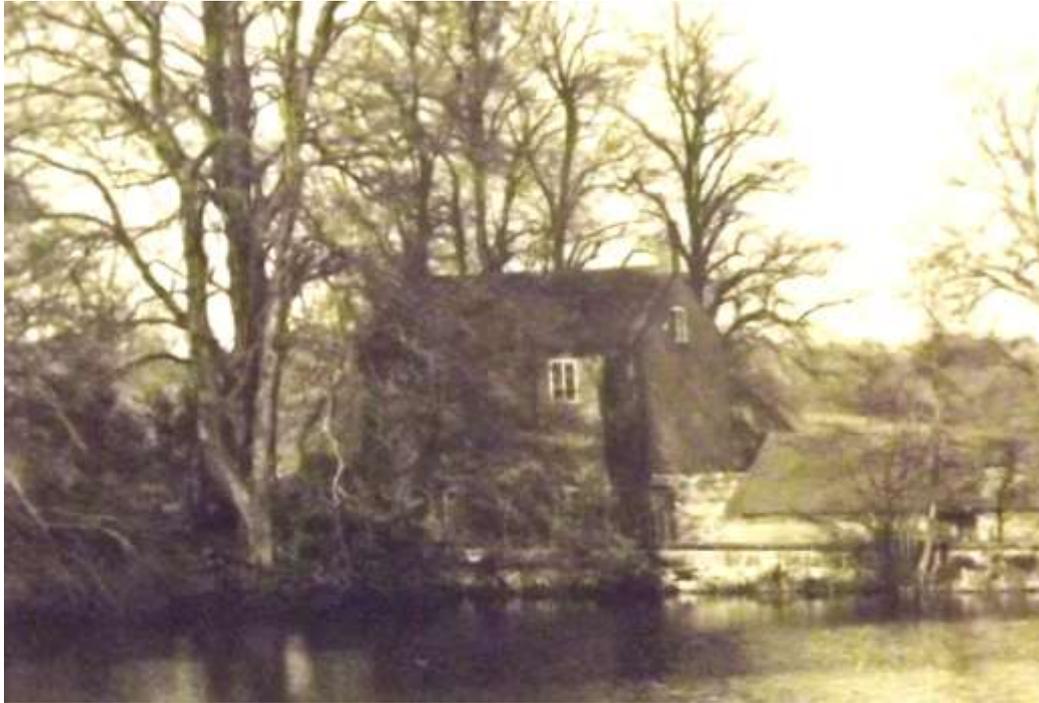
Figure 22 The front elevation of the mill c.1930, showing historic casement windows

3.3.3 No windows or frames remain in the mill buildings, however where the buildings remain intact, original openings are still apparent. Arched fenestration combines with square openings to the maltings and historically the mill house had side-opening, timber casement window of 3 lights, recorded on historic photographs.

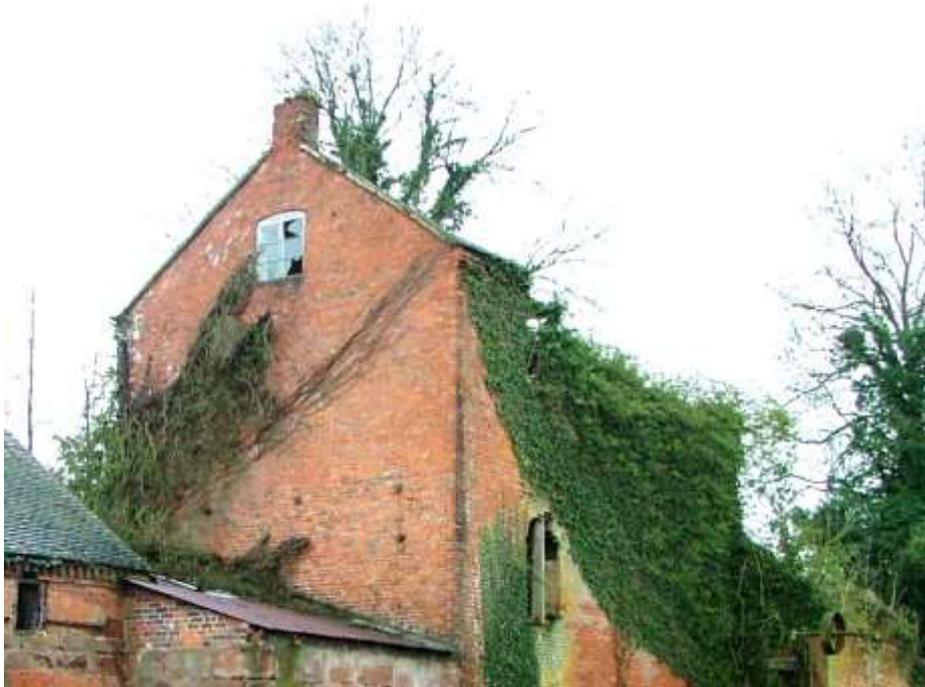
Figure 23 Side elevation of mill house c.2009, prior to loss of upper storeys, showing 3 pane side opening casement windows

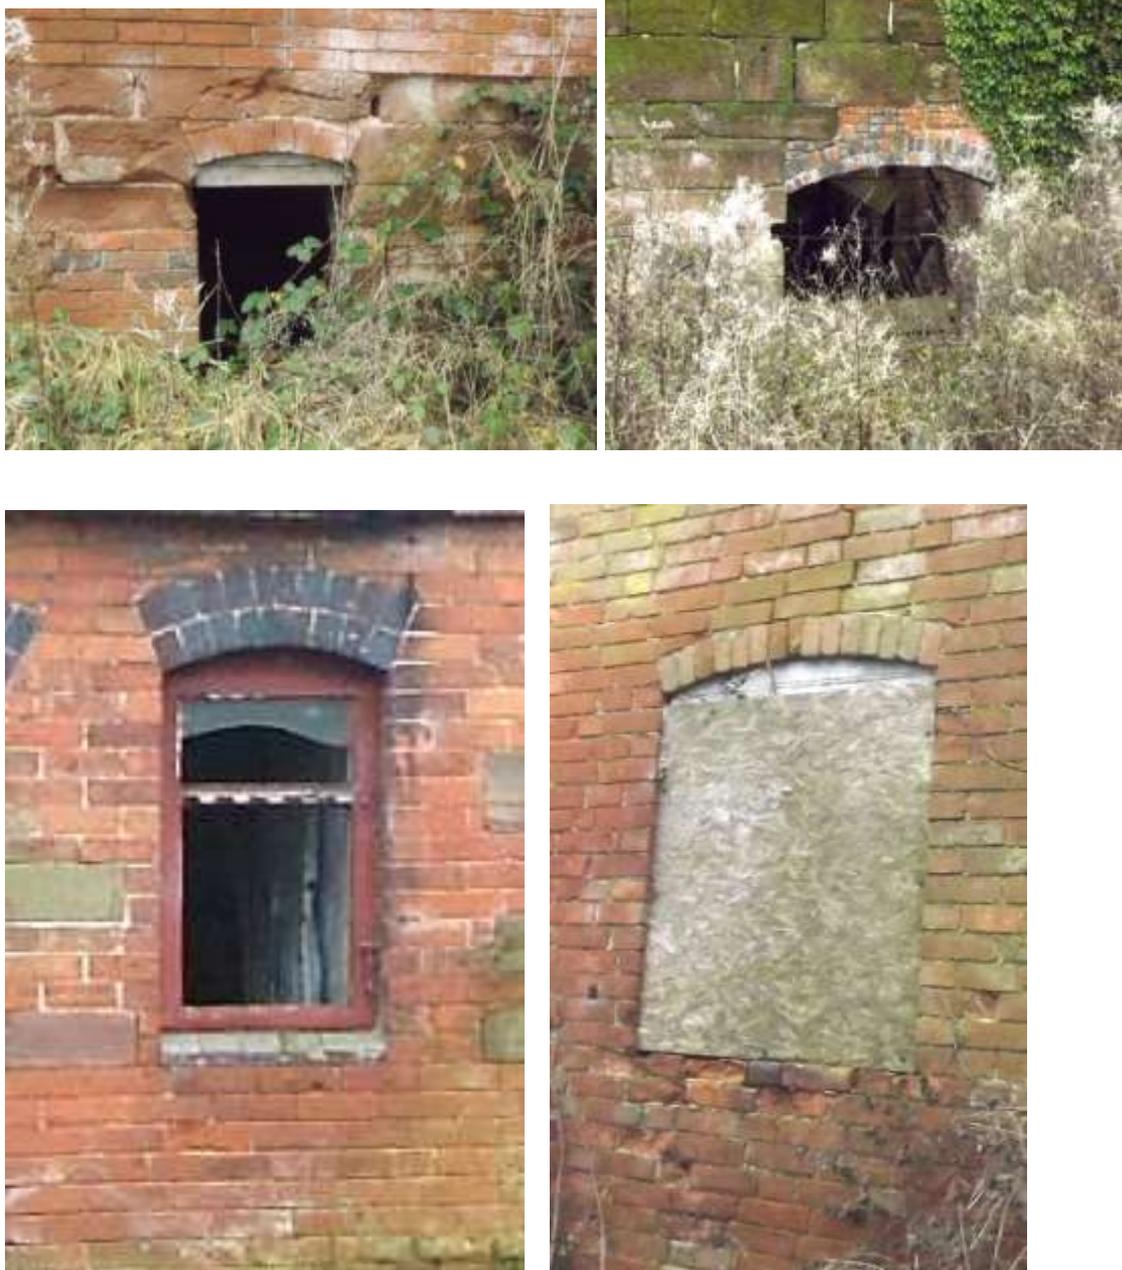
Figure 24 Variety of segmental arch lintels to windows

3.3.4 Variations of segmental arched brick lintels can be found to the windows and other fenestration of the mill and associated agricultural buildings. Simple, single-course red brick is seen to the mill and maltings, whereas the former cart shed has double-course, blue brick lintels. A double-course combination of red and blue brick arch to the wheel house gives further variation in style and adds architectural interest to these buildings. The domestic buildings display a marked contrast to the segmental arch with stone lintels to be found at Walk Mill House and Walk Mill Farm.

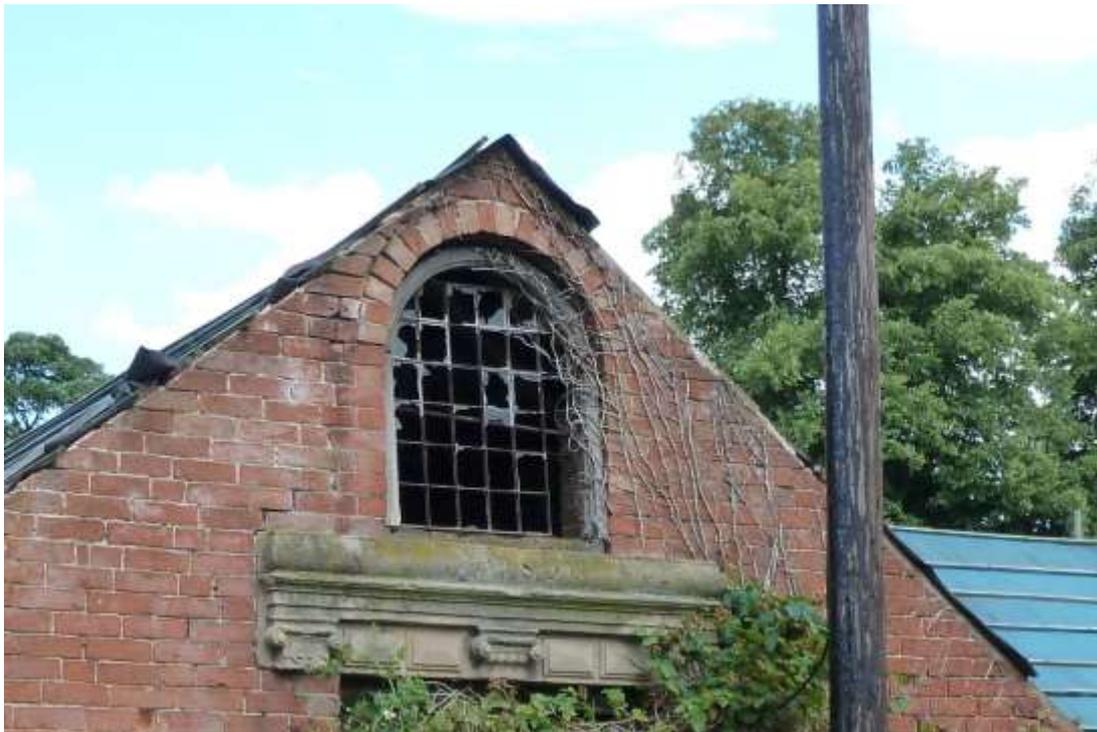
Figure 25 Moulded datestone lintel to maltings

3.3.5 There is an unusual, moulded stone lintel above the doorway to the south side of the malt house. Inscribed *I.D. 1830*, it is thought to reference Isaiah Deakin, occupier of Walk Mill House and surrounding land in the early-mid 19th century. The elaborate lintel appears to be out of context with the brick maltings and it is unclear whether it is contemporary with the building, although the building is of 19th century construction. A semi-circular iron framed window above the date stone, with a red and buff brick segmental arch, adds additional architectural interest to this unusual feature.

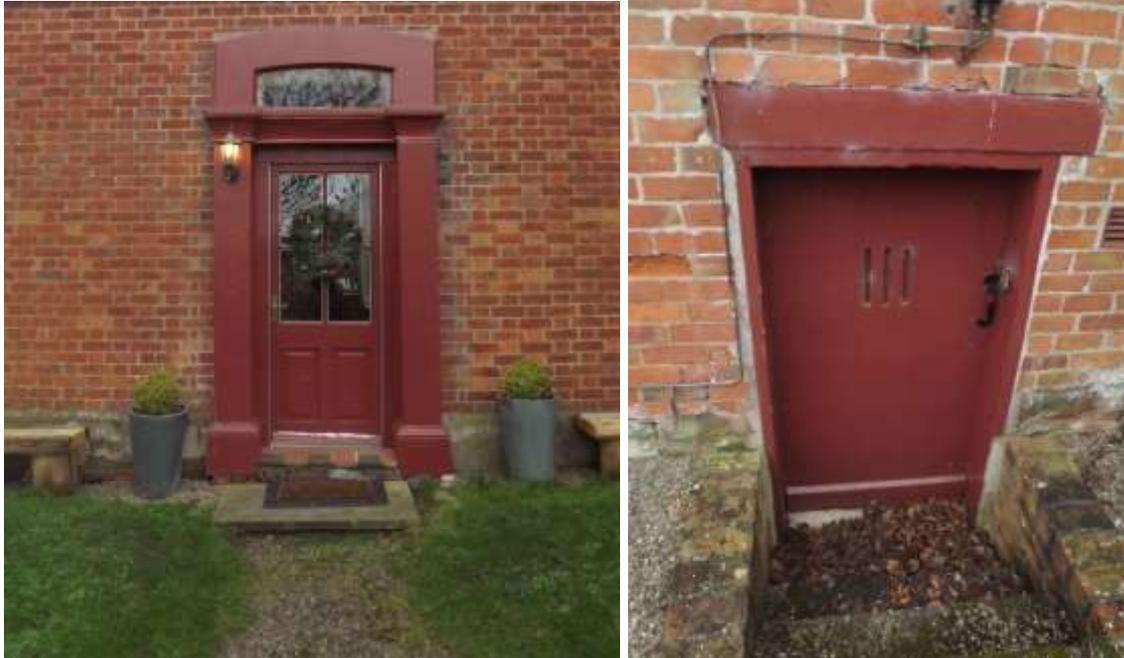
Figure 26 Doorways to domestic buildings of Conservation Area

3.3.6 Few original doorways remain within the Conservation Area. The doorway to Walk Mill Farm has a moulded stone surround, an unusual stone surround fanlight, and there is an historic cellar door. Walk Mill House has a pitched roof porch which, whilst not original to the building, compliments some architectural features.

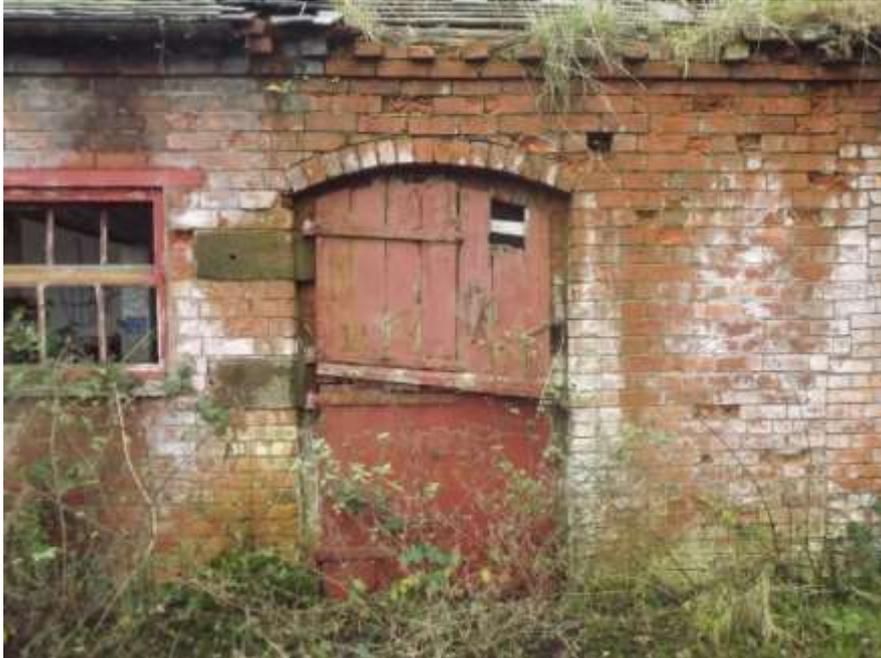
Figure 27 Doorways to farm buildings of Conservation Area

3.3.7 The loss of historic doors is particularly evident in the mill and farm buildings. Most original openings however, can be identified and there is evidence of plank doors, which refer to former agricultural use. Although little remains by way of doors, door arches are worthy of note. Brick, segmental arched lintels of varying materials and colours add architectural interest to otherwise simply designed structures. .

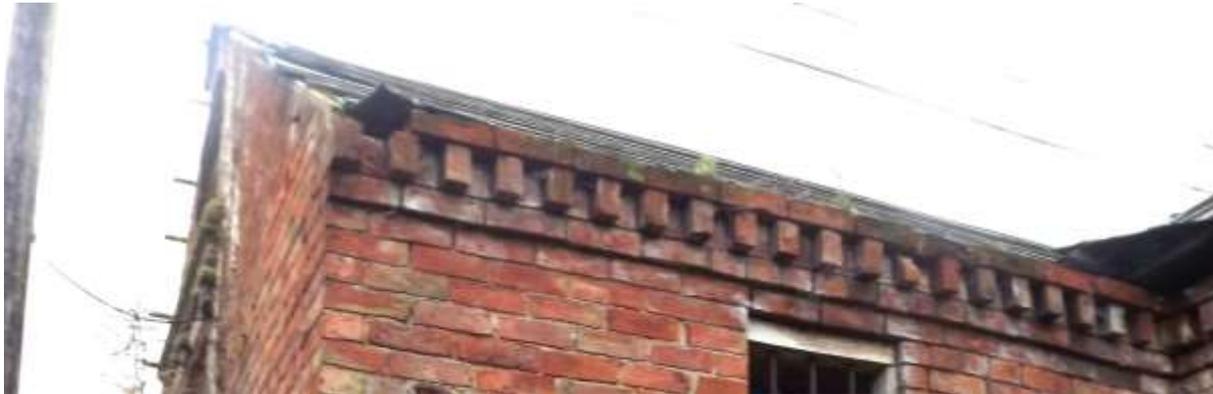
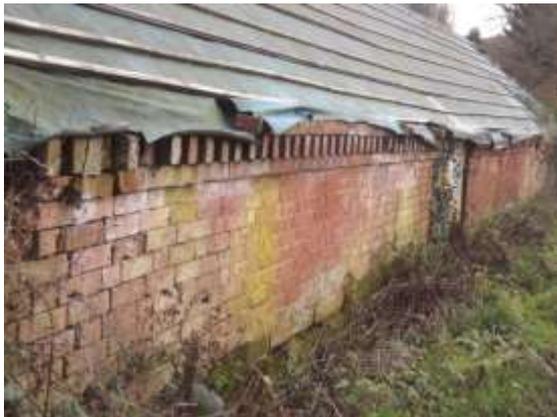
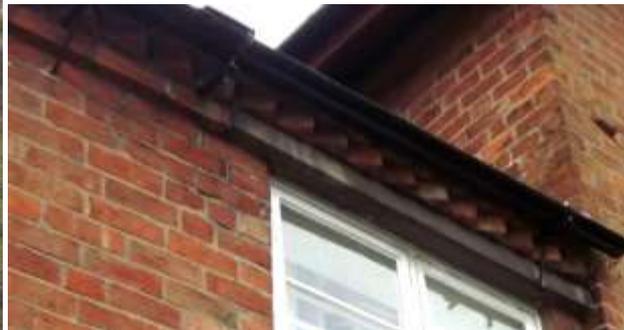
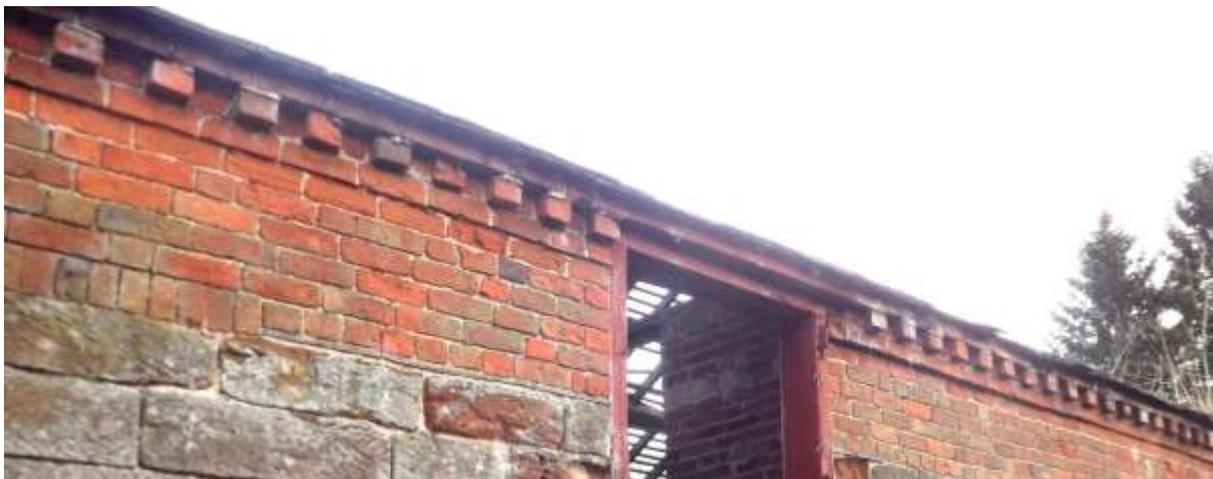
Figure 28 Dentilation to eaves to the maltings, Walk Mill Farm and the barn

3.3.8 Dentilation at eaves provides architectural interest on all of the buildings within the Conservation Area. This feature is echoed throughout the mill and farm buildings, as well as the domestic buildings; Walk Mill Farmhouse displays diagonally set dentilations which provides a contrast. This link through architectural features gives a unity of style, and helps to draw the varying building types together to form a harmonious group.

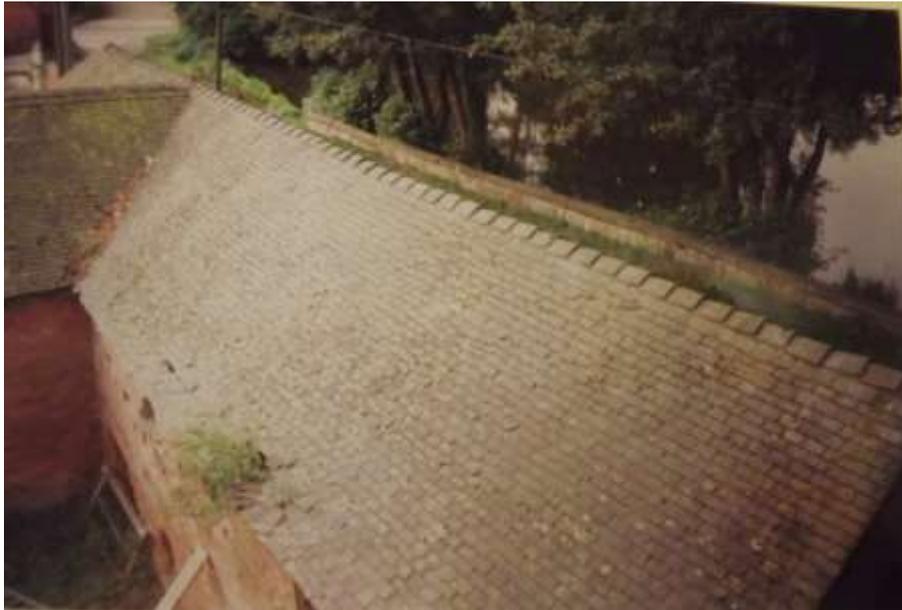
Figure 29 Staffordshire blue clay tiles to the roof of the maltings

3.4.1 The predominant building material within the Walk Mill conservation area is red brick built in Flemish or Flemish Stretcher Bond. Contrasts are found in the use of Staffordshire blue bricks for some segmental door and window arches, and within walls such as on the road-side elevation of the mill and cow shed. Roof material is exclusively Staffordshire blue clay tile.

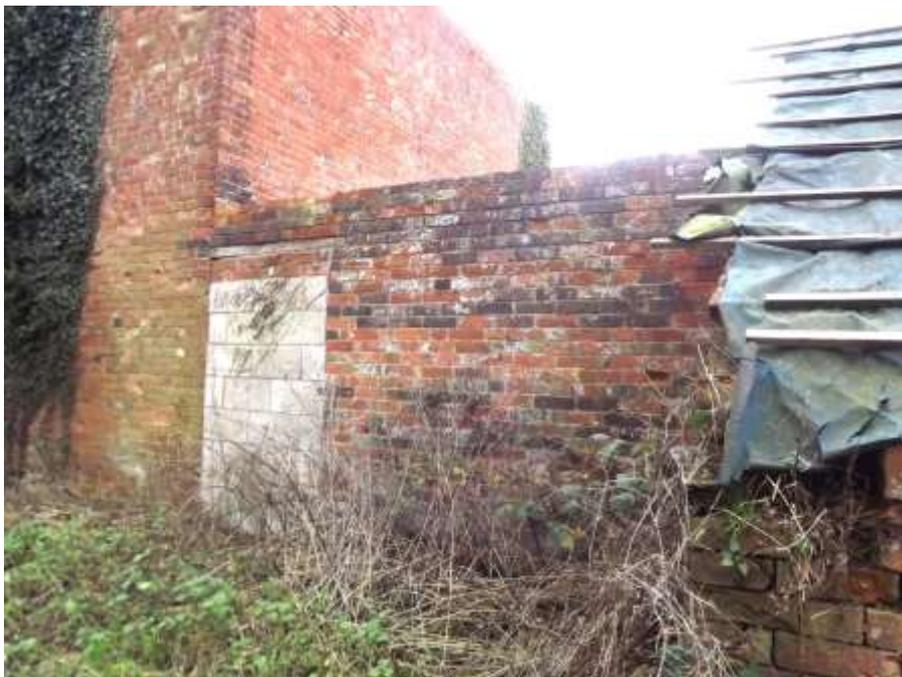
Figure 30 Blue and red brick to road side elevation of mill building

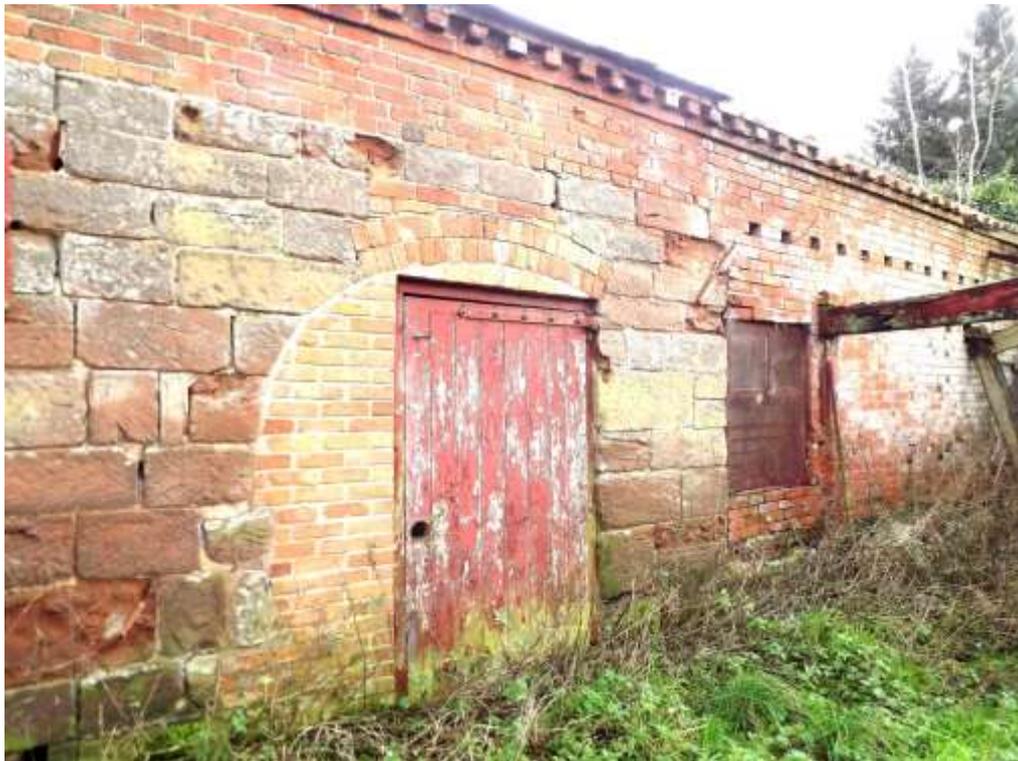
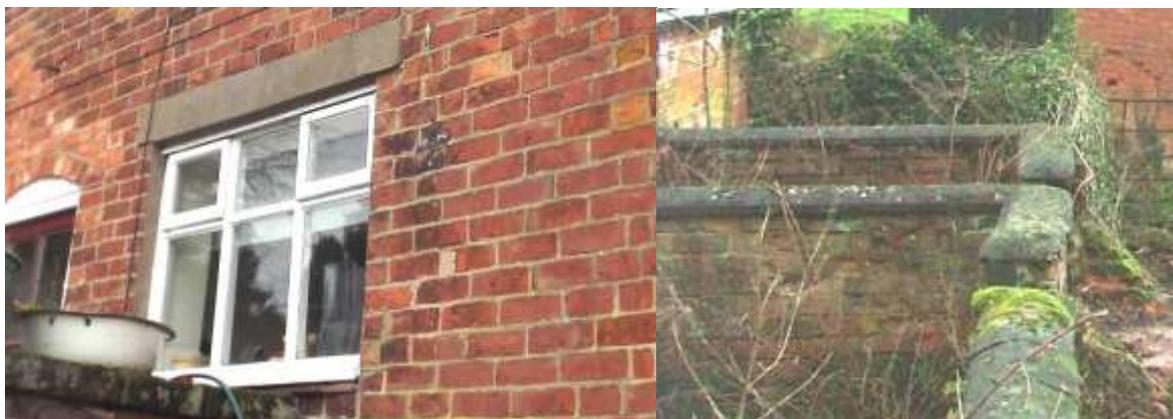
Figure 31 Use of stone within Conservation Area

3.4.2 Stone is used throughout the Conservation Area, most likely due to the nearby location of a number of historic quarries. Often found combined with red brick to the farm and mill buildings, stone foundations are evident to the former barn and to the lower courses of the maltings and Walk Mill Farm. There are stone copings to the pen area of the piggery and stone walls define historic boundaries. There are painted stone lintels and cills to Walk Mill Farm and Walk Mill House and the farmhouse has a painted stone string course. Historically, all stone would have been unpainted, such as is found to the lintels on the rear of the farmhouse.
