Walk Mill Conservation Area Appraisal

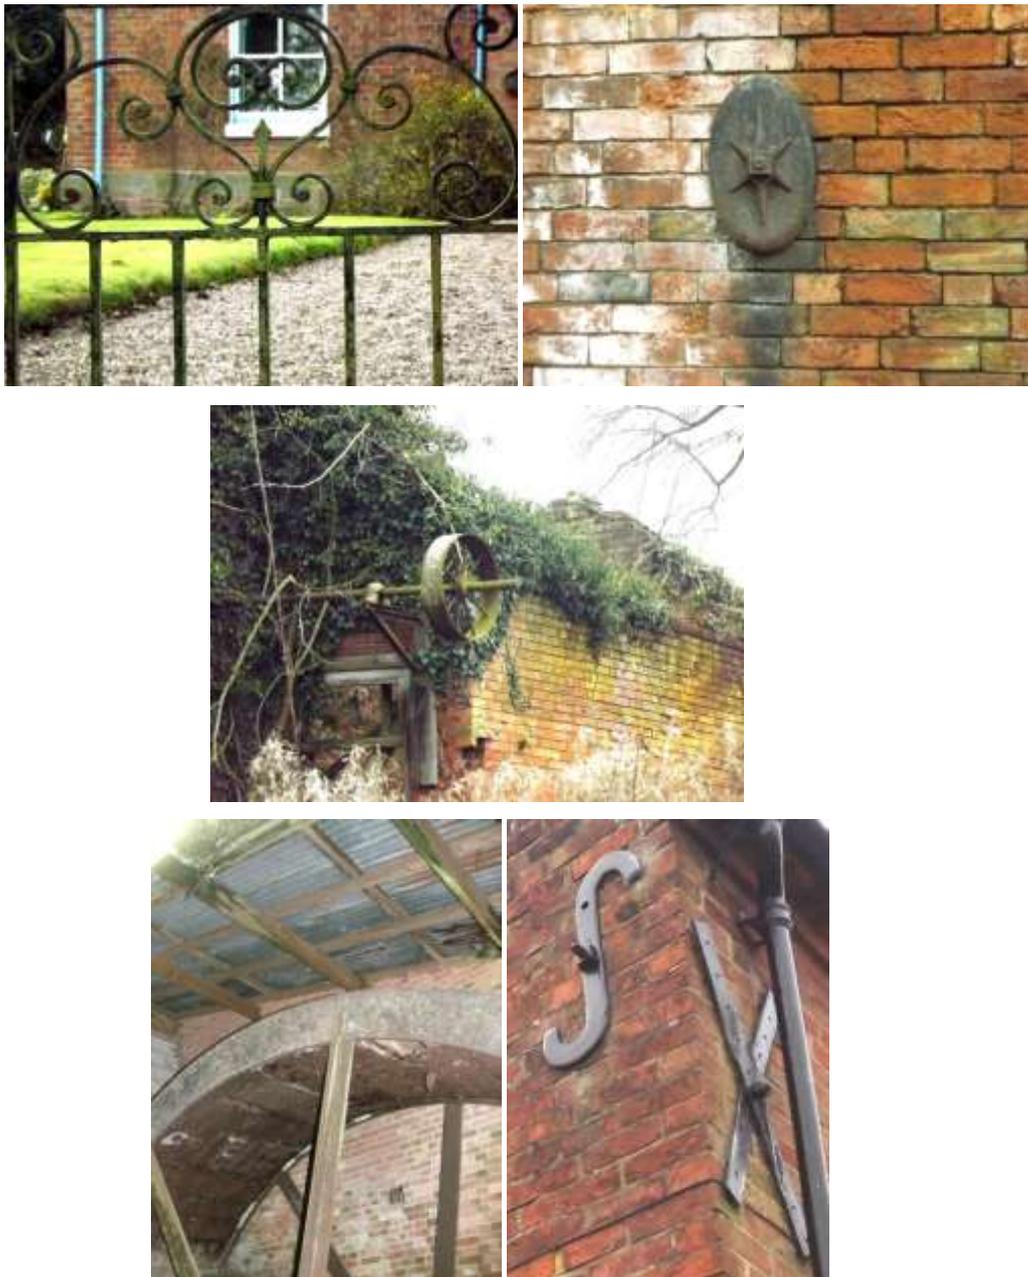
Figure 32 Use of metal within Conservation Area

3.4.3 Historic metalwork can be found in the Conservation Area. Iron gates help define the front and side entrances to Walk Mill House and cast iron structural supports can be seen to the maltings. Walk Mill Farmhouse has more recent metal structural supports, although these are in keeping with the character of the Conservation Area. The mill wheelhouse retains its historic iron undershot waterwheel and much of its historic machinery. An iron pulley wheel attached to the rear wall of the mill continues the use of historic metal and adds interest to the mill site.

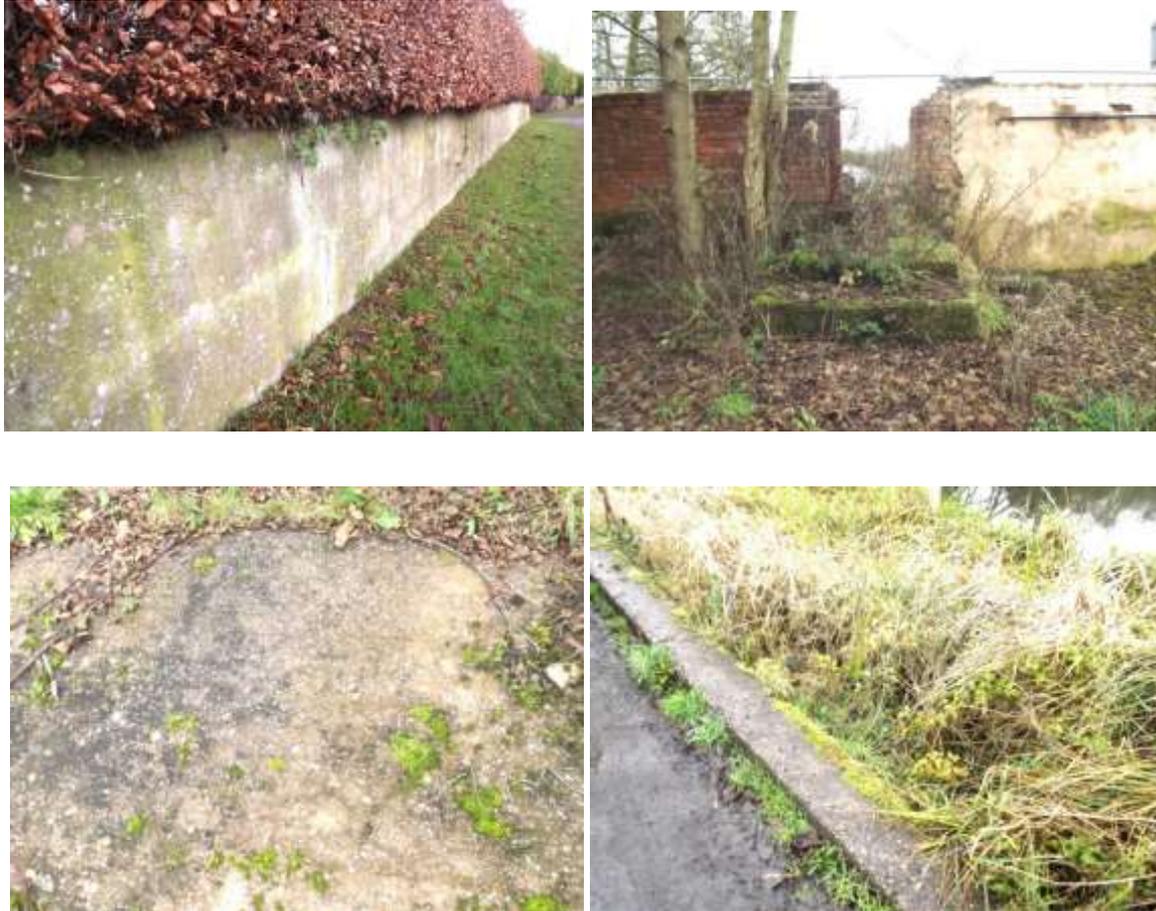
Figure 33 Use of 20th century material within Conservation Area

3.4.4 The use of 20th century materials can be found throughout the Conservation Area. There is a section of concrete wall, topped with hedges, to the south boundary of Walk Mill Farm, some concrete kerbing to the lay-by and concrete render to the inside of the mill site boundary wall. The former farm yard is laid with concrete to the rear of the barn and cowshed.

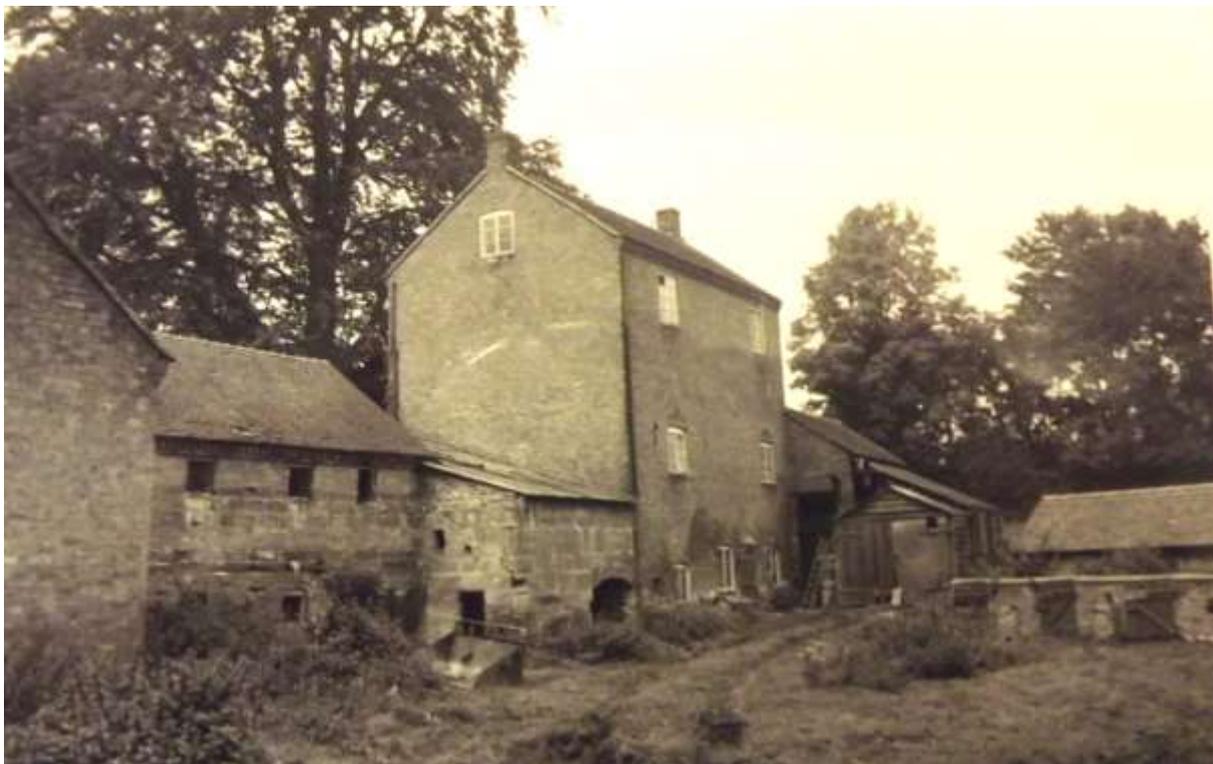
Figure 34 The mill, wheelhouse, maltings and piggery c.1930

The mill and maltings are grade II listed and are one of the very few surviving examples of a dual-purpose building of this type. The most prominent feature of the mill complex is the three-and-a-half storey mill house which houses the waterwheel within a one-storey attached building. The mill is thought to have replaced a former fulling mill on the site in the late 18th century.

In addition to grinding corn, the mill range was also used for the production of malt. Before the development of large-scale breweries, malting was a local, small-scale activity. The long, two-storey building to the south of the mill is the former maltings, thought to have been rebuilt sometime in the early 19th century. The architecture of the maltings derives from its functionality and is more associated with the agricultural than the industrial tradition of building (Cossons, 1975). The malthouse retains on its upper level the growing floor where barley was spread during its germination period. The kiln in which the germinated grain was roasted to produce malt was in the south east corner of the building, formerly heated by a furnace on the lower, yard level.

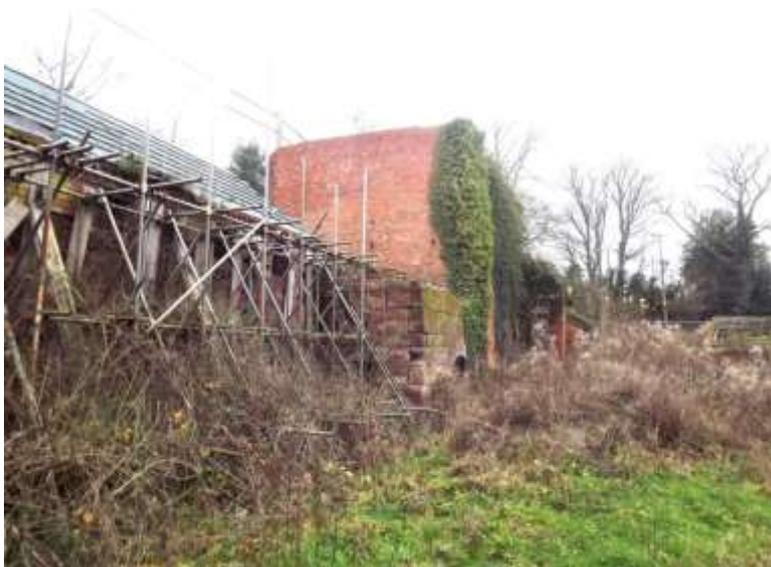
Figure 35 The grade II listed mill and maltings

Both the mill house and the maltings are in a ruinous state after storm damage occurred in the 1970s. The mill house has lost its top one and a half storeys and roof, and the maltings has had its roof tiles removed.

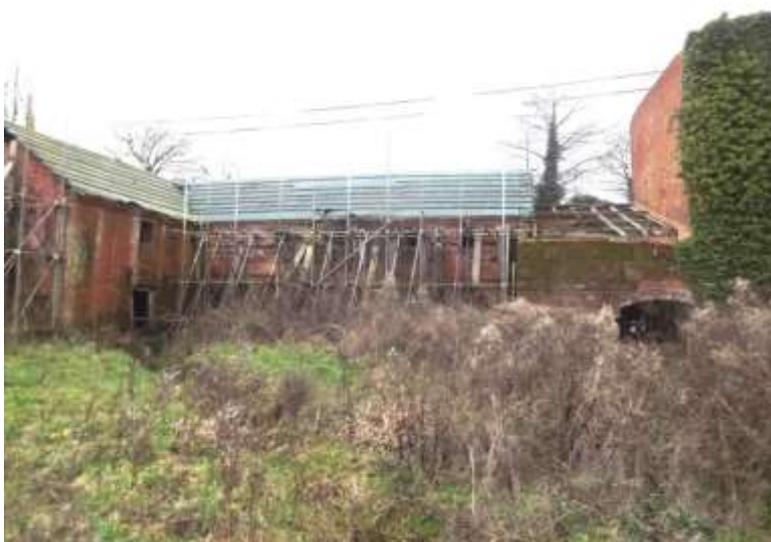
Figure 36 The maltings and former grain store

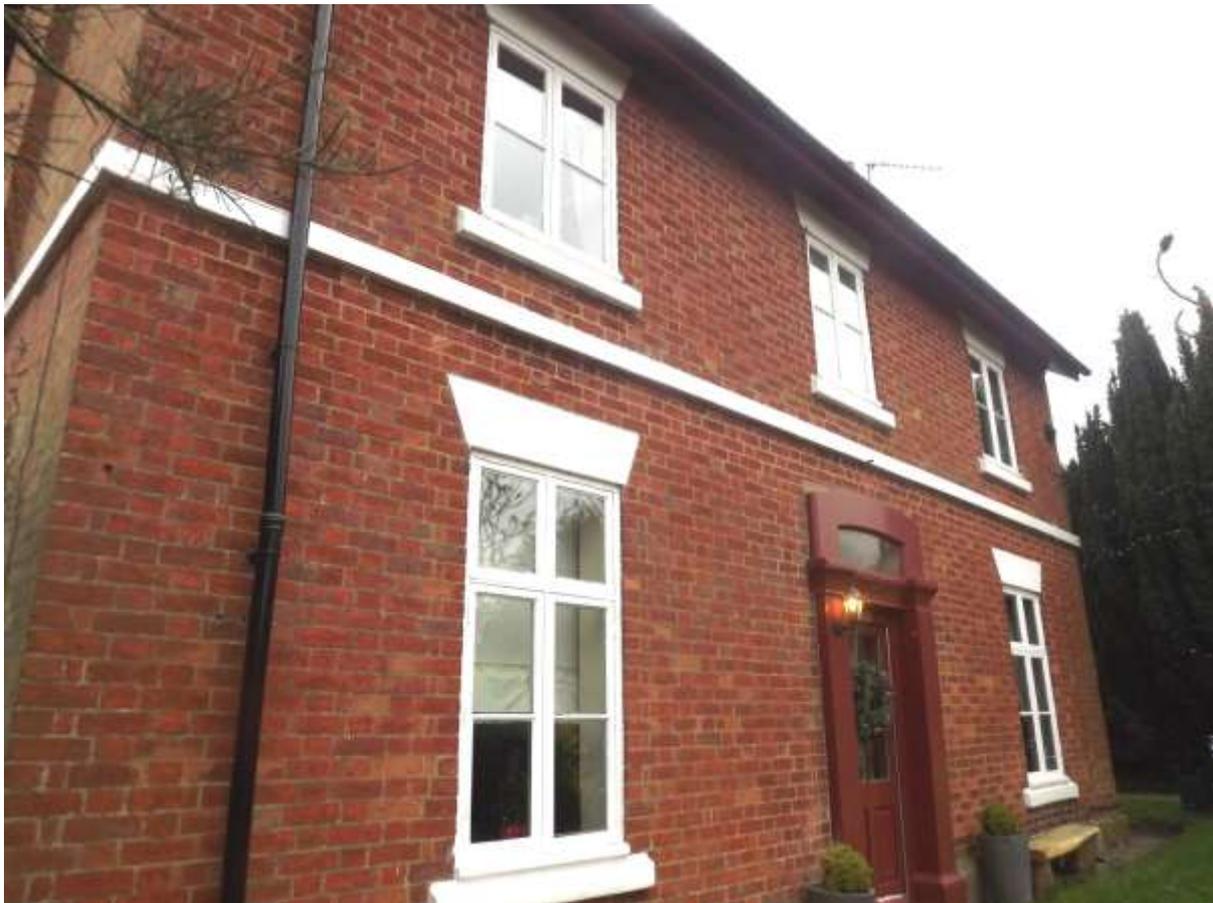
Figure 37 Walk Mill Farmhouse

3.7.1 Walk Mill Farm Built c.1850, Walk Mill Farm is a two-storey farmhouse of three bays, square on plan, with a double-gabled rear section. The farmhouse is of red brick built in Flemish bond, with a pitched, tile roof. The farmhouse has a stone plinth, painted stone lintels and cills, and a stone string course. Although the windows are later timber replacement casements of traditional form, Walk Mill Farm is a good example of a modest Midlands farmhouse, adding a contrast in scale and architecture to the agricultural buildings of the farmyard.

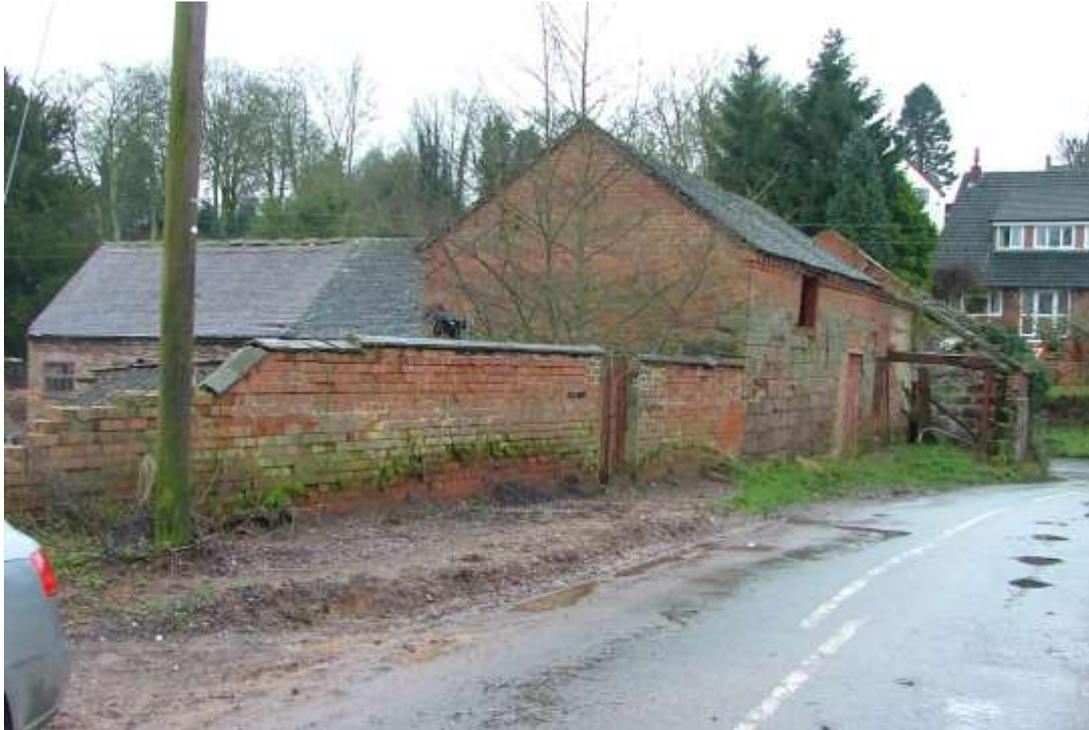
Figure 38 The barn as viewed from the north along Sugnall Road

The Barn and cowshed A building is recorded on this site from 1837. Recorded on the 1841 tithe as a dwelling, it is not clear when the building changed to agricultural use, although it is likely to have occurred around the time of the construction of Walk Mill Farmhouse in the 1850s. The building lies within the curtilage of the grade II listed mill building and, as the earliest of the farm buildings, holds significance in the development of the site. Built predominantly of sandstone, with some red brick in a Flemish Stretcher bond, the building is of three bays, with a two bay cow shed or 'shippon' to the rear and some original cobblestone flooring. Building recording, carried out in 2009 by Casterling Archaeology, revealed sandstone foundations and a single remaining timber post suggest that the three bay barn was originally of timber frame and sandstone construction; it is thought that the shippon may have been rebuilt in red brick in the late 19th century. There is a 20th century extension to the west bay of the shippon, added post 1957 and first appearing on OS mapping in 1970. The barn became disused in the late 1990s.

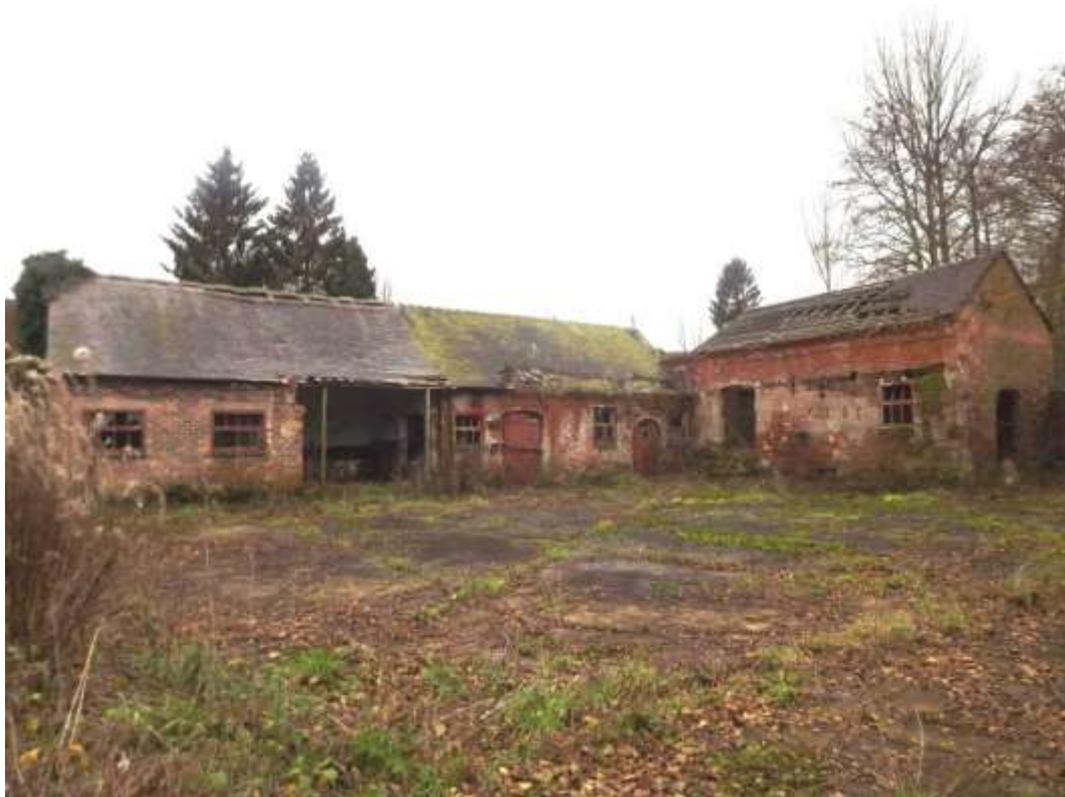
Figure 39 The rear of the barn and attached shippon, as viewed from former farmyard

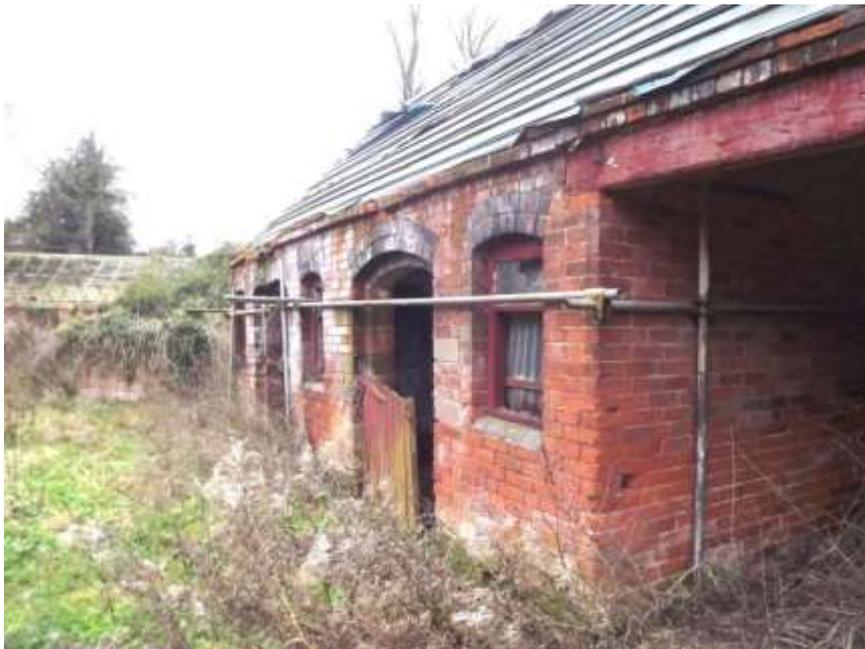
Figure 40 The former cart shed and stables

The cart shed and stables A traditional 19th century agricultural building of red brick and tile, the cart shed forms part of the historic farmstead. Sited opposite the mill buildings and facing inwards to the farmyard site, the building was described in sale particulars from 1911 as 'a trap house, wagon and implement shed with a two-stall stable'. Displaying original openings, and blue brick segmental window and door arches, the cart shed is currently in extremely poor condition and has had the historic tiled roof covering removed.

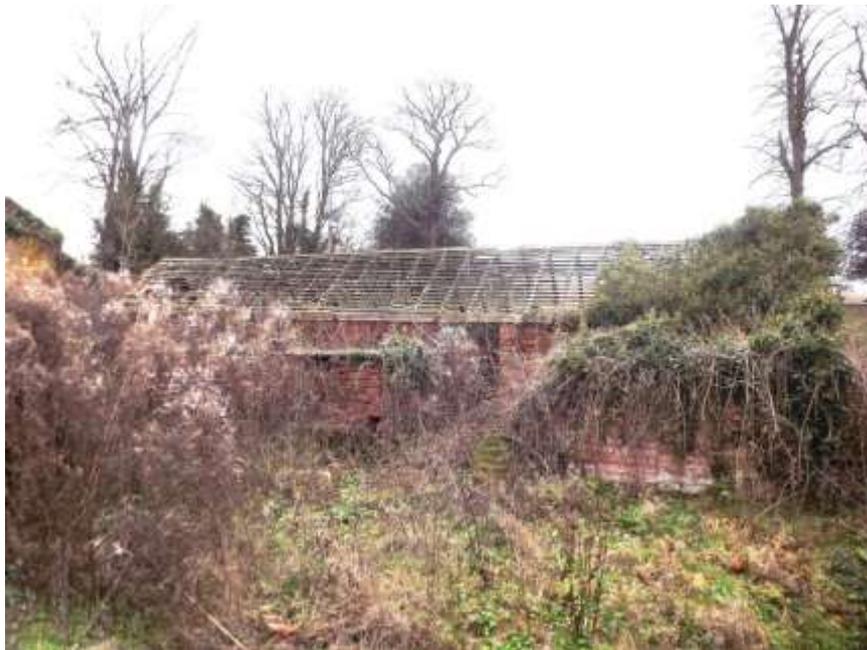
Figure 41 The piggery. Currently without roof tiles and in a dilapidated condition

The piggery A small scale, low building of less than a storey high, the piggery defines the northern boundary of the mill site. Located immediately to the west of the mill, facing inwards towards the farmyard, the piggery forms part of the curtilage of the listed building. Part of the 19th century farmstead, the building is of red brick with a low-pitched roof, previously of tile. The tiles have been removed exposing roof trusses beneath. There is a brick and stone walled pen to the front.

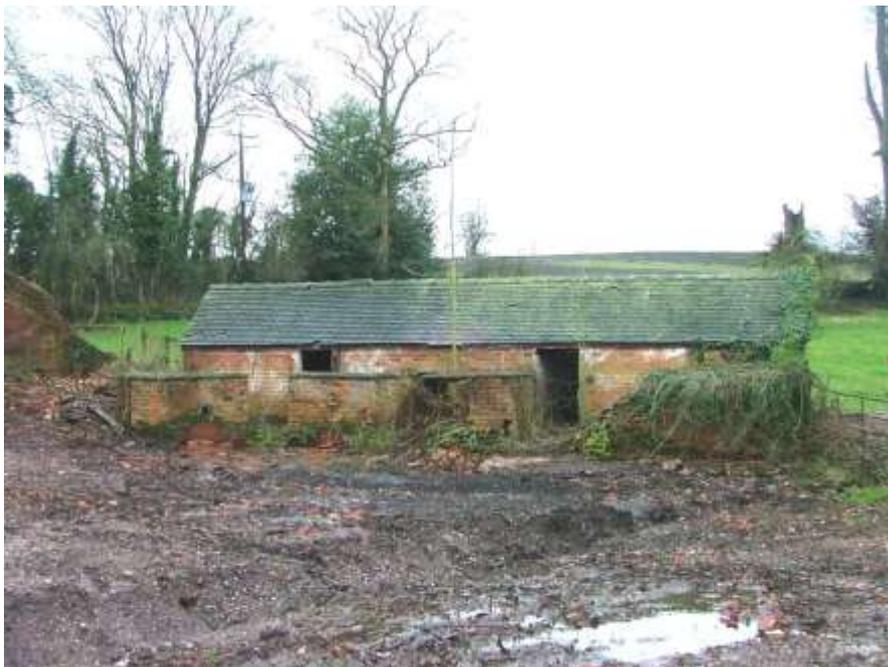
Figure 42 The piggery in 2009 prior to the removal of historic roof tiles.

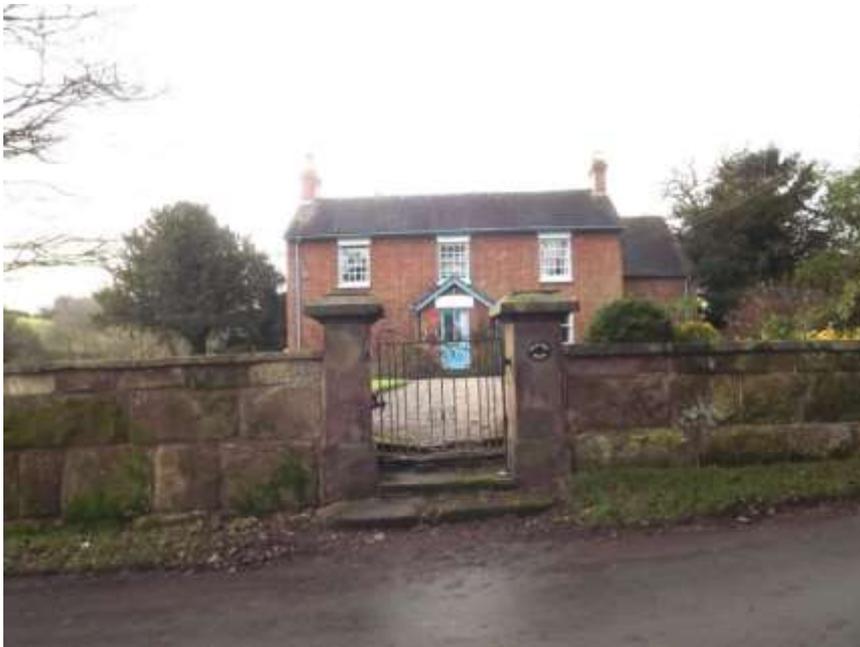
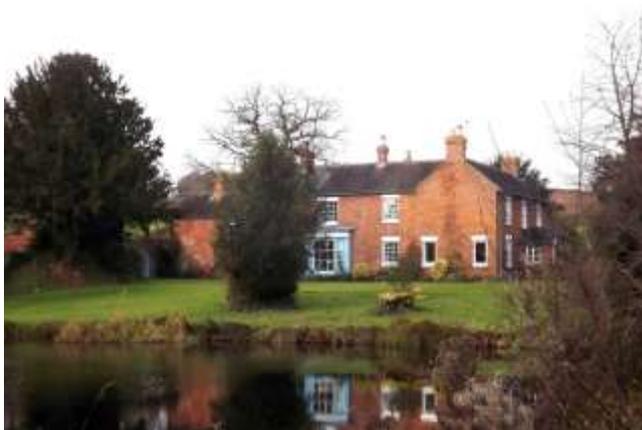
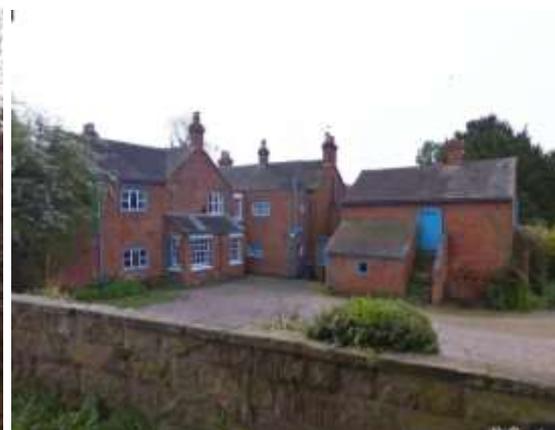
Figure 43 Walk Mill House front, side and rear elevation

3.7.3 Walk Mill House A two-storey farmhouse of brick and tile, Walk Mill House is of larger proportions than Walk Mill Farm and stands in its own well-tended grounds, and is bounded by a stone wall and iron gates. Dating from the early 19th century, the house displays a more polite architecture than the other buildings within Walk Mill and retains much original fenestration. With three bays to the front elevation, the house is asymmetrical on plan with a range of historic farm outbuildings to the rear. The large grounds to the west elevation slope down to the Mill pond and border the length of the northerly boundary to the Conservation Area. Listed for sale in 1911 as a 'residential and sporting property', Walk Mill House formed part of the sale lot along with the mill, farm and pond.

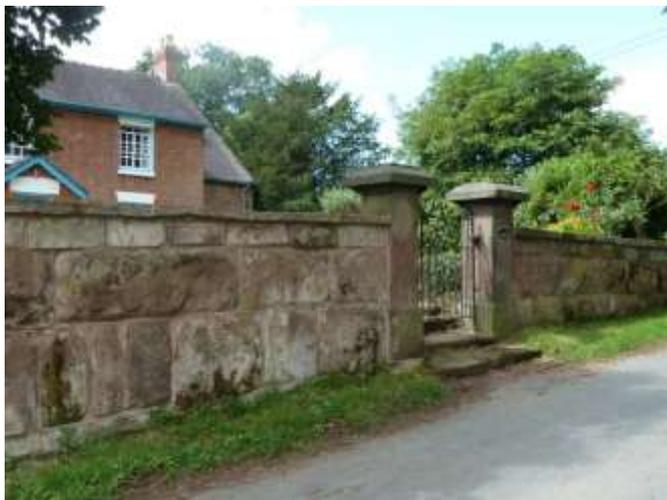
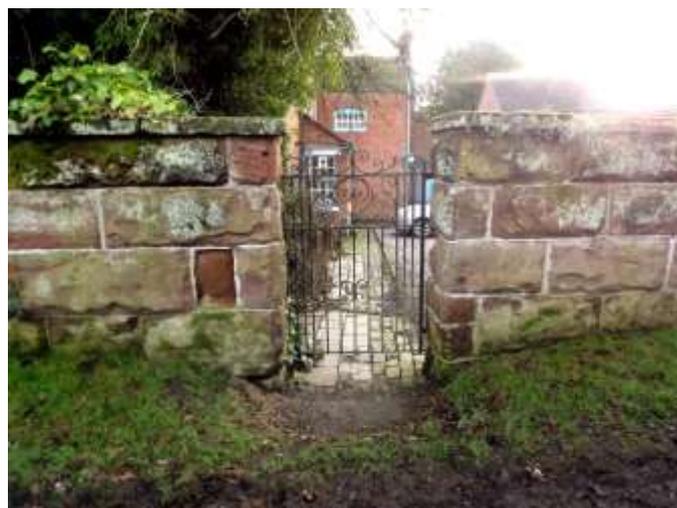
Figure 68 Stone walling and gate posts with historic metal gates to Walk Mill House

4.6.1 Substantial stone walls define the front and side boundaries of Walk Mill House; the pinkish-grey, large block sandstone echoes that found to the mill and farm buildings. This contrasts with the lower, smaller block and rubble stone walls elsewhere in the Conservation Area. Stone gateposts mark the entrance to the house and an historic wrought iron gate adds interest. A further wrought iron gate can be found to the side entrance to the property.

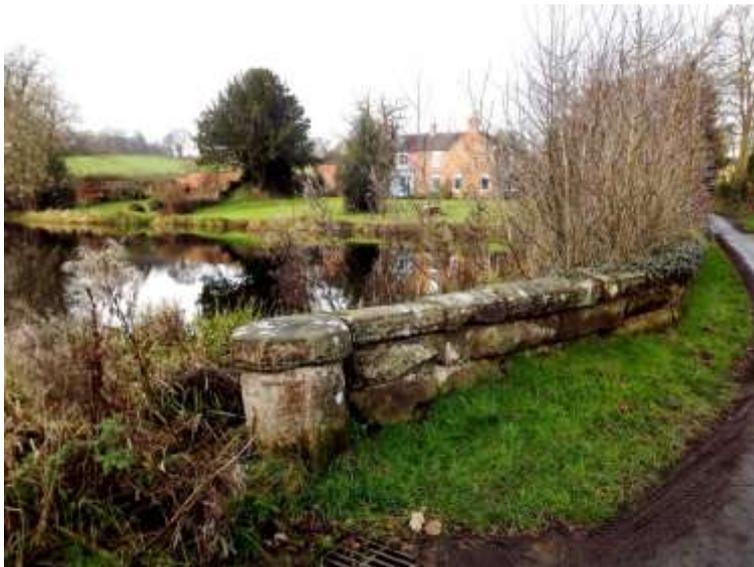
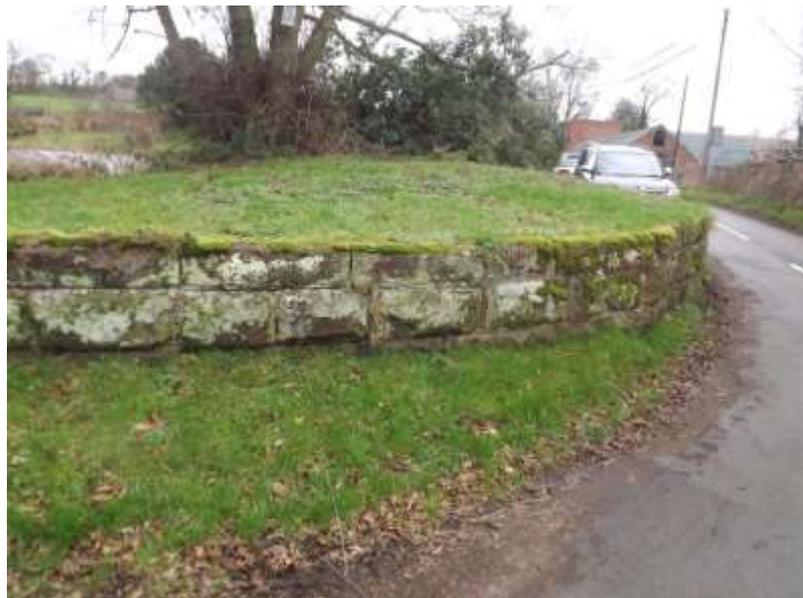
4.6.2 Less grand stone boundary walls define the boundary between the Sugnall Road and the mill pond. Of one to two courses with stone copings, the boundary wall here is lower than that which borders Walk Mill House and culminates in an interesting cylindrical end post. A section of stone kerbing leads to a further low stone wall which follows a curved pattern and continues along into the south boundary of the Conservation Area; the lower height of the wall allows for open views across the water.

Figure 69 Lower stone walls border the mill pond and continue down Sugnall Road

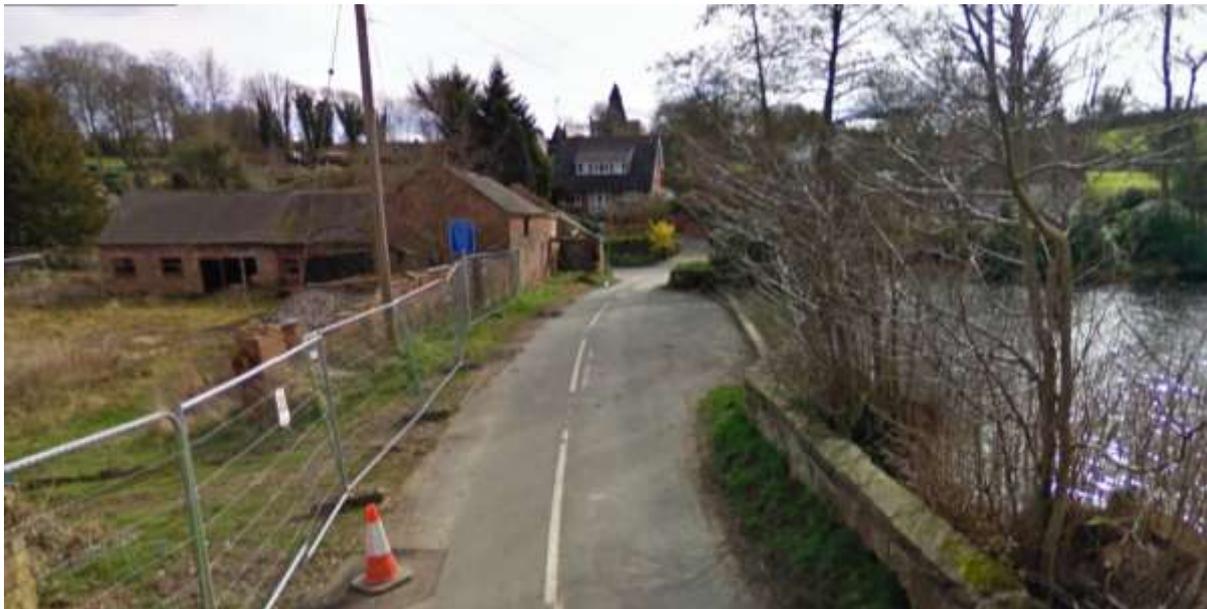
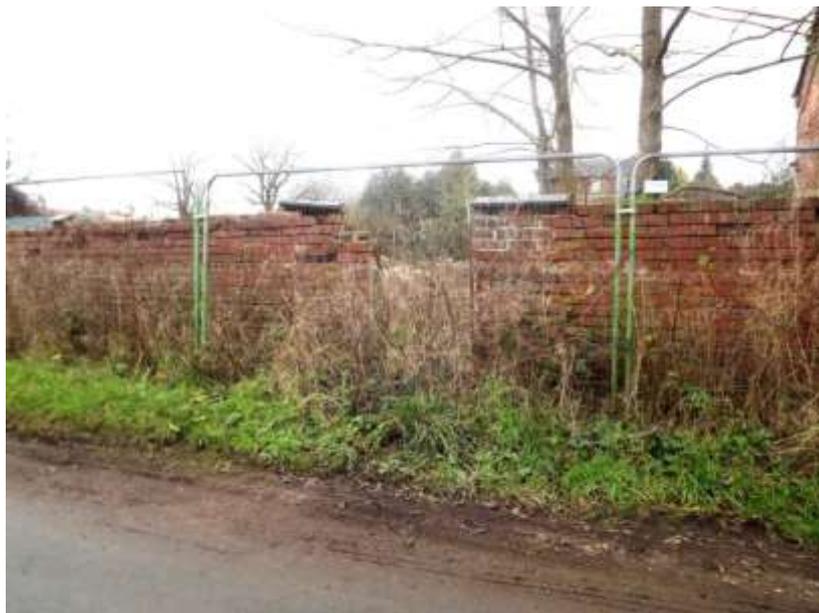
Figure 70 Brick boundary walls to the mill site

4.6.3 Brick provides a contrast and variety to the boundary treatments of the Conservation Area. A red brick wall with blue brick copings borders the mill site and farmyard; the bricks mirror those used in the buildings. A wooden gateway marks a previous entrance to the site and remnants of former brick gateposts can still be seen. Identified as an important boundary, the wall has deteriorated significantly in recent years and is currently in a dilapidated state. Unsightly metal fencing secures the site, whilst the surviving areas of the wall provide a clue to the former size and style of this historic structure.

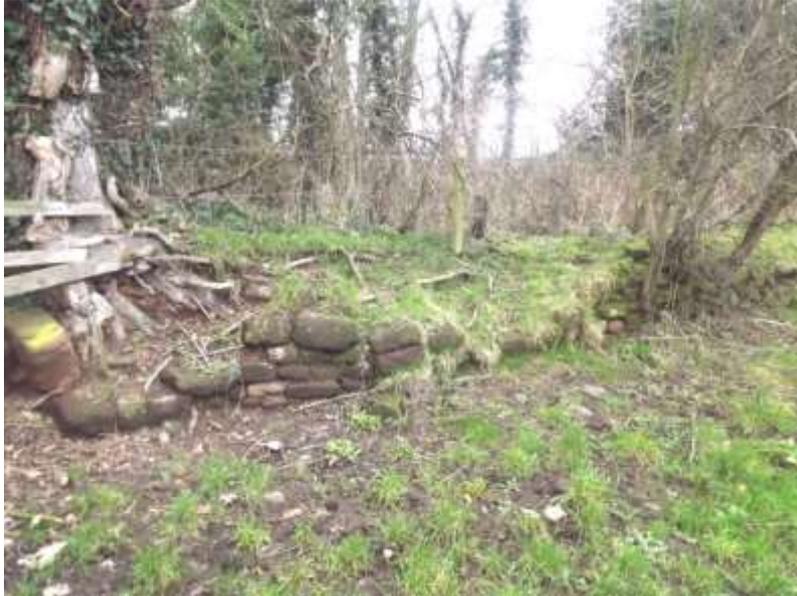
4.6.4 Combinations of hedges and trees, some interspersed with rubble stone walling, closely follow historic field boundaries, many of which define the Conservation Area boundary.

Figure 71 Rubble stone walling along historic field boundaries

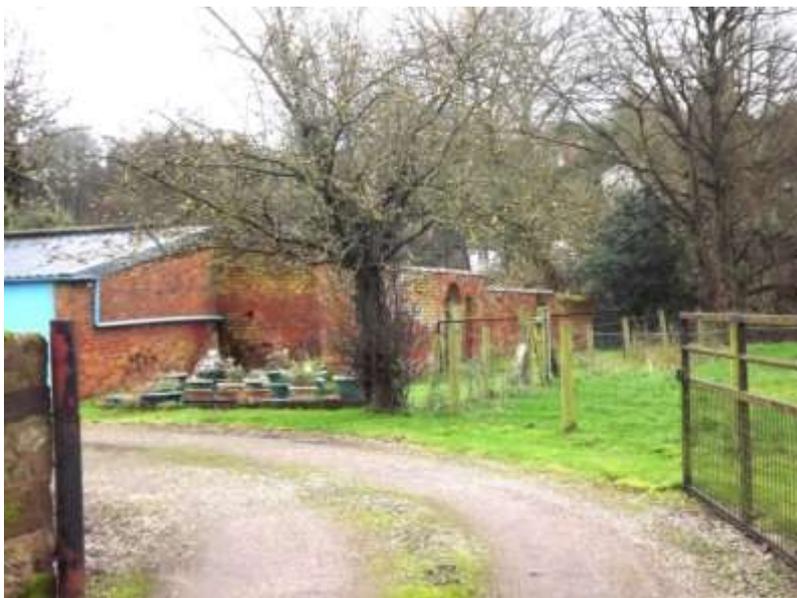
4.6.5 What appears to be the wall of a former walled garden can be found in the grounds of Walk Mill House. An important boundary wall, it is of red brick with red tile copings. Built on three sides, the wall can be seen from across the mill pond.

Figure 72 Walled garden wall in Walk Mill House grounds

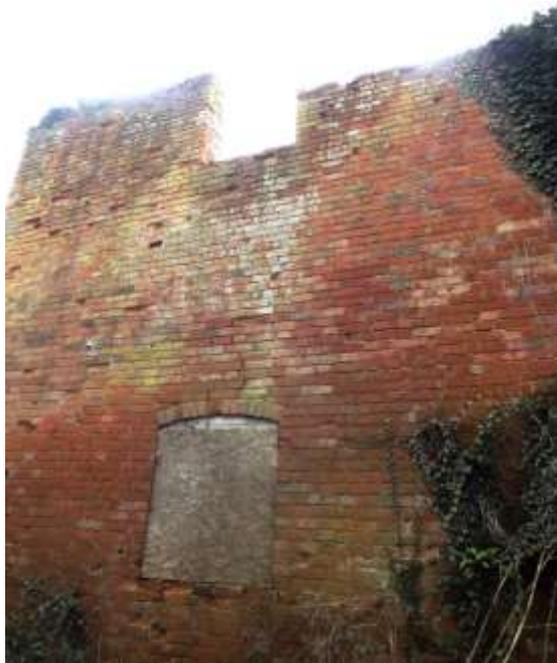
Figure 73 The mill building has now lost its upper two storeys

The mill building was damaged by a falling tree in the mid-1970s and has never been repaired. As a result of this damage and subsequent neglect, the building has deteriorated significantly and requires a substantial amount of rebuilding and repair. This is of particular concern as the building is grade II listed and therefore holds national significance. The mill building is without a roof, which has escalated deterioration and subsequently led to the loss of the upper storeys. The attached maltings, which also form part of the statutory listing, is structurally unsound and in a poor state of repair. Roof tiles have been lost, damaged and removed from the roof, although temporary covering means that the building is weather tight.

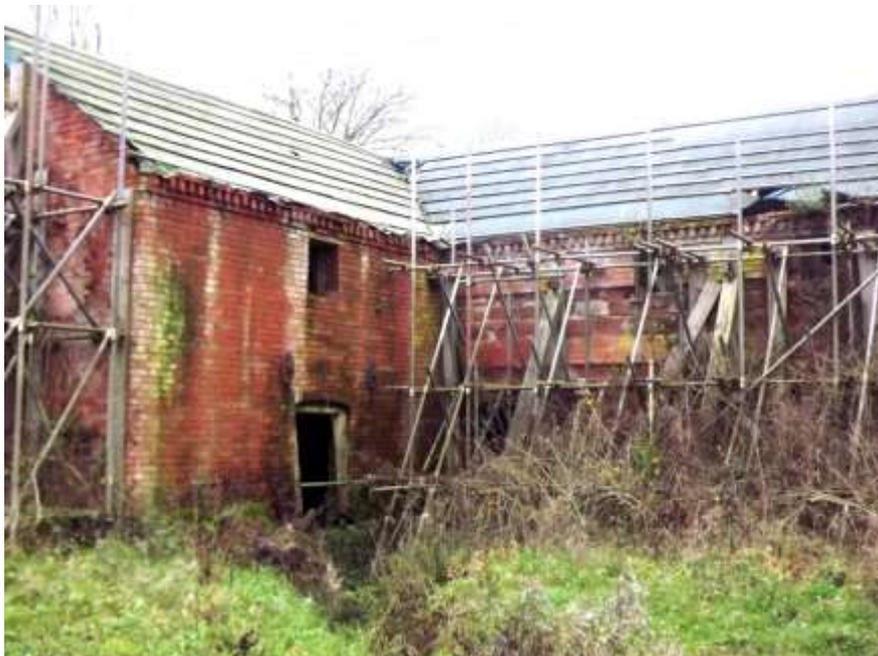
Figure 74 Scaffolding supports the former maltings

The Walk Mill site is surrounded by modern metal security fencing and scaffolding supports have been put in place due to structural issues with the buildings. Some historic roof tiles have been removed for preservation purposes, and weather proof roof coverings have been fitted to help reduce the rate of deterioration to the buildings. These measures have had a negative effect on the appearance of the Conservation Area and have dramatically changed the appearance of the buildings; the modern material covering jars against the historic buildings. The use of these materials must only be considered as a temporary measure.

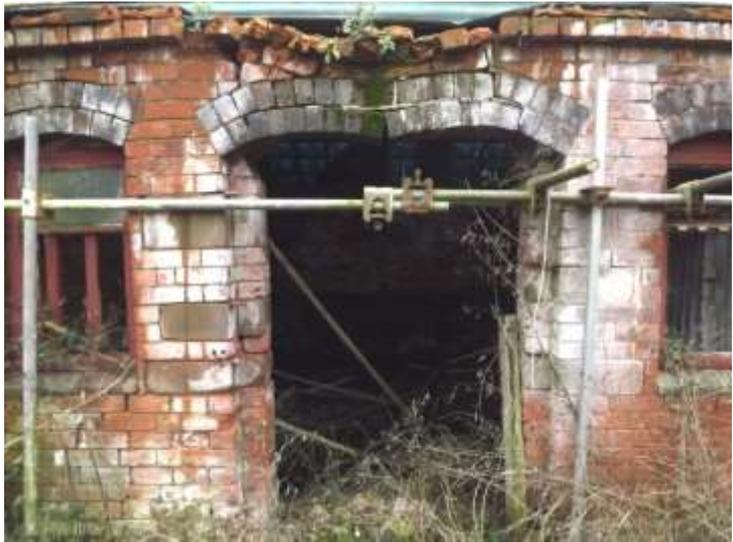
Figure 75 Wall collapse to the cart shed

The former farmyard and mill site has become heavily overgrown and untidy and this has had a negative impact on the appearance of the Conservation Area. Vegetation growth is evident on all mill and farm buildings and there is excessive vegetation growth to the mill building. This carries a more serious concern than just appearance, as not only can vegetation growth accelerate the rate of decay, but it can also contribute to serious structural problems.

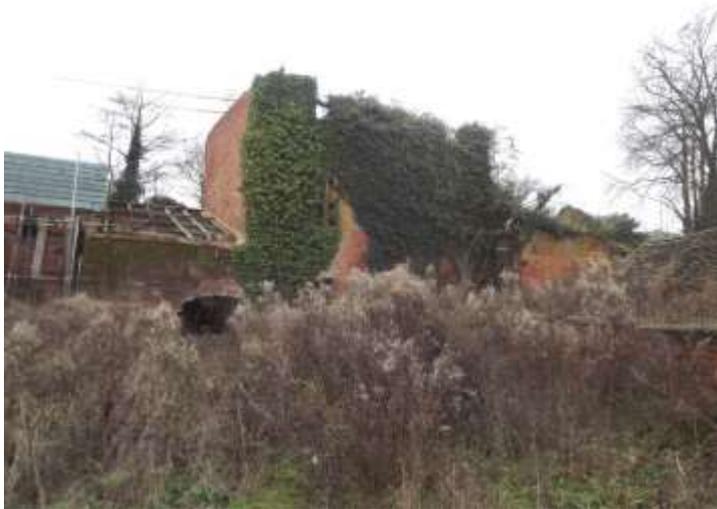
Figure 76 Excessive vegetation growth to the mill building

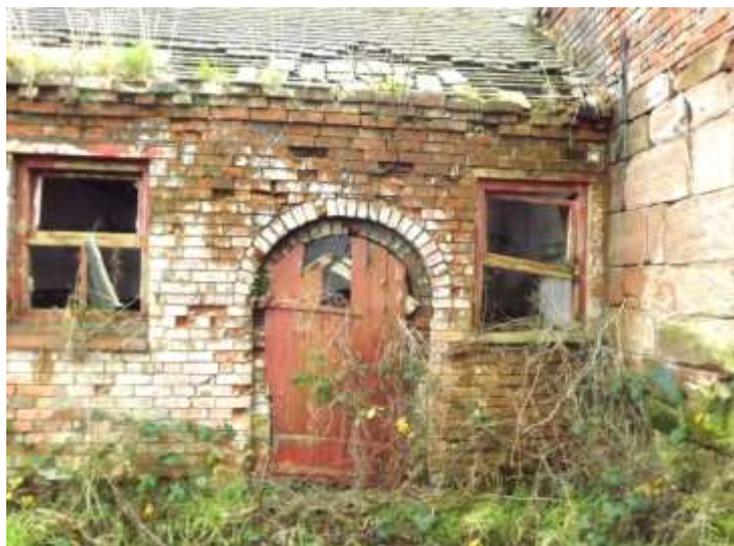
Figure 77 Damage and decay to cowshed

Decay and deterioration of historic fabric has occurred to the mill and associated buildings. Historic bricks and roof tiles have been lost through damage to the mill and the subsequent decay through neglect. There is a notable loss of roof tiles from damage, theft and removal. Some roof tiles have been salvaged for storage and the roofs covered for weather proofing, although there is a notable lack of protection to the piggery.

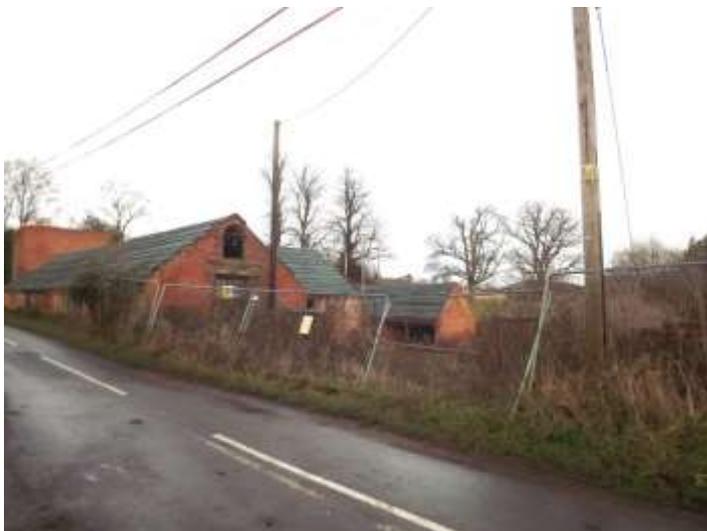
Figure 78 Weather proofing to roofs of mill and farm buildings

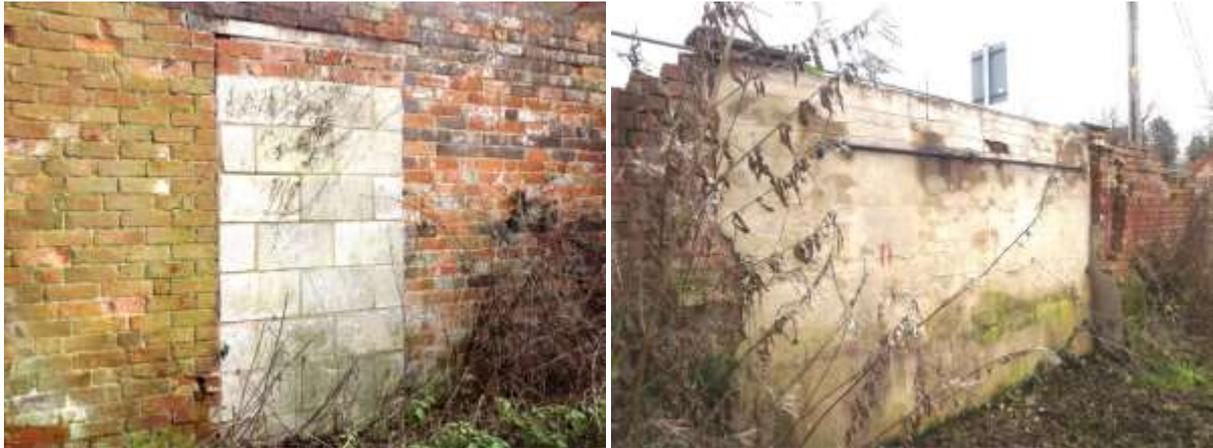
figure 79 Inappropriate materials used to block up doorways and cover walls have a negative impact on the Conservation Area.

The use of 20th century materials within the Conservation area impacts on the appearance of some buildings. Blocked up windows and doors, the use of breeze blocks to the mill building and failed concrete render to an historic boundary wall, all have a negative visual impact on the Conservation Area. Non-historic paint colours have been used to some buildings, which create a noticeable conflict to the historic colour palette.

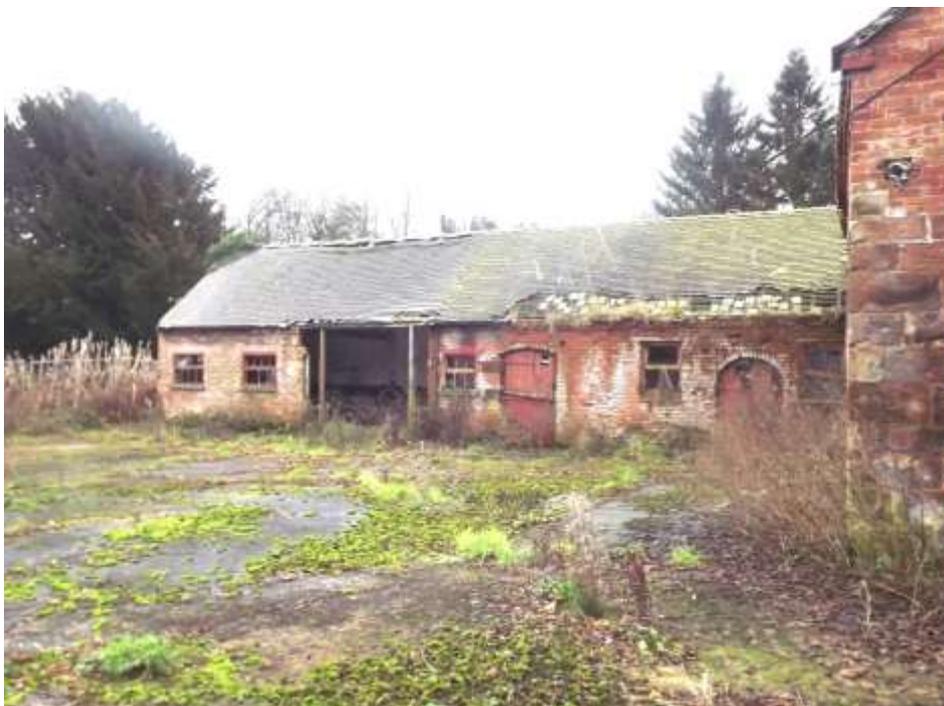
Figure 80 The cowshed to the rear of the former barn has been subject to heritage crime

The Walk Mill site has been subject to some heritage crime. The theft of some roof tiles has necessitated the removal of others for preservation and protection. The barn and cowshed retain the majority of roof tiles although many are damaged and missing which has had a negative impact on the building. In addition, this building has been subjected to some graffiti within the rear cowshed section.
