Forton and Meretown Conservation Area Appraisal

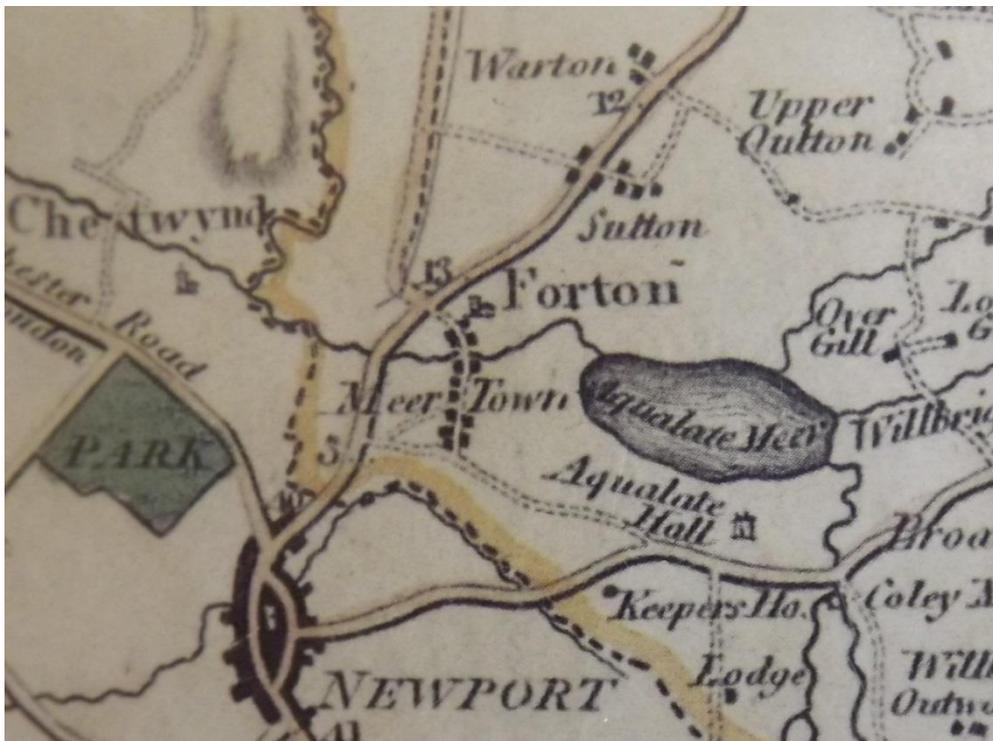
Figure 1 Yate's Map of 1798 shows the linear settlement of Forton and Meretown

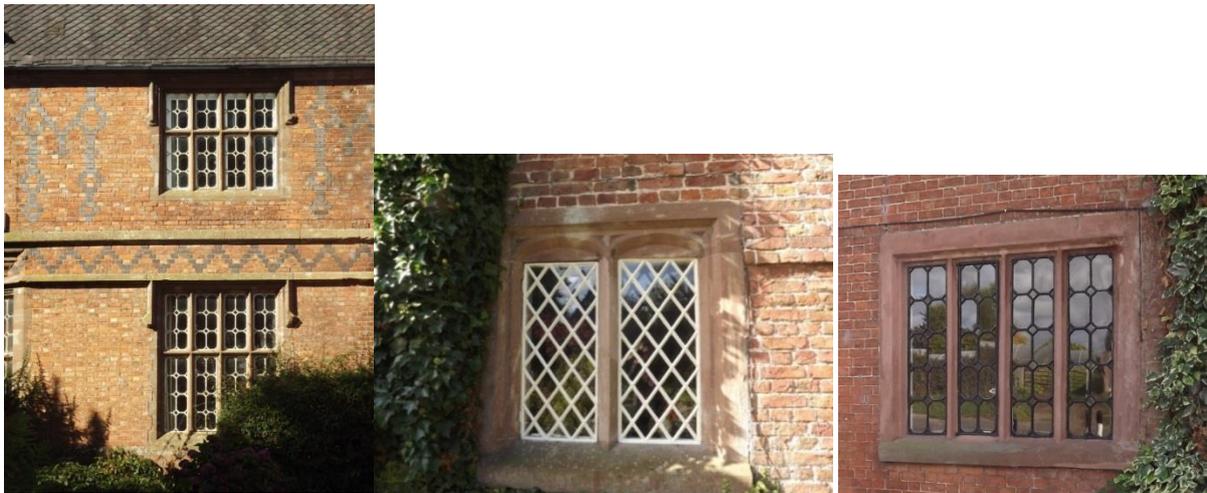
Figure 7 The distinctive windows of the conservation area seen at Meretown Grange, Brook House and the Swan

3.3.2. Coalbrookdale iron casement windows with diamond lattice glazing bars set in a moulded, Tudor arch stone, mullioned frame are found throughout the conservation area. Particularly good examples are seen at Brook House, Meretown Cottage and Meredale House. This distinctive window style contributes significantly to the character and appearance of the Forton and Meretown Conservation Area. Other historic windows are found at Meretown Grange which has stone transomed windows with decorative iron lights, a feature mirrored at The Swan public house, and there are good examples of eight over eight sash windows at Meretown Farm.

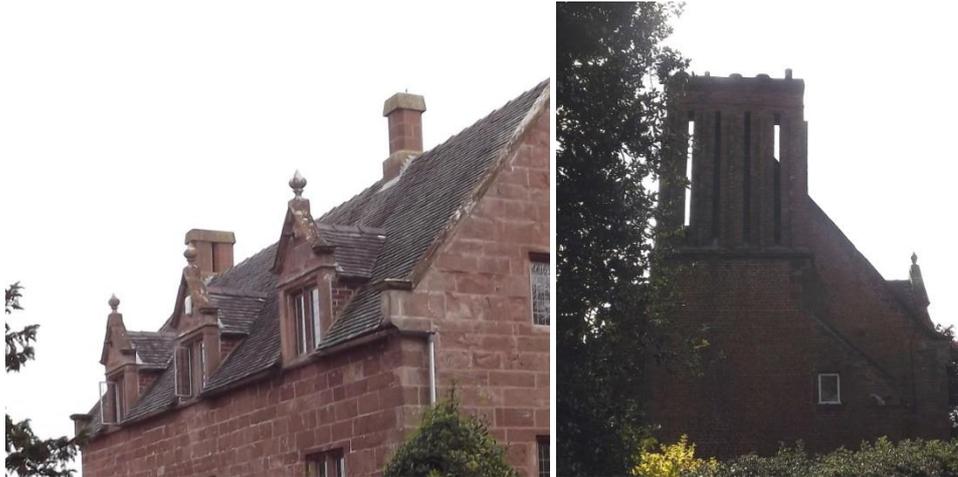
Figure 8 Roof dormers and finials at Forton House and chimney stacks to Forton Hall

3.3.3 Dormer windows are a characteristic feature within the conservation area and take the form of either full dormers, as seen at Forton House or, more frequently, half-dormers as at the Old School House. The dormers give a vertical emphasis to the buildings and many are finished with decorative stone finials. Chimney stacks and pots also feature strongly within the conservation area adding further to the verticality of the buildings; the exceptional chimney stacks of Forton Hall are worthy of note.

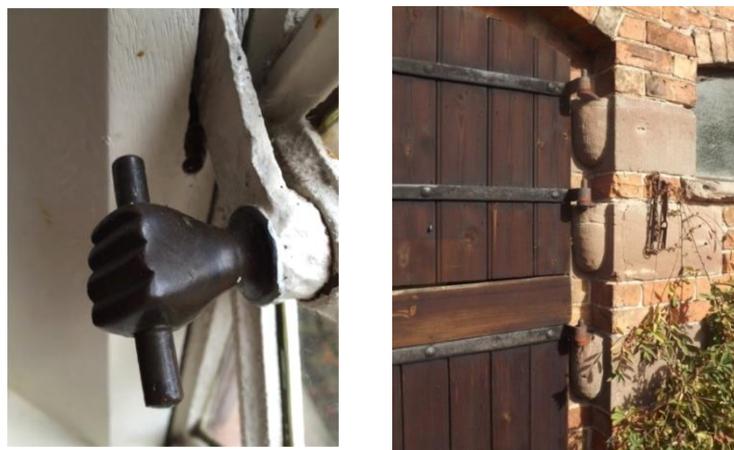
Figure 9 Brass 'hand and scroll' and cast iron window catches and moulded quoin hinge holders

3.3.4 There are a variety of bespoke decorative and architecturally attractive features in Forton and Meretown. The brass 'hand and scroll' and cast iron window catches made in Coalbrookdale in Ironbridge are thought to be exclusive to Meretown, and the moulded hinge block quoins carved from ashlar stone form an integral part of the stable building at Brook House.

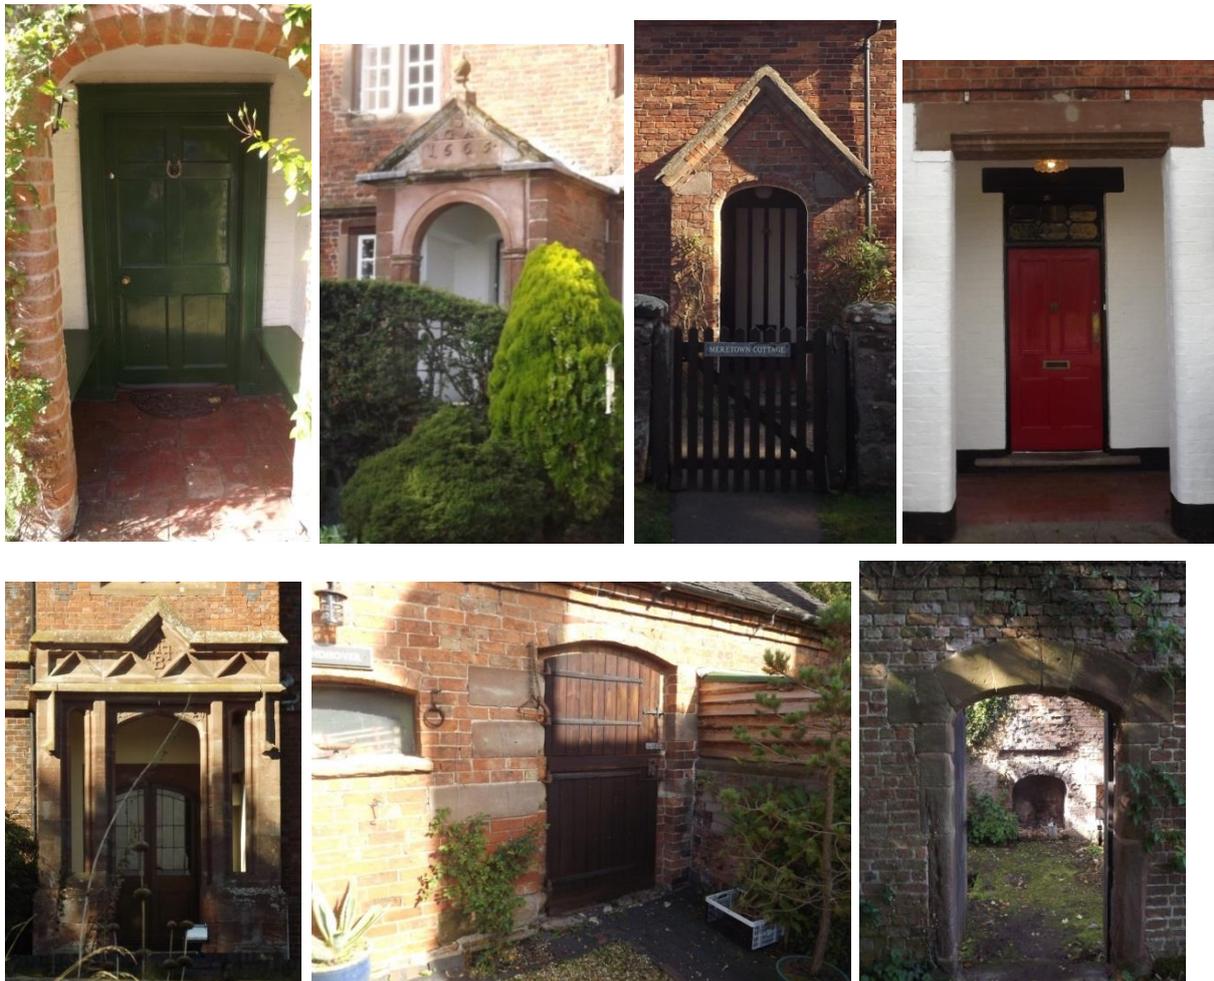
Figure 10 Doors and porches of the conservation area

3.3.5 Doors within the Conservation Area are mostly traditional timber panelled doors or simple plank doors. Doorways are enhanced by distinguished porches which range from the highly ornate stone carved to the more simple brick and pitched tile roof porches. Some porches are recessed back beyond a projecting central gable as seen at the Swan Public House and Meretown Grange. Traditional stables doors at Brook House and Meretown House, and the surviving stone arched doorway of the mill create a pleasing contrast to the more formal doorways of the houses.

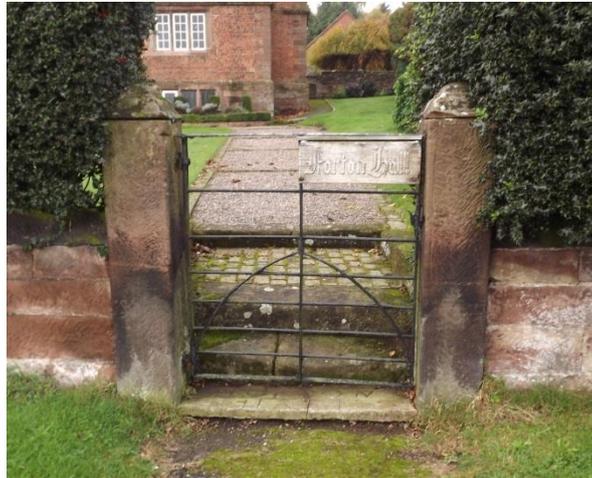
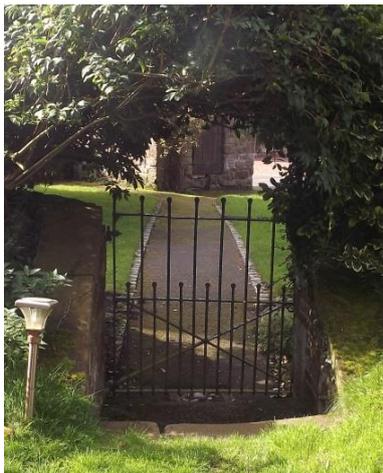
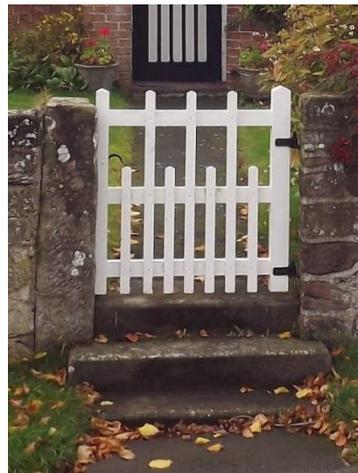
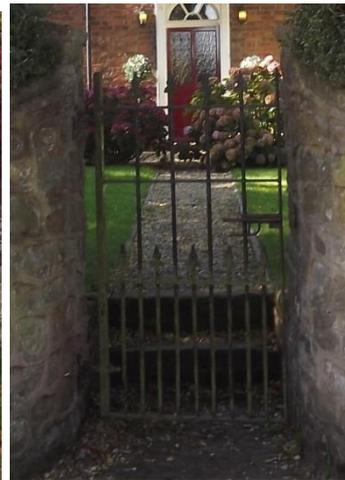
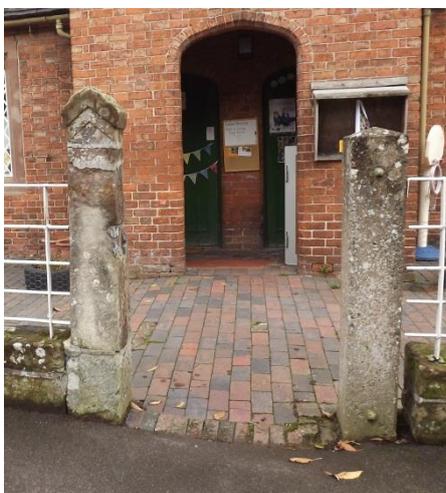
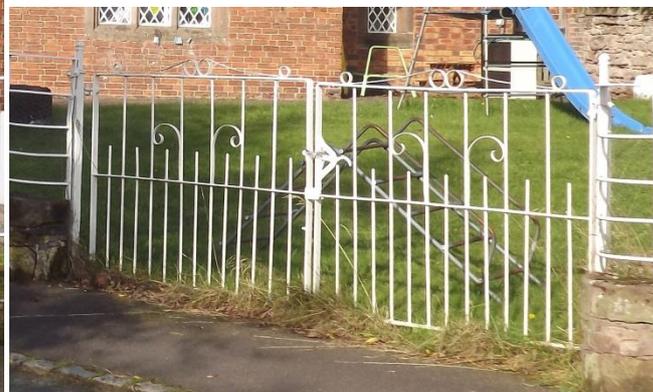
Figure 11 Gates and gateposts of the conservation area

3.3.6 Gates and gate posts feature throughout the conservation area and create a traditional, well-defined entrance at many of the houses and cottages. Stone gateposts and iron gates combine with simple picket gates to give an organised and clearly defined entrance to many of the houses and cottages.

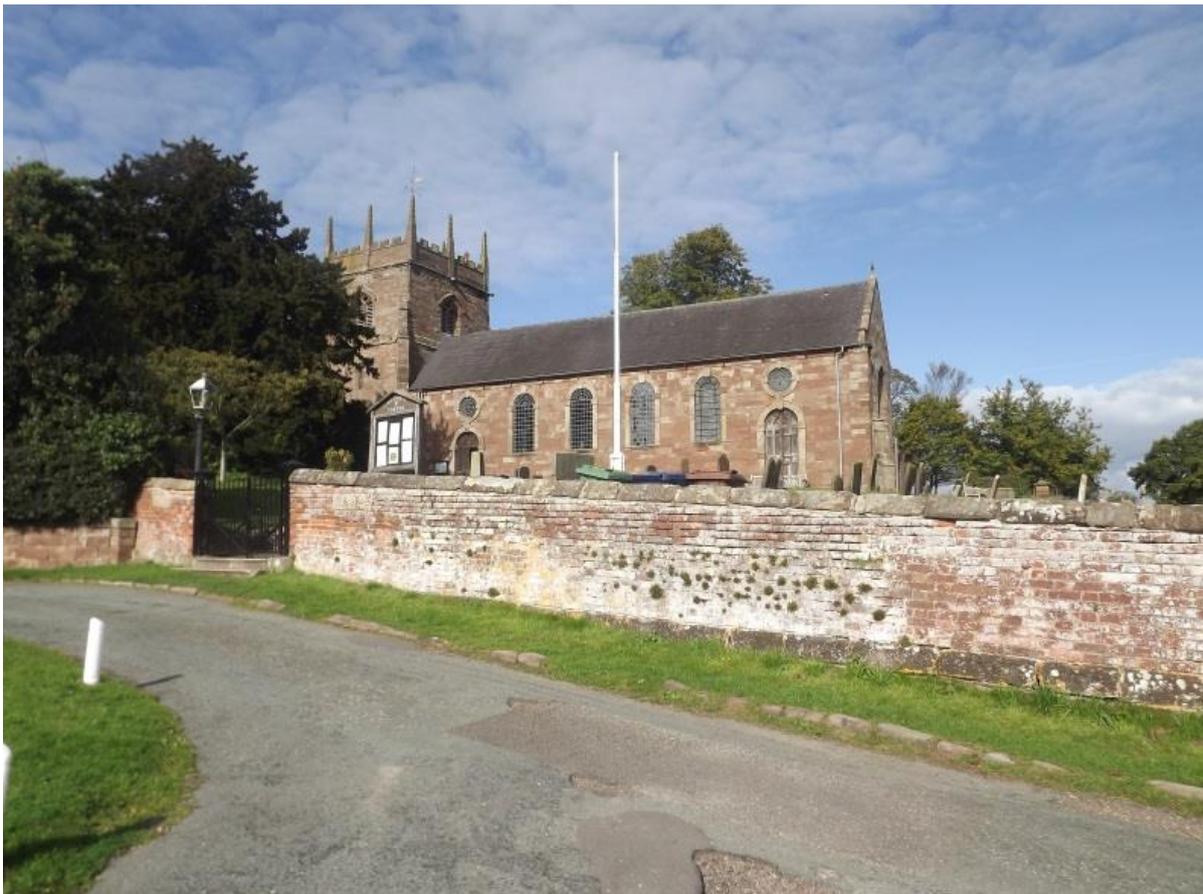
Figure 12 Church of All Saints

Built of dressed sandstone the medieval tower of the church rises to the west, the chancel east wall and the north aisle are also medieval. The nave is reputed to have been rebuilt in 1723 as part of extensive alterations inspired by Acton Baldwyn, then heir to the manor of Mere, whose arms appear in the centre of the south wall. There was later restoration work in the very early 20th century when the 18th century box pews were removed.

EXTERIOR: West tower with early C13 base, angled buttresses and late medieval upper part with a decorated frieze and eight pinnacles. The chancel is of early C13 date, possibly earlier, with a small window to the north. The east window is a Victorian replacement in Perpendicular style. The east window of the aisle is of C15 date with quatrefoil detail. The north wall (aisle) is of C14 with Decorated style windows. The south wall of the nave was rebuilt in 1723 and consists of 1:4:1 bays; four tall keyed round-arched windows flanked by round arched doors surmounted by keyed oculi. INTERIOR: To the north of the nave is an arcade of 1723 comprising six Tuscan columns on high plinths with round arches. The nave and chancel have a continuous flat plaster ceiling with moulded cornice. The northern aisle has a C19 close boarded roof with arched braces and pendants. The organ and alabaster monument (see below) are situated at the east end of the aisle. Much old clear glass survives. FITTINGS: Stylish C18 marble baluster font with waterleaf decoration presumably contemporary with the early C18 remodelling of the church. There is also a plain wooden C18 pulpit. Good modern screens of Classical Character. MONUMENTS: C17 Alabaster table tomb with effigies to Sir Thomas Skrymsher (1633) and his wife Anne (1656) by Garrat Hollemans. The two effigies lie beneath a flat canopy on four columns; the couple's children are represented along the side of

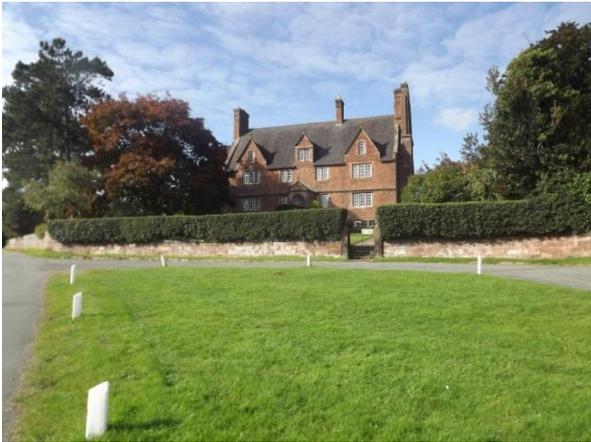
Figure 13 Forton Hall

Located to the west of All Saint's Church, Forton Hall is a 17th century hall of four storeys including a basement and attics. Of red brick and tile over three bays with stone quoins and eaves, the building is symmetrical on a rectangular plan. Windows are stone mullioned and there are three half-dormers with gables and stone ball finials. Large external chimney stacks. A stone string course separates the ground and first floors and in the centre is a stone porch which has a round-headed opening and a date inscription of 1665. Its proximity to the church illustrates the importance of the Hall. Apart from a Georgian bay window and some additional chimneys, the house is little altered and stands as a good example of its period.

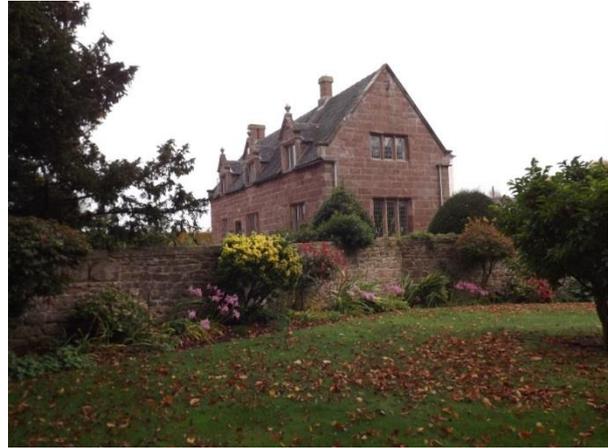
Figure 14 Forton House

3.5.3 Forton House

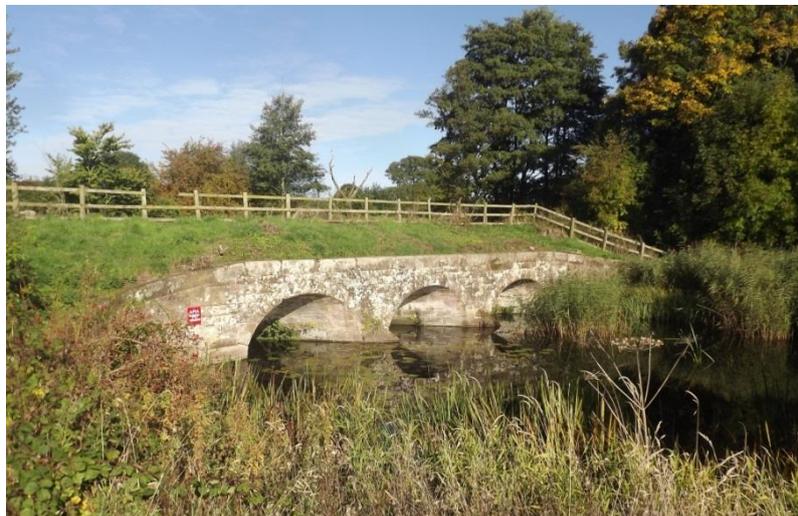
Figure 15 The Forton Canal Aqueduct

A Scheduled Ancient Monument, this skew arched aqueduct and road bridge was built by Thomas Telford to carry the Newport Branch Canal and public road across the River Meese. A novel feat of engineering, the aqueduct combined the re-aligned road and a three arch aqueduct for the canal together in a single structure built of ashlar stone. The bridge is unique in Staffordshire, an unusual structure in the country as a whole, and an important monument to the technology of the canal era. Just south of the aqueduct, Skew Bridge combines three bridges: one over the Strine Brook, one over the canal and a road bridge. All three bridges are at 'skewed' angles giving the structure its name.

The multi span canal aqueduct and skew bridge 90m ENE of Brook House survives in good condition. It is representative of Thomas Telford's engineering achievements and an important period in the development of the network of waterway transportation and associated structures.

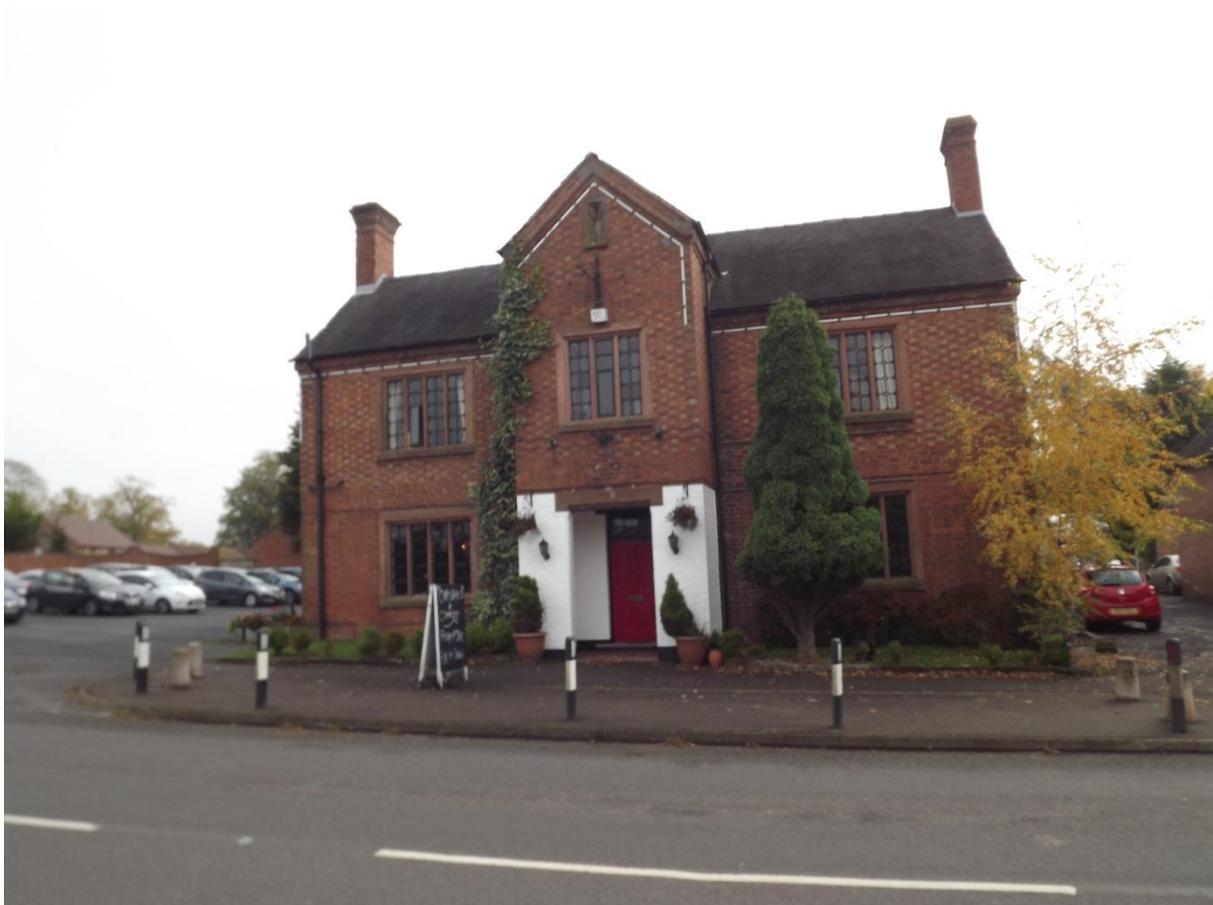
Figure 17 The Swan

A former 18th century coaching inn, The Swan is a substantial building located on the main A519 road through Forton. Of red brick and tile, the building has the characteristic stone mullion windows and decorative panes. A projecting bay to the central gable houses a recessed porch and there are several large chimney stacks.

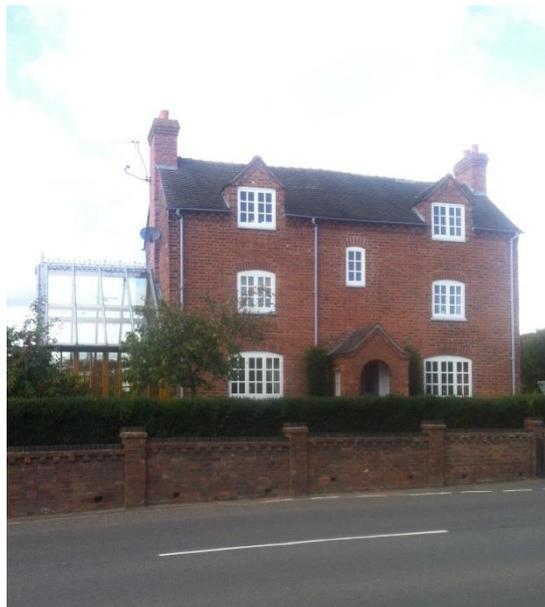
Figure 18 Hi Vue

A traditional red brick and tile former farmhouse set over three storeys and three bays with half-dormers passing through the roof space and traditional style casement windows. The extant building appears to date from the early 19th century although there is evidence of an earlier building on this site. The building forms part of an historic linear group of buildings along with Swan Farm Cottages.

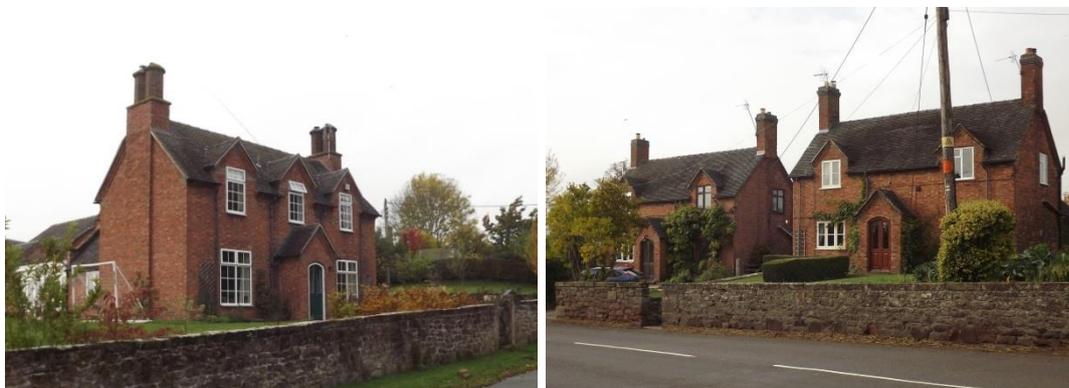
Figure 19 Swan Farm and Swan Farm cottages

3.6.3 Swan Farm and Swan Farm Cottages display the traditional, estate village architectural style built in the 19th century during the re-building of the village built by Sir Thomas in the style of some of the other larger buildings in the village, although they have regrettably lost their lattice windows.

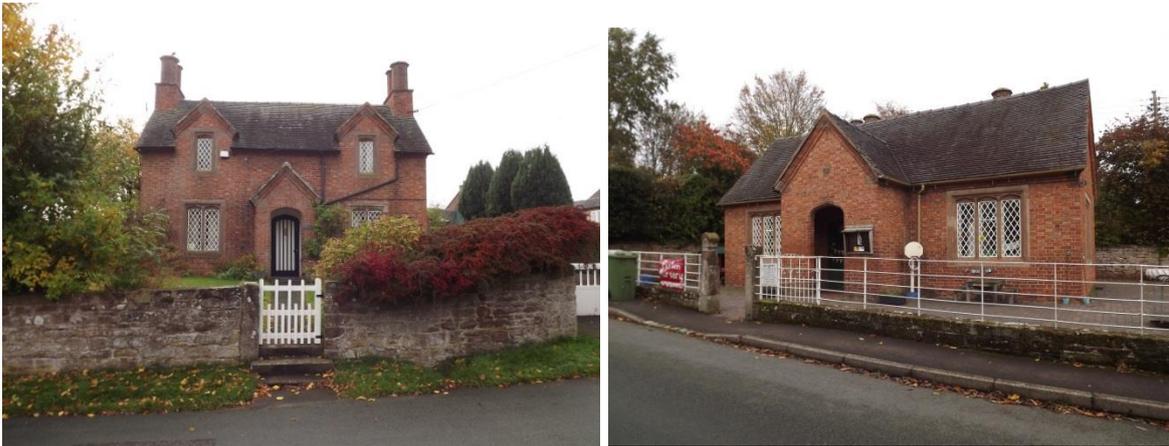
Figure 20 The Old School House and the former National school

3.6.4 The Old School House and the former National school are also buildings of the early 19th century re-building period and retain many of the distinctive neo-Tudor features with half-dormers, front porch and mullion lattice windows. The projecting gable of the school displays the date stamp of 1843. The former National school is currently used as a nursery school.

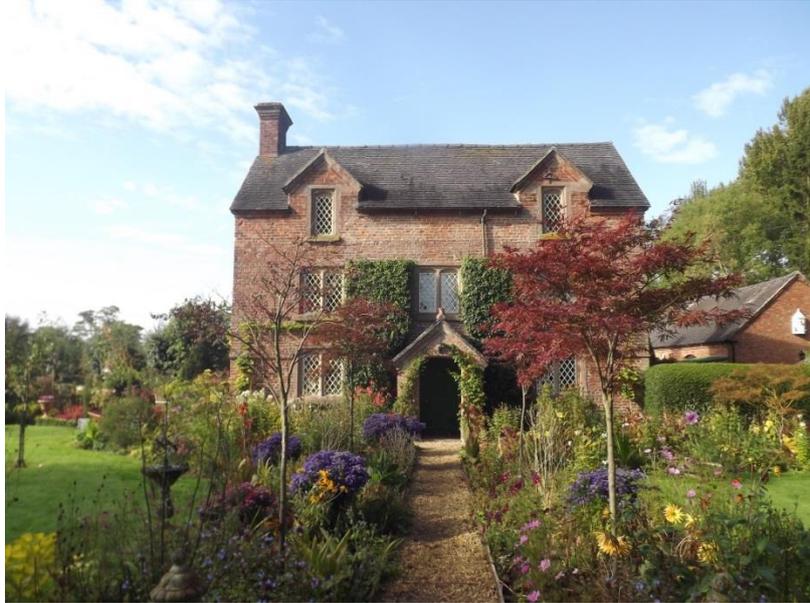
Figure 21 Brook House

Located next to the Canal Aqueduct and Skew Bridge, Brook House was probably the original mill house. Thought to have 15th century origins, the house itself contains 17th century brickwork, but was extensively altered in the mid-19th century when it assumed its present Jacobethan appearance, with gabled half dormers and diamond lattice windows. A picturesque house over three storeys, Brook House is set in immaculate gardens with the River Meese and a small tributary with a stone culvert passing through the grounds. To the rear of the house lies a brick and tile stable block and former piggery both of which retain original fenestration and architectural features.

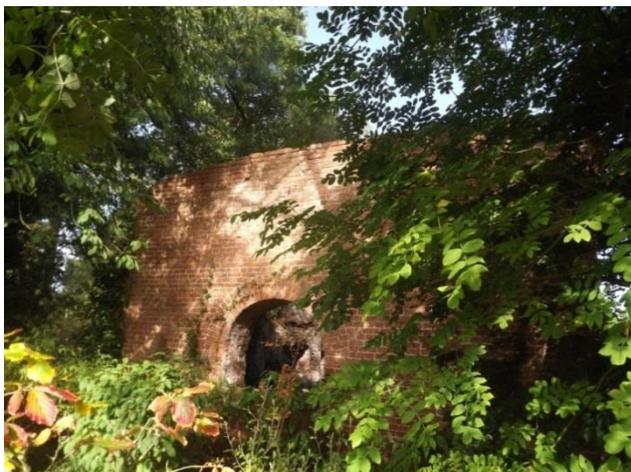
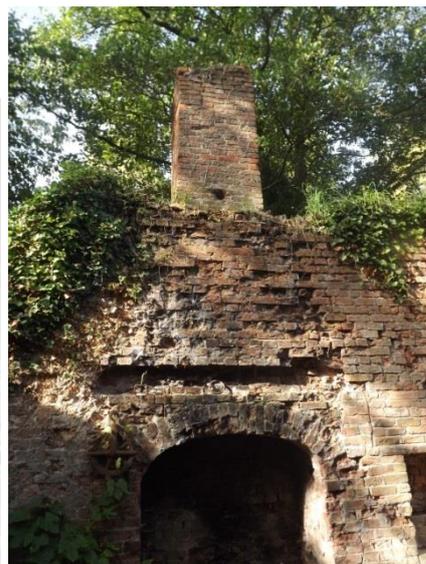
Figure 22 The mill

The mill itself stood in a small red brick building on a stone base of 17th century date alongside the River Meese. Now derelict this former hemp mill is thought to stand on the site of a Saxon mill, mentioned in the Domesday Book, and retains its open hearth and chimney stack and stone entrance doorway. The waterwheel was an undershot type which along with its machinery was dismantled in the 18th century. The sluices and culverts are however, still in place and the iron sluice gate handle survives within the mill building.

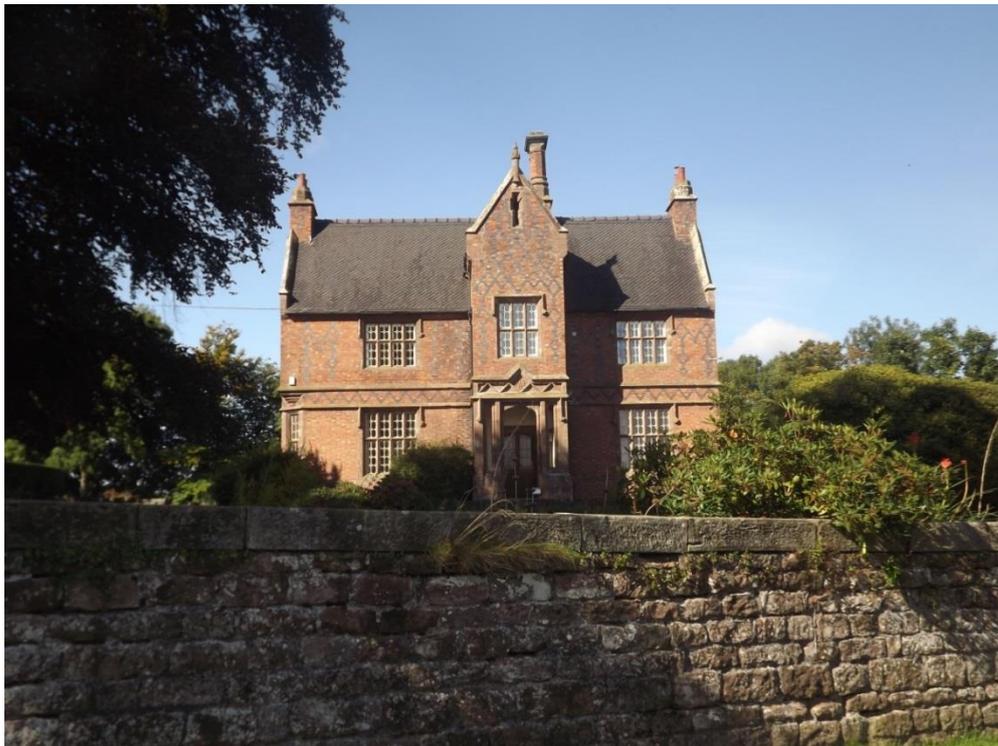
Figure 23 Meretown Grange

Entering the hamlet of Meretown, the impressive Meretown Grange sits on a bank to the west. Formerly Bank House Farm, the building is gabled with black diaper patterns in the brickwork, distinctive ornate chimneys and stone finials, and stone mullion and transom lattice windows with hood moulds. The central projecting gabled bay incorporates a decorative stone porch. To the south of the house former outbuildings have been converted to three residential dwellings, now known as Meretown Court.

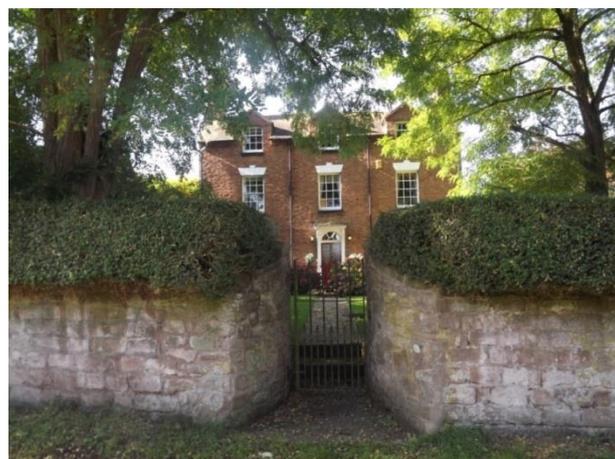
Figure 25 Meretown Farm

A late 18th century farmhouse, Meretown Farm is a three storey farmhouse over three bays with gabled half-dormers and eight over eight sash windows with stone lintels and projecting keystones.

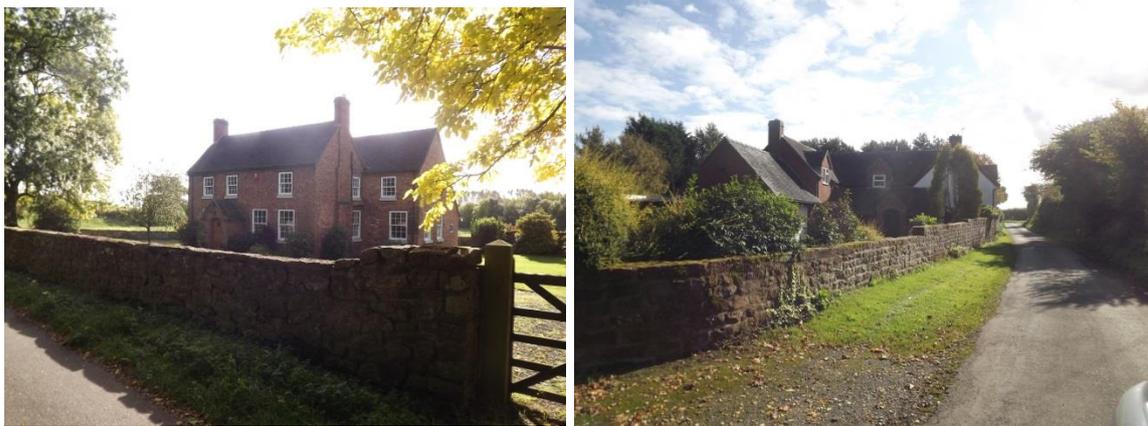
Figure 26 Gorleston Cottage and Warwick Cottage

3.6.12 Warwick Cottage and Gorleston Cottage lie to the south of the conservation area, slightly more dispersed from the other buildings. Warwick Cottage shows evidence of the neo-Tudor features found elsewhere in the village although it has been much extended and altered and Gorleston Cottage is an 18th century cottage which has been extended to the side elevation. This two storey cottage is built in the local vernacular of red brick and tile, and has eight-over-eight sash windows although these appear to be 20th century replacements.

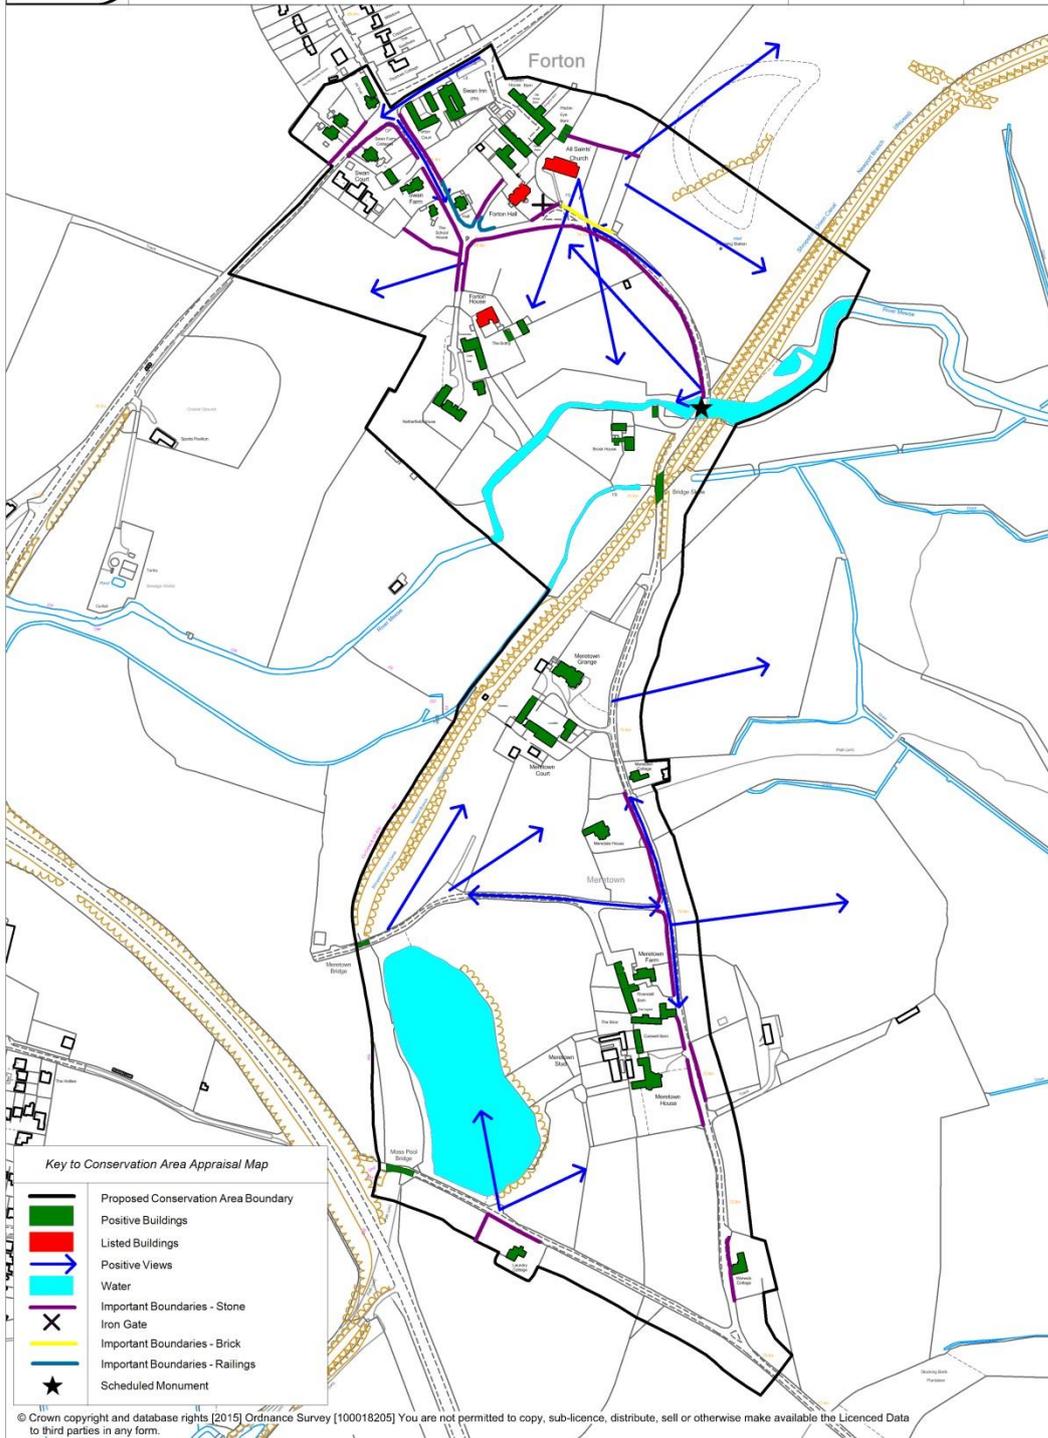
Key to Conservation Area Appraisal Map

- Proposed Conservation Area Boundary
- Positive Buildings
- Listed Buildings
- Positive Views
- Water
- Important Boundaries - Stone
- Iron Gate
- Important Boundaries - Brick
- Important Boundaries - Railings
- Scheduled Monument

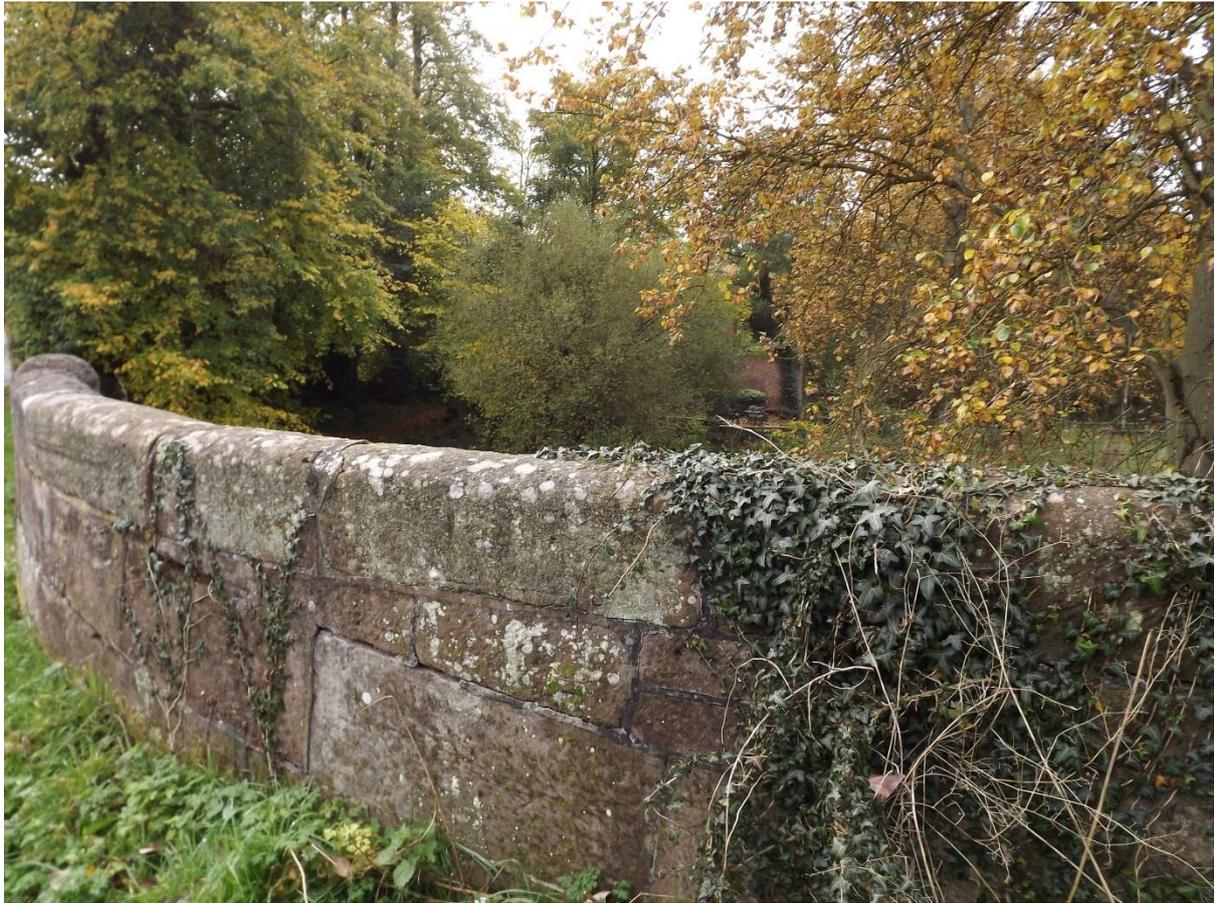
4.2.4 The Canal Aqueduct bridge is a key focal point of the conservation area. This Scheduled Ancient Monument combines a road bridge, aqueduct and canal bridge, and carries the road from Forton into Meretown. Views from the canal bridge are of the former Newport Branch Canal and the River Meese to the northeast, and from the road bridge above the aqueduct, glimpse views of the mill provide a focal point to the west.

Figure 30 Glimpse views of the mill from the aqueduct bridge

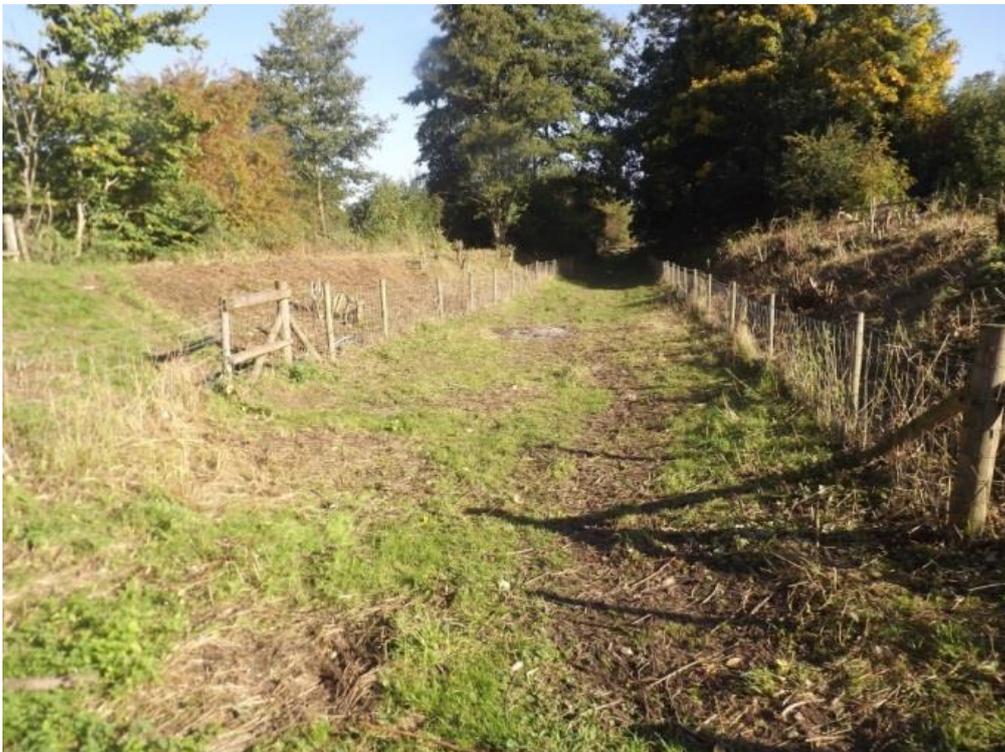
4.3.4 The coming of the Newport Branch Canal through Forton and Meretown in the 19th century made a significant contribution not only to the built character of the area but also to the landscape character. The canal channel is now back-filled and has been assimilated into the landscape creating a corridor of open space through parts of the conservation area. Despite this, evidence of the canal cut is still well-defined in many parts and serves as a tangible visual reminder of what once was a busy branch canal.

Figure 34 Site of the former branch canal to the north of the Skew Bridge

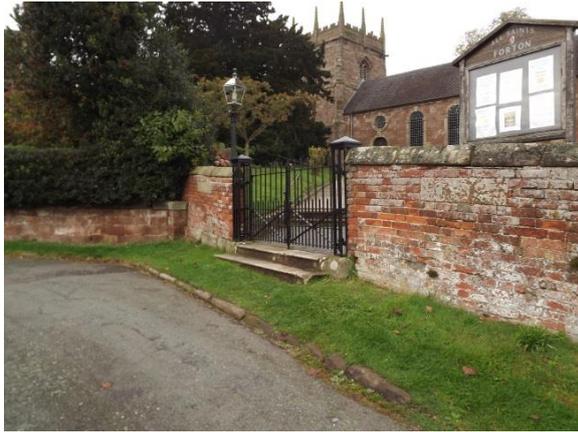
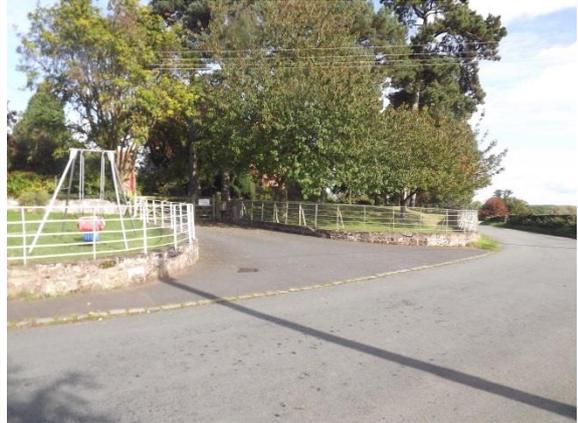
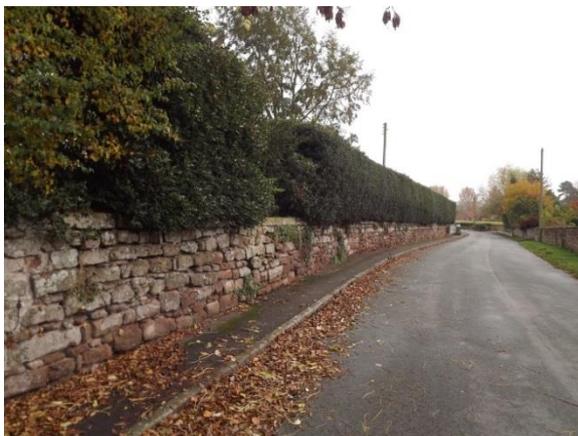
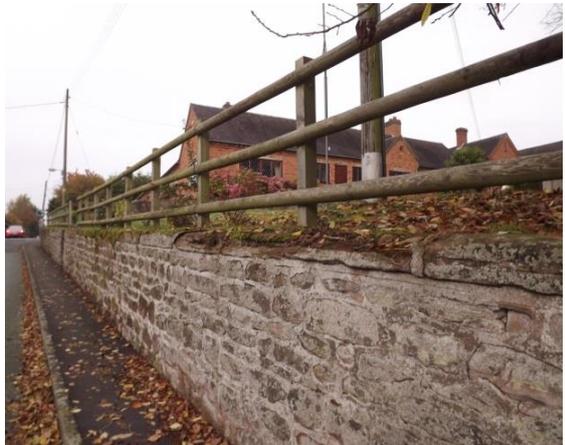
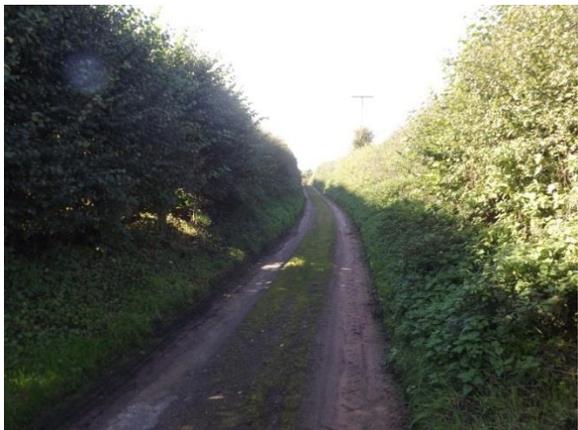
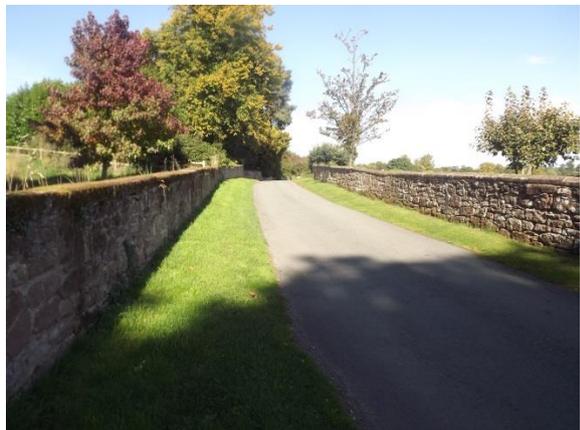
4.6.3 The stone and brick walls that bound the houses of the conservation area tend to create a planned and formal feel, contrasting with the more informal hedges and timber fences which convey a rustic, agricultural character. This is, particularly noticeable through Meretown where the sturdy line of ashlar stone walls regularly gives way to hedgerows and fencing. Breaks in boundaries occur as walls curve up driveways, and entrances to courtyards and driveway surfaces are either of tarmac, brick paving or untreated or gravelled, with some historic cobbles found at Meretown House,

4.6.4 Natural boundaries are also a key feature of the conservation area and the native hawthorn and holly hedgerows that line Meretown Lane create a sense of enclosure and emphasise the narrow winding nature of the lane.

Figure 38 Varying boundary treatments throughout the conservation area

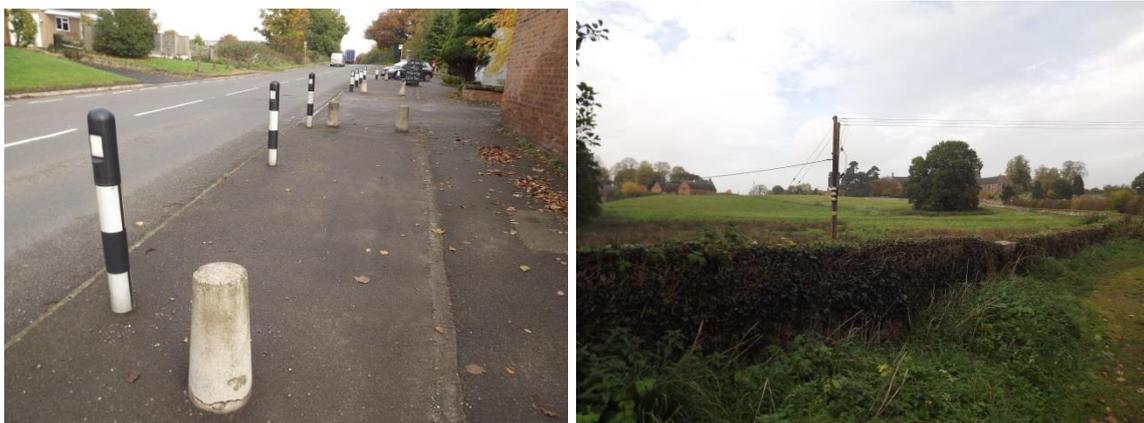
6.3 In the public realm street signage, telegraph wires and columns, and traffic bollards have a tendency to create visual clutter. Any new structures need to be carefully designed and sited in order to minimise the impact on the conservation area. The siting of telegraph posts and wire across an area of significant open green space creates a visual intrusion into the conservation area.

Figure 39 Traffic bollards and telegraph poles and wires create a visual intrusion

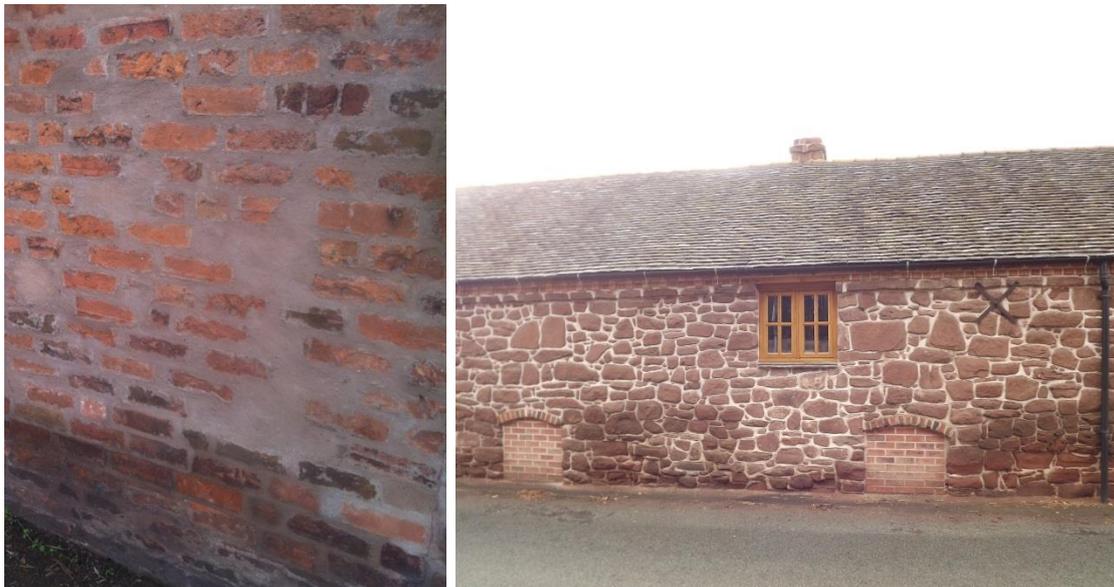
6.4 The buildings of Forton and Meretown are generally well-maintained and in good condition. However, the use of hard cementitious mortar is noted in some areas and is causing erosion of masonry. If the mortar used is harder than the brick or stone, then water will become trapped within the masonry, and cause erosion, particularly by ‘spalling’ in cold weather, when the moisture freezes, expands and blows the face off the masonry. If a damp proof course has been installed, this will then exacerbate the problem. The life of historic masonry can be protected by the use of softer, lime-based mortars which is permeable and thus sacrificial to the decay of the masonry.

6.5 Some cementitious mortars have been applied across the surface of historic masonry which, not only masks the historic material, but when mortar is flush with the masonry there is no channel to allow the water to run off. The over-zealous use of mortar to some buildings has also occurred which creates an unnatural appearance to historic stonework.

Figure 40 The use of cementitious mortar can both mask and detract from historic masonry

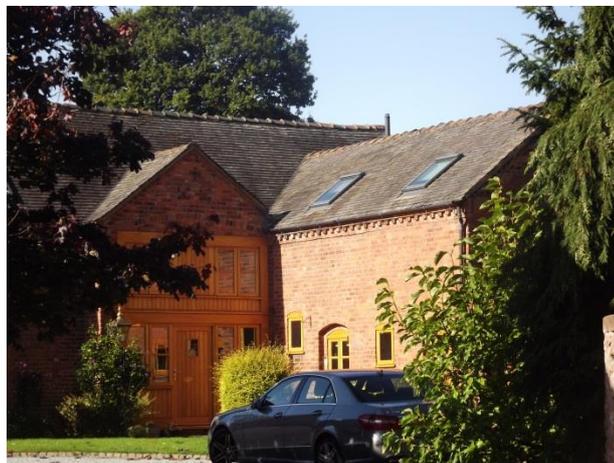
6.6 There has been little development within the Forton and Meretown Conservation Area since designation in 1978 and as such the conservation area has retained much of its historic, unspoilt character. Late 20th and early 21st century development has mostly been kept to the conversion of agricultural buildings to residential dwellings. Whilst some care has been taken with the conversions to retain features, the domestication of agricultural buildings almost always results in a loss or weakening of agricultural character for the following reasons:

- Loss of or alteration of original fenestration, including insertion of new openings and the use of 'timber-effect' uPVC windows
- The addition of raised roof lights
- The addition of chimneys to agricultural buildings
- The domestication of boundaries and creation of gardens breaks up the historic courtyard plan form
- The severing of the relationship between the buildings and the farmhouse by creating courtyard style developments with new names.

Figure 41 The domestication of agricultural buildings can cause loss or weakening of character

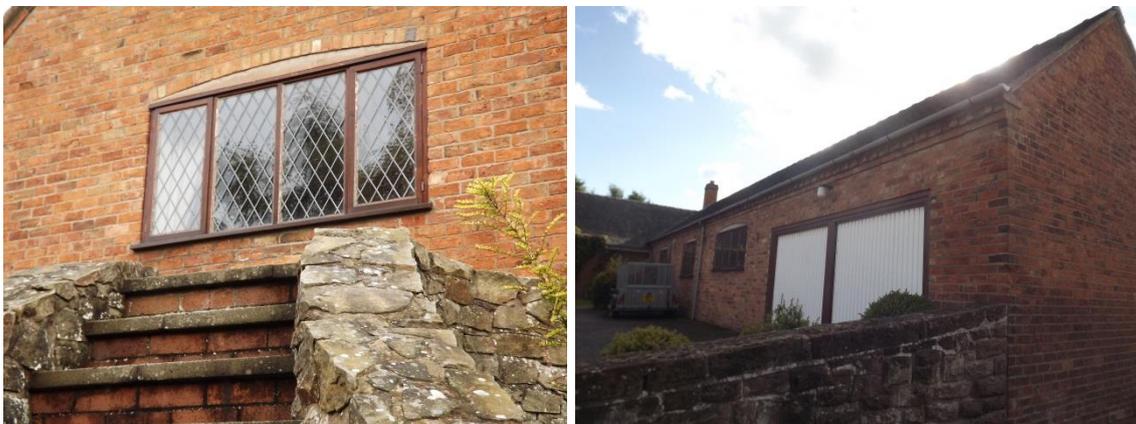
6.8 The use of modern building materials can have an adverse effect on historic character. This is particularly noticeable in Forton and Meretown where there is a distinctive architectural style and high retention of historic materials. Whilst many of the buildings retain their historic windows, some have been replaced in non-historic materials or styles such as uPVC or stained hardwood and in non-traditional top-opening styles. Where this has occurred, the variance with the established historic character is clear. In some cases there has been an attempt to mimic the neo-Tudor lattice iron windows with modern replicas, the result being one of an historic pastiche

Figure 42 Modern windows and doors can have an adverse effect on historic character
