Forton and Meretown Conservation Area Appraisal

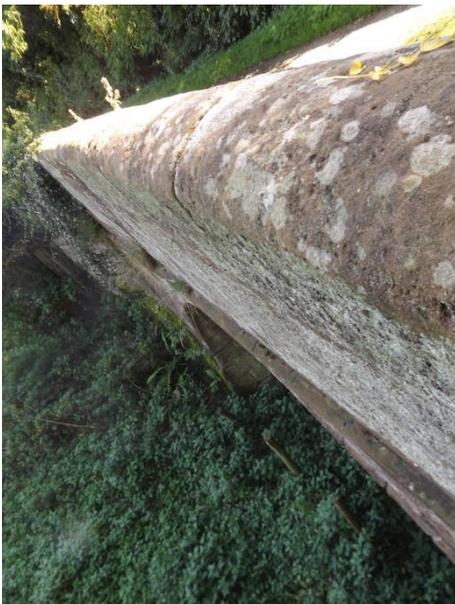
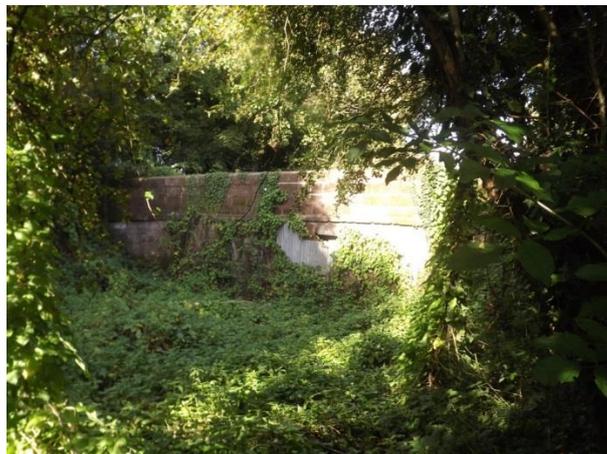
Figure 43 Meretown Bridge and Moss Pool Bridge

7.2 Along this small stretch of the former branch canal there remains intact two canal bridges. Meretown Bridge and Moss Pool Bridge are fine examples of traditional Thomas Telford engineered canal bridges and form a distinctive character group along with the nationally significant Skew Bridge. Currently defunct as canal bridges, and subsequently neglected significantly, the reinstatement of these bridges would be considered to be a positive enhancement to the conservation area.

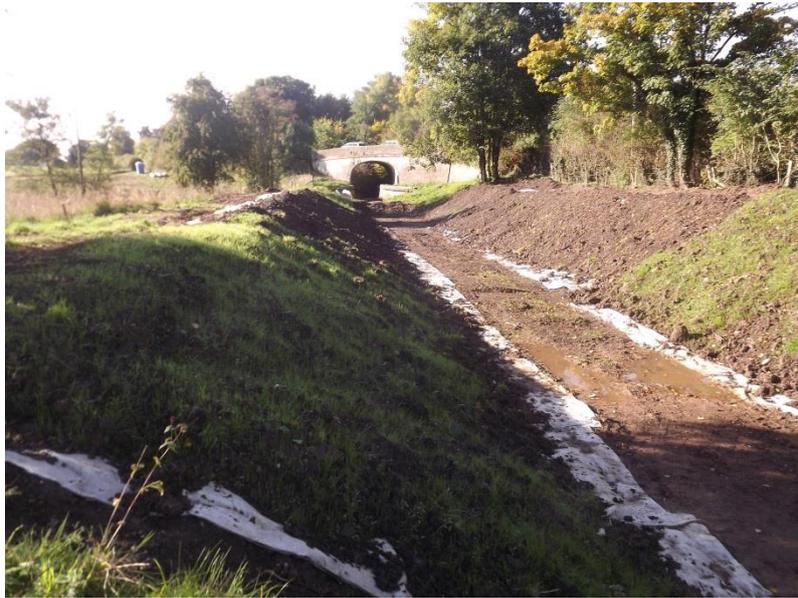
Figure 44 Recent excavation of the Newport Branch Canal looking towards Skew Bridge

7.3 A project to restore the Newport branch canal, from Norbury Junction in Staffordshire to Wappenshall in Shropshire, by the Shrewbury and Newport Canals Trust began in 2000. As part of the restoration the Trust identified a potential initial phase of restoration which includes the section of canal which travels from Forton to Newport, and includes the complete section which travels through the Forton and Meretown Conservation Area. Round one Heritage Lottery Fund (HLF) funding has been secured by the Trust and in 2015 excavation work began.

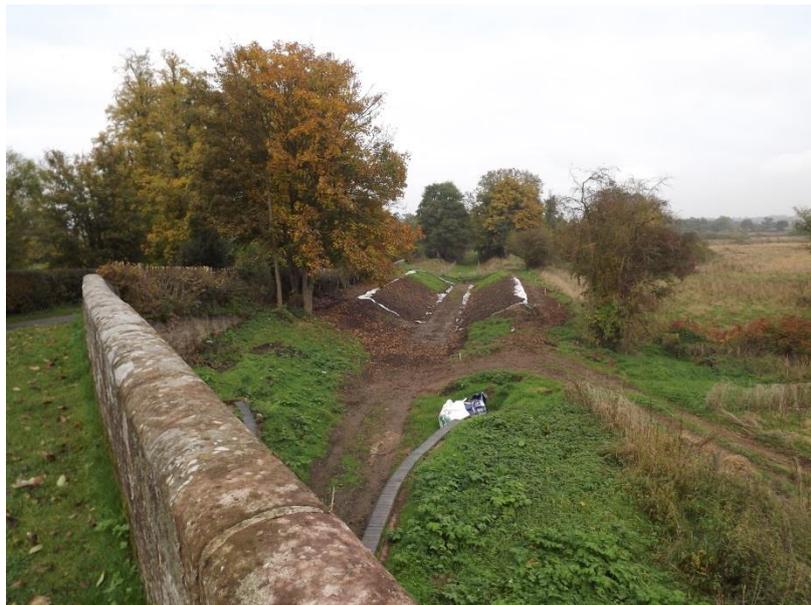
Figure 45 View of branch canal excavation from Skew Bridge
